## PROJECT MEMORANDUM SCE DPV2 TRANSMISSION PROJECT

**To:** Billie Blanchard, Project Manager, CPUC  
**From:** Vida Strong, Aspen Project Manager  
**Date:** August 27, 2012  
**Subject:** Weekly Report 53, July 16 to July 22, 2012 (revised)

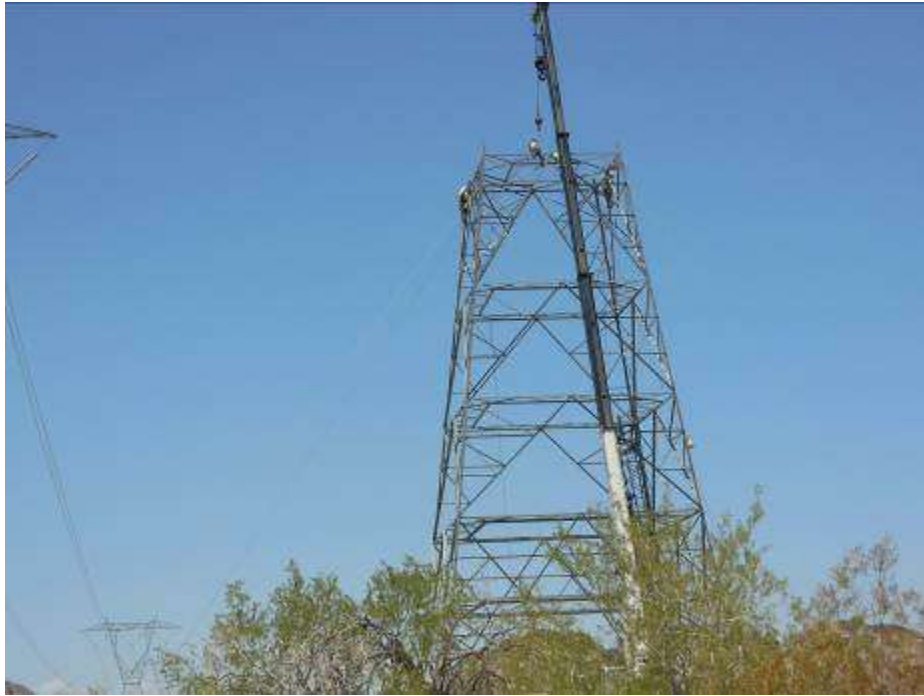
**Figure 1.** Assembly activities at Tower 2518.

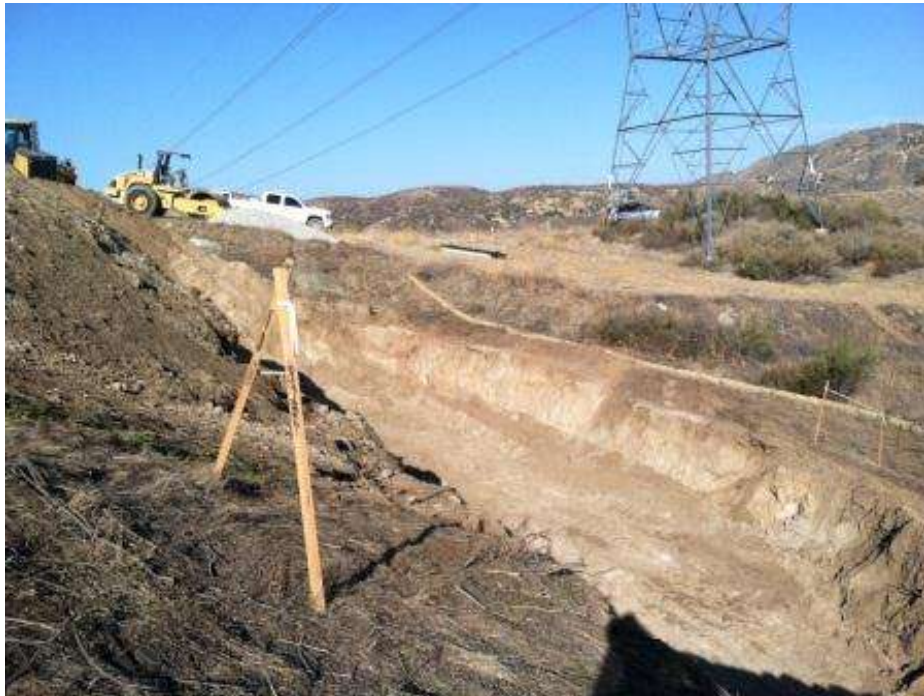
**Figure 2.** Grading activities at Tower 1110.

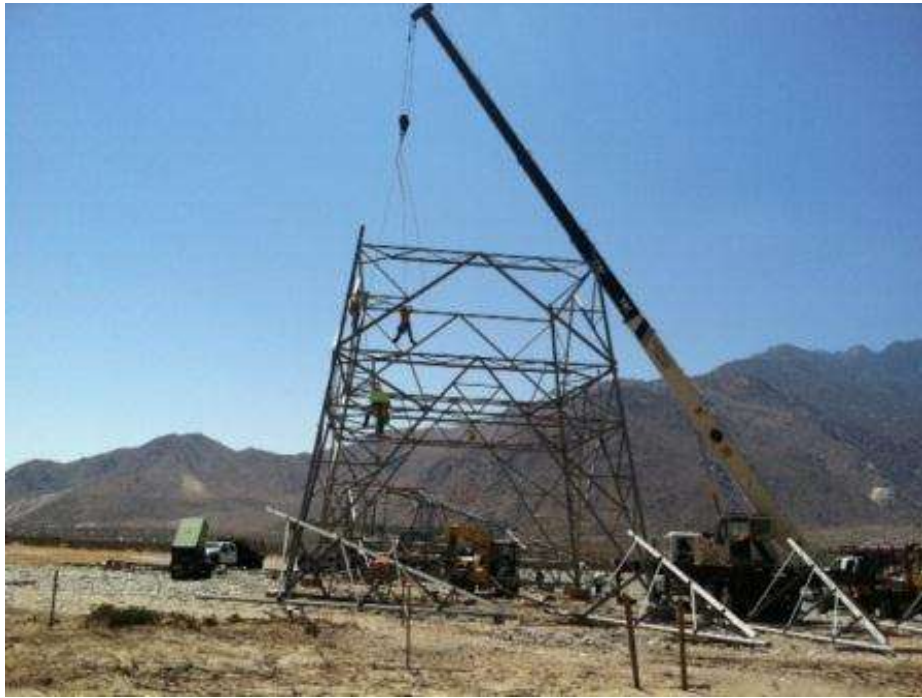
**Figure 3.** Tower assembly at Tower 1030.

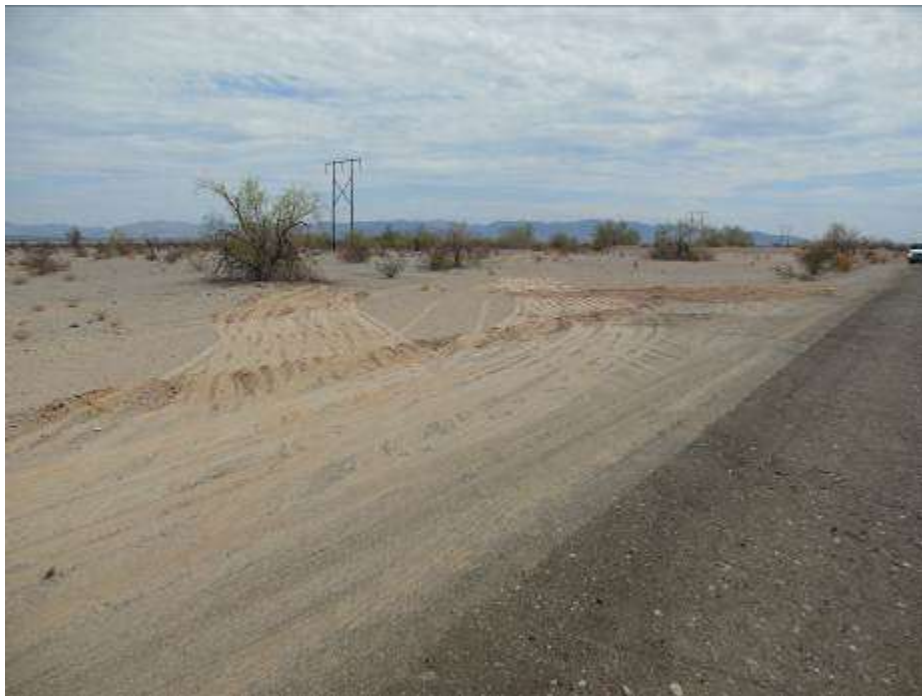
- On July 19, a PAR subcontractor (JD Reed) unloaded a drill rig near the ROW entrance to Tower 2604 along Chuckwalla Road. The drill rig was then escorted by an SCE Biological Monitor to Tower 2601. After the SCE Biological Monitor and other associated escort vehicles had left the location, the transport vehicle operator backed the approximately 50-foot long “low-boy” trailer off the northern shoulder of Chuckwalla Road two times and then proceeded to become stuck in the soft sand along the southern shoulder. A water truck was being used to extract the trailer from its position when the CPUC EM, the SCE General Monitor, and the Kenny Construction Coordinator arrived onsite. It was undetermined whether or not the vehicle operator had received project WEAP training because he fled the scene upon being approached by compliance personnel. The incident resulted in multi-wheeled tracks extending approximately 40-50 feet and impacting roughly 0.106 acre of desert tortoise habitat and 200-300 square feet of poorly developed desert pavement surface (see Figure 4). Consequently, the CPUC issued NCR #8 on July 23.

**Figure 4.** Multi-wheel tracks where trailer entered area outside of northern shoulder of Chuckwalla Road.

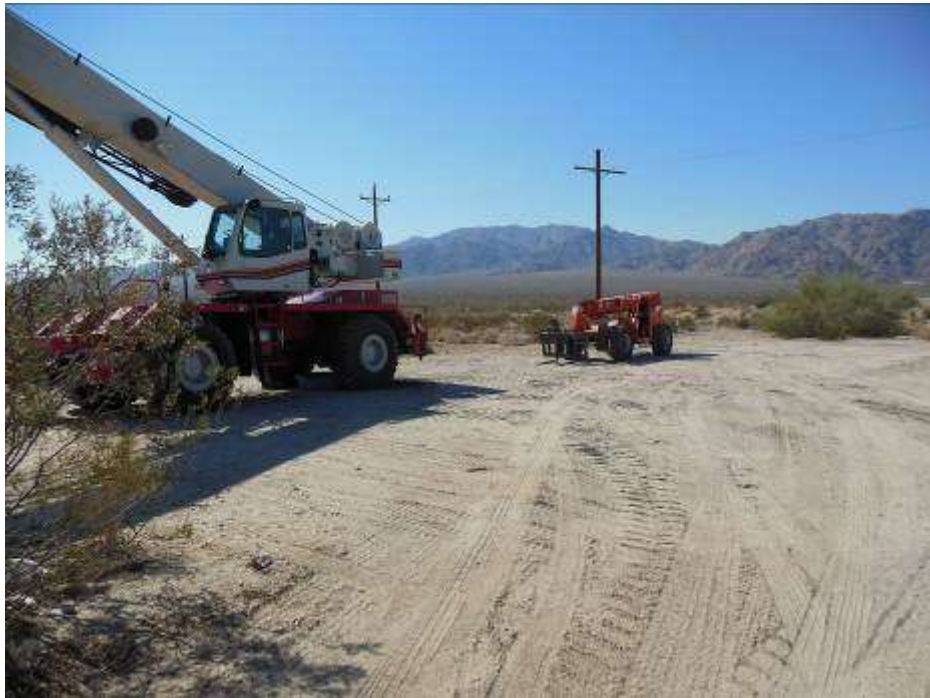
- There were three reported incidents associated with excessive track-out during the subject period.
- On July 17, the CPUC EM observed a crane and forklift staged at the intersection of Hayfield and Gasline Roads (see Figure 5). Although the roads in this area are approved for project access, they are not authorized for staging of equipment. The CPUC EM notified the SCE Environmental Coordinator (EC) and it was confirmed that the equipment was removed the following morning.

**Figure 5.** Crane and forklift parked in an unapproved area for staging equipment near Hayfield Road.

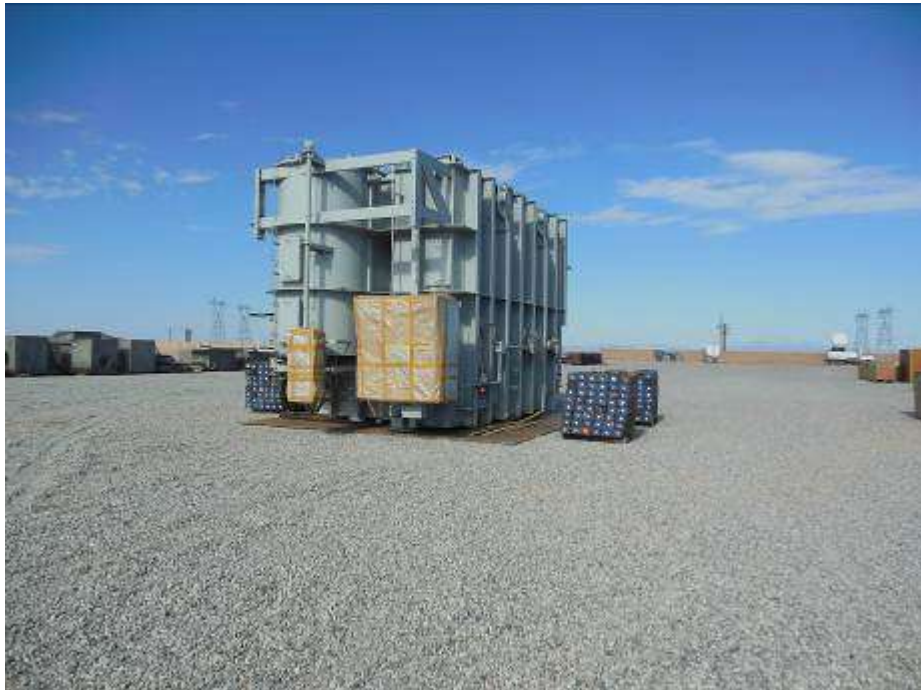
**Figure 6.** As part of the Package 2 construction phase, the first of four transformers was delivered to the CRS site during the subject period.

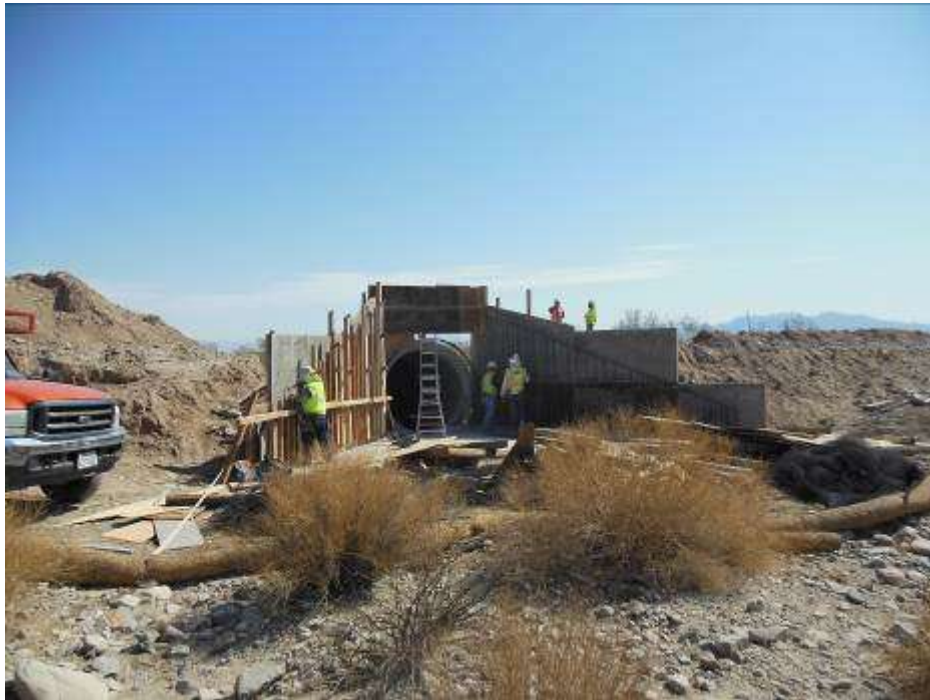
**Figure 7.** Drainage improvements continue along the Red Bluff access road.

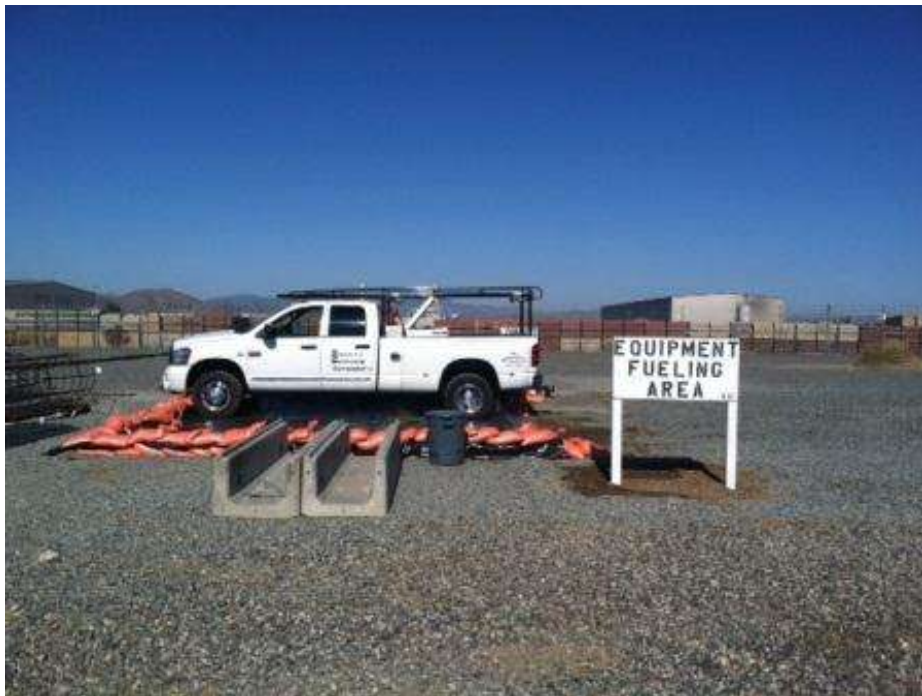
6. Valley Substation (Private Lands) – Activities included mobilizing the contractor to the site, setting up equipment and containment areas, setting up BMPs, and clearing gravel from the work area (see Figure 8).

**Figure 8.** Containment areas established to ensure compliance at the Valley Substation.

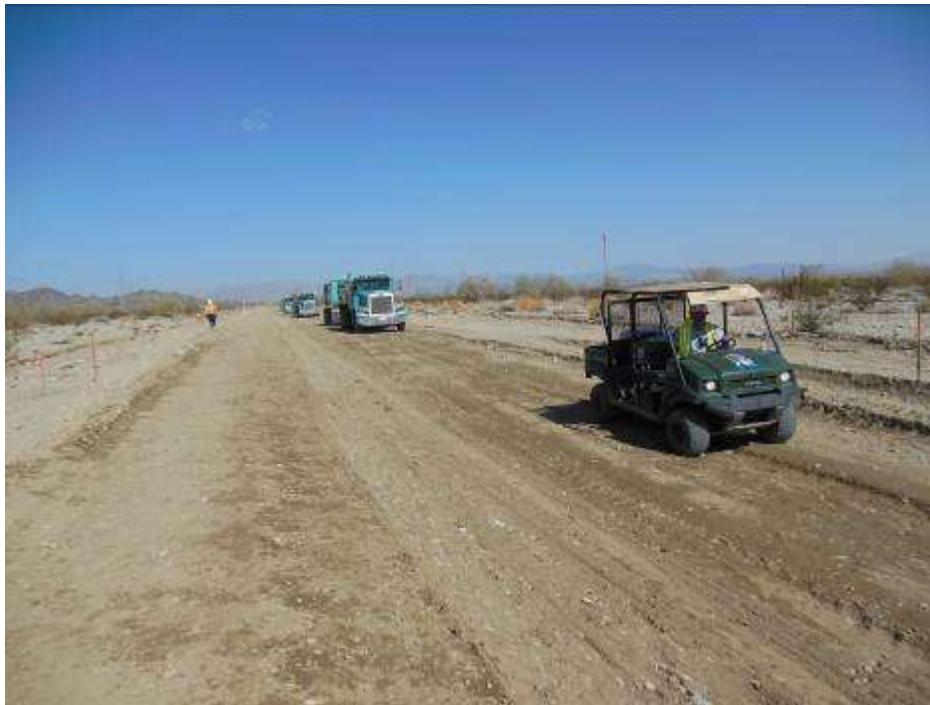
- On July 19, the CPUC EM was informed that Cattrac Construction is requiring all new construction vehicles to be escorted along the Red Bluff access road in an effort to maintain project speed limits. Subsequently, the CPUC EM observed this practice in action soon after as a construction buggy was escorting several haul trucks east on the access road (see Figure 9).

**Figure 9.** Procession of haul truck being escorted by Catrac representative to maintain speed limits along Red Bluff access road.

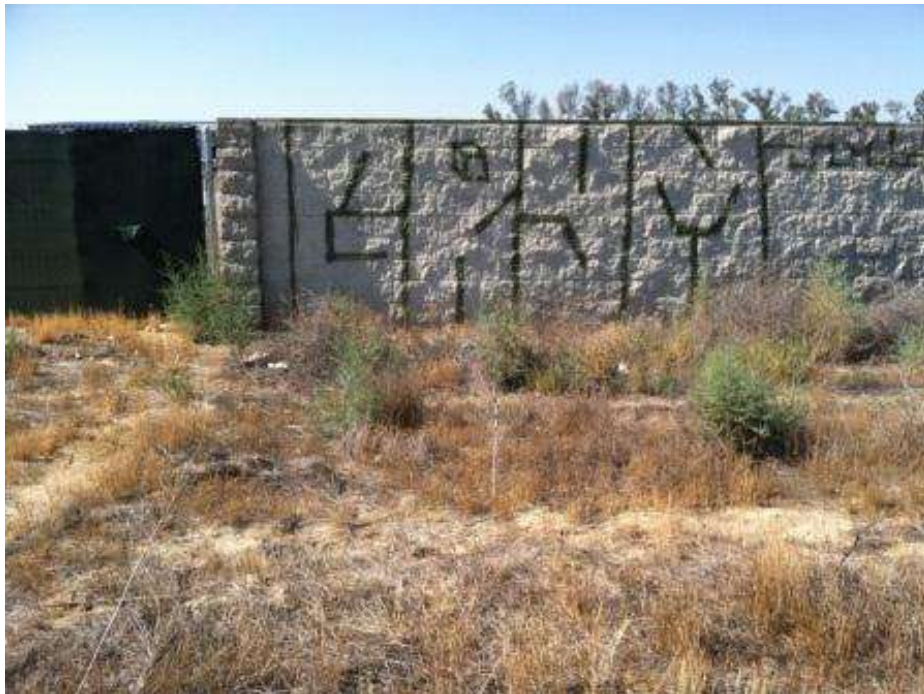
- On July 17, the SCE General Monitor observed graffiti still present on the block wall along the southern boundary of the Perris Yard (see Figure 10). The contractor confirmed on July 27 that the graffiti was removed.

**Figure 10.** Graffiti discovered of the wall at the Perris Yard. Photo courtesy of FRED.
