PROJECT MEMORANDUM SCE DPV2 TRANSMISSION PROJECT

To:	Billie Blanchard, Project Manager, CPUC
From:	Vida Strong, Aspen Project Manager
Date:	December 10, 2012
Subject:	Weekly Report 70, November 12 to November 18, 2012

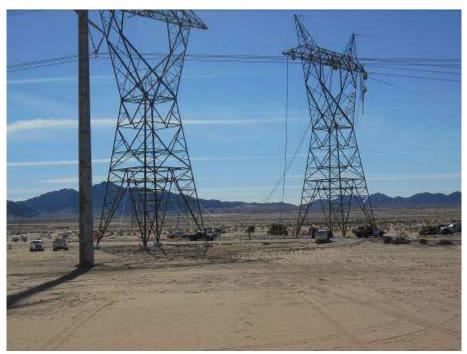
Figure 1. Wire stringing at Towers 2648 and CR1-1W.

- Wire stringing activities were conducted between Towers CR1-5E and M122-T3, at all of the CRS loop-ins, and at associated wire stringing locations (see Figure 1).

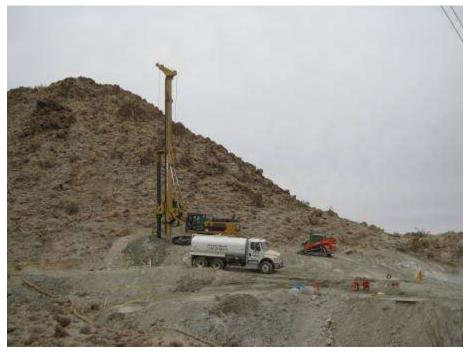
Figure 2. Drilling activities at Tower 2413.

- Micropile activities occurred at Tower 2308.
- Tower foundation drilling activities occurred at Tower 2413 (see Figure 2).
- Tower foundation concrete pouring activities occurred at Towers 2222 and 2413.

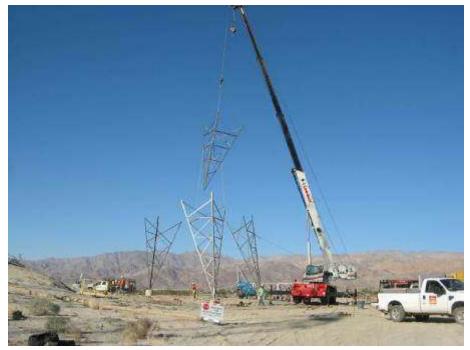
Figure 3. Steel erection at Tower 2246.

- Foundation repairs were conducted at Towers 2400 and 2455.
- Tower assembly and/or steel deliveries occurred at Towers 2000A, 2000B, 2001, 2003, 2013, 2015, 2105, 2108, 2121, 2242, 2244, 2246, 2251, 2260, 2404, 2415, 2434, 2443, 2443ALT, 2454, 2507, and 2508, and within Helicopter Landing Zone (HLZ) H1E (see Figure 3).

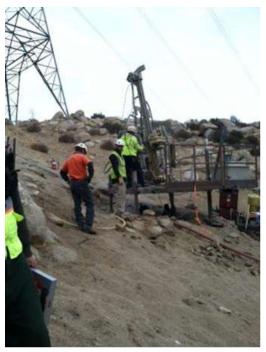
Figure 4. Micropile drilling at Tower 1038.

- Micropile site preparation occurred at Towers 1043, 1044, and 1046.
- Micropile foundation activities occurred at Towers 1037, 1038, 1039, and 1042 (see Figure 4).

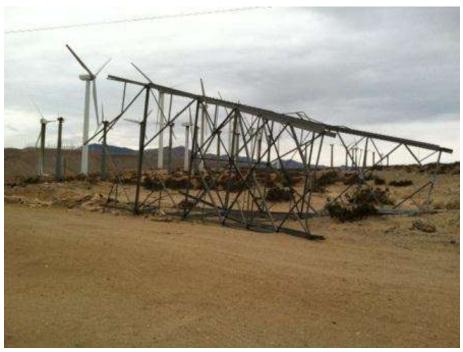
- On November 15, the CPUC EM observed a portion of assembled tower steel that was blown over and landed outside of Tower 1016 disturbance area limits in modeled Desert Tortoise habitat (see Figure 5). The CPUC LEM informed the SCE Environmental Coordinator (EC) immediately. SCE stated it is unknown how the tower piece fell over, but high winds in the area were suspected. To date, the CPUC is still awaiting SCE's final safety incident report for this tower and for steel that also fell over at Tower 1003 within the disturbance area.

Figure 5. Portion of assembled tower that fell outside of the disturbance limits at Tower 1016.

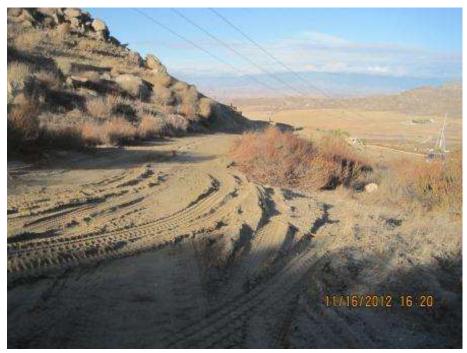
- On November 16, a Biological Monitor was monitoring the apparent exit of the PAR steel delivery truck from Tower 1135 when the truck went off the right-of-way (ROW) (see Figure 6). The Biological Monitor inspected the area and found no sensitive resources were impacted. To date, SCE has not provided a resolution to this incident.

Figure 6. Impacts outside of the approved road limits at the entrance to Tower 1135.

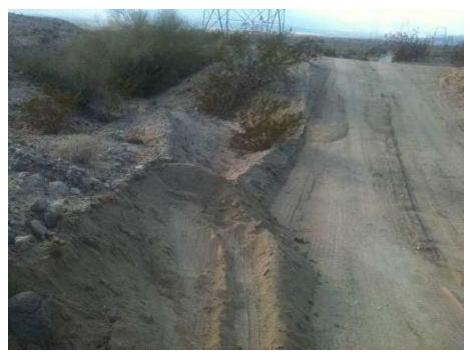
- On November 17, a Biological Monitor was monitoring a PAR steel delivery truck attempting to enter the spur road to Tower 2260 when the truck went off the ROW at the access road (see Figure 7). The length of the tire marks beyond the access road limits was approximately 10 feet. The Biological Monitor did not state that the area was inspected and if sensitive resources were impacted. This incident occurred in desert tortoise modeled habitat. To date, SCE has not provided a resolution to this incident.

Figure 7. Impacts outside of the approved road limits at the entrance to Tower 2260. Photo courtesy of FRED.

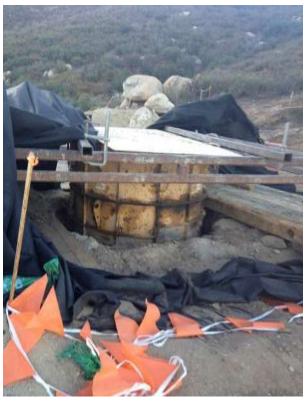
- On November 11, while conducting the initial clearance of Tower 1093, the Biological Monitor observed an open foundation hole. The hole was covered properly the previous day, but wind conditions tore the felt material, leaving a large gap (see Figure 8). The hole was inspected with a mirror by the crew to ensure no wildlife was present in the hole before foundation pouring began. The two remaining open holes were covered securely at the end of the day.

Figure 8. Improperly covered excavation hole at Tower 1093. The hole was covered properly the previous day but wind conditions tore the felt material, leaving a large gap.

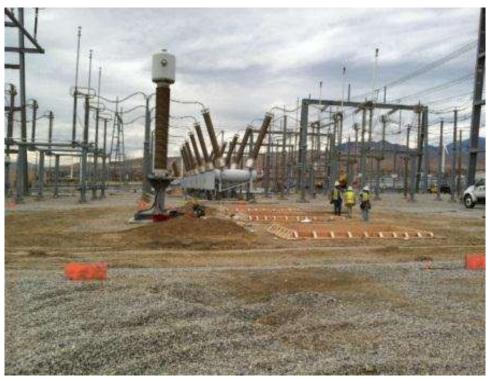
Figure 9. Foundation work for the 500 kV switchrack within the Devers Substation expansion.

- 7. Devers Substation (Private Lands) Activities that were conducted for the Devers Substation expansion and upgrades included foundation excavation and concrete for the extension of the 500 kV switchrack, pole installation, conduit work, lighting installation, 220 kV switchrack upgrades, and SWPPP BMP repair work (see Figure 9).
