**PROJECT MEMORANDUM
SCE EL CASCO SYSTEM PROJECT**

To: Lynne Mosley, CPUC
From: Vida Strong, Aspen Project Manager
Date: July 2, 2009
Subject: Report #2: March 1, 2009 –June 27, 2009

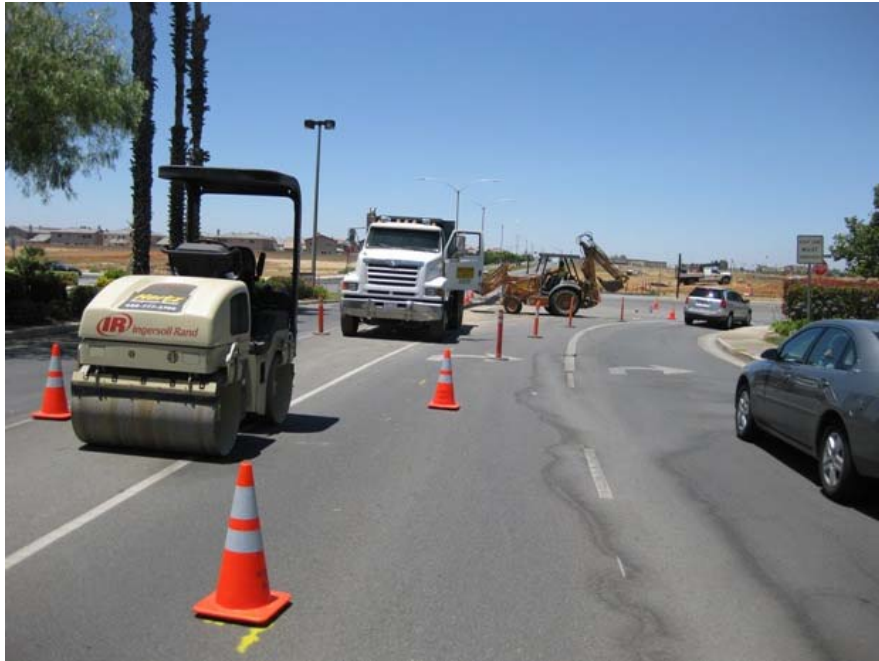
Figure 1: Installation of underground FOC conduit is occurring on First Street in Beaumont and on Sun Lakes Boulevard in Beaumont.

Approximately 850 feet of conduit was placed in First Street.

The installation then crossed Highlands Springs Road (behind the backhoe, and was beginning to be placed in the left hand westbound lane of Sun Lakes Boulevard on Friday, June 26. Construction activities included trenching, laying of conduit, backfill, compaction, and resurfacing with asphalt. Traffic control was adequate and no other environmental issues were observed by the CPUC EM. The photograph faces westward.

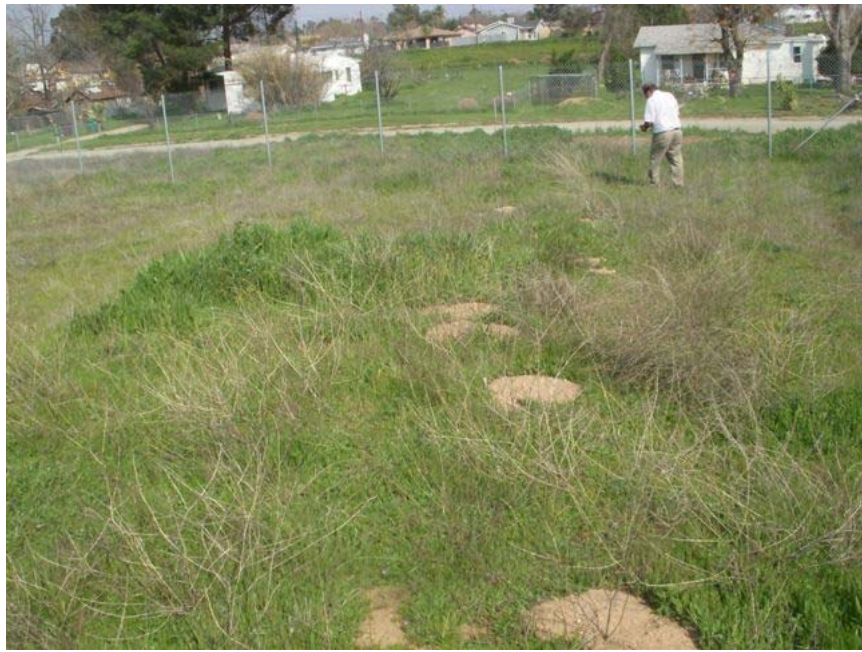
Figure 2: The vegetated portion of the Maraschino Laydown Yard site parcel was excluded from the actual yard. The photograph was taken prior to yard construction and faces eastward.

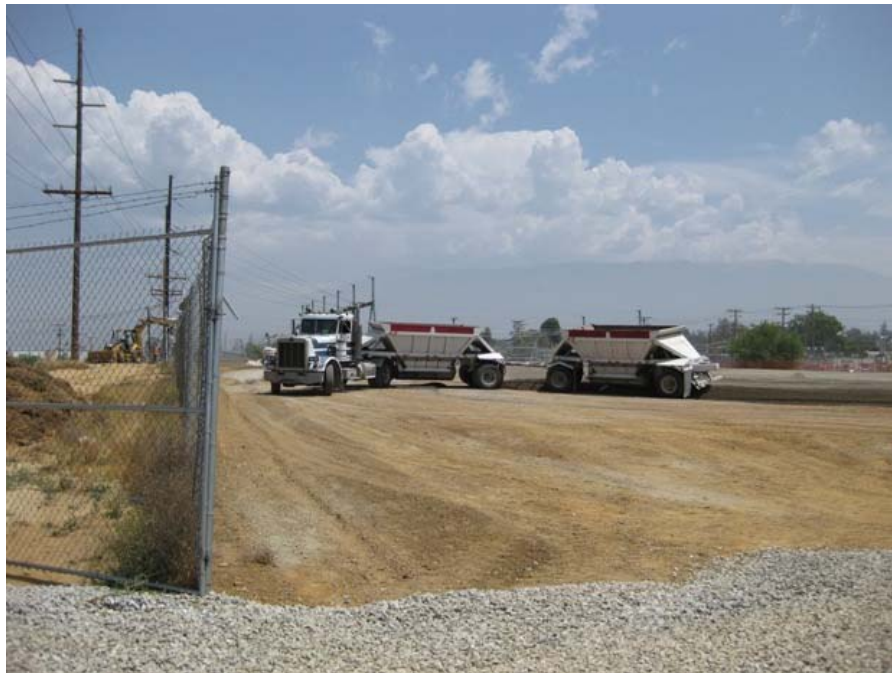
Figure 3: The Maraschino Laydown Yard was prepared by light scraping and removal of vegetation, and hauling in and spreading of gravel base. The photograph was taken during preparation of the yard and faces northward.

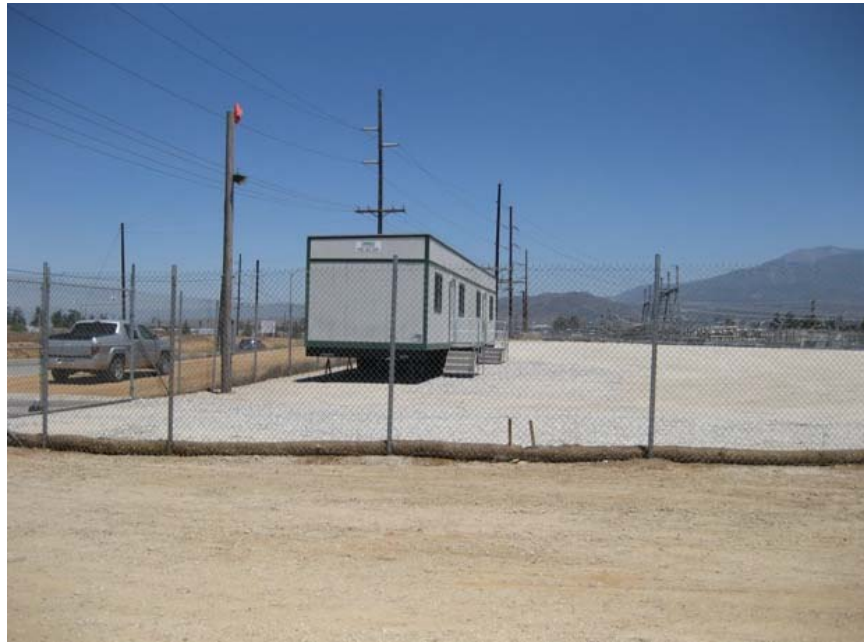
As of June 26, several transmission towers have been stored in the yard. The yard trailer has been hauled in, but is not yet hooked up. Nor has the porta-potty arrived. Otherwise, the yard looks completed, including locked gate (see Figures 4 and 5).

Figure 4: The Maraschino Substation Laydown Yard has been completed. The yard office trailer is on site, but has not been electrically connected and is not yet functional. The south border fence (in foreground) was moved northward thirty-five feet to ensure that the Yard is wholly located on one property. The straw wattling at the base of the south border fence was placed to prevent siltation onto adjacent property. The entrance gate is to the left in the foreground and has an asphalt driveway connecting from Veile Street. The photograph faces northward.

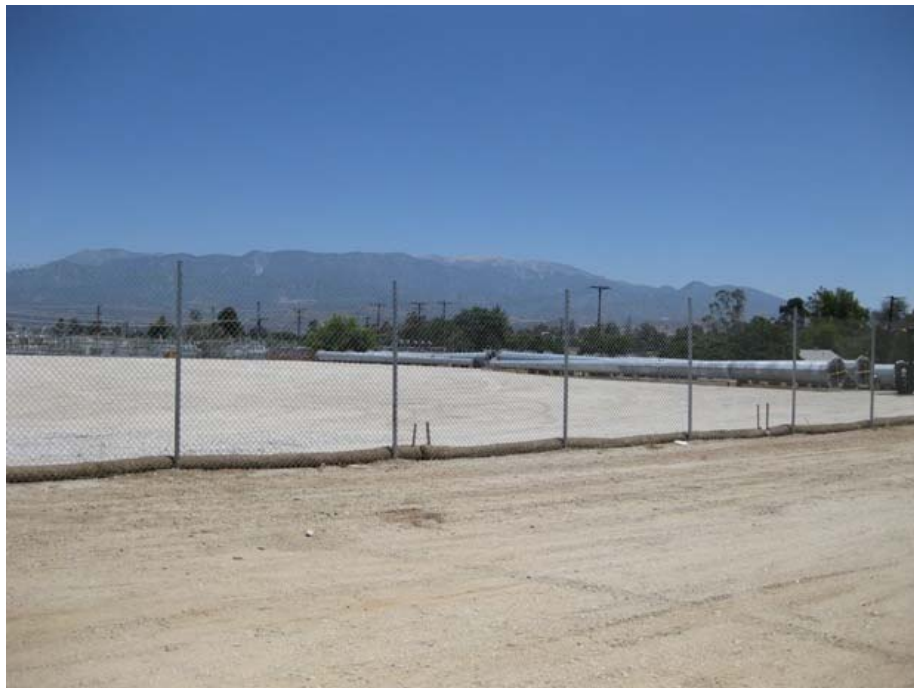
Figure 5: Transmission towers are being stored at the Maraschino Substation Laydown Yard. The east border fence which separates the yard from the vegetated portion of the property is beyond the stacked towers. The photograph faces northeastward.

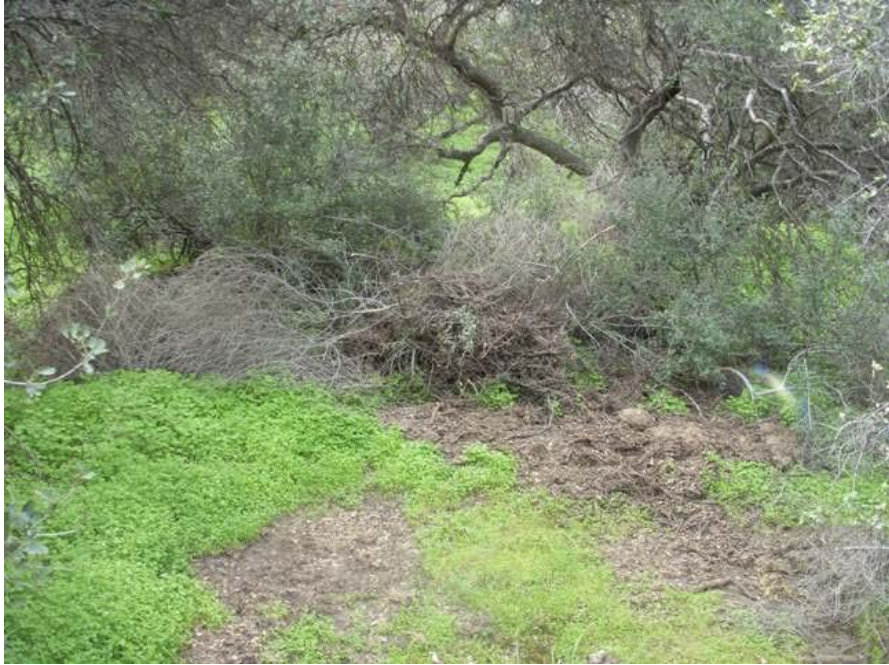
On March 16, 2009, a Project Memorandum was issued for El Casco Substation vegetation clearing activities by the CPUC EM for failure to implement Mitigation Measure B-18: Avoid active burrows or nests and relocate during non-breeding seasons. The pre-NTP biological survey indicated that “No badger dens, burrowing owl nest, or woodrat middens were located during the survey”. During vegetation clearing, more than twenty woodrat middens were discovered and moved. Some of the middens contained young and were moved to adjacent habitat within Younglove Reserve (see Figure 6). Other middens were empty and were placed in adjacent fields within the Reserve (see Figure 7). CPUC was not notified of the event until almost two weeks afterwards. The CPUC EM was provided the survey report at the beginning of clearance activities, and therefore, was unable to conduct a field verification. Please also note that during nest removal project equipment went outside of the approved work boundaries.

Figure 6: The active woodrat middens at the El Casco Substation site were placed in adjacent habitat by equipment within the Norton Younglove Reserve.

On April 2, 2009, SCE submitted a response letter where SCE addressed the issues raised in the Project Memoranda. According to the CPUC Memorandum, LOA’s survey report should have stated that “it was impossible to survey for woodrat middens” instead of implying that a valid survey had been conducted. SCE acknowledges that this report should have included more detail. However, at the same time, SCE also believes that Aspen’s Memorandum was not entirely accurate in its description and depiction of the vegetation that existed prior to the removal activities. As stated both SCE and LOA now understand the level of detail that is required in all future reports to the CPUC (please note that shortly there after LOA was replaced by NRC as the biological consultant). In total, 26 middens were exposed on the dense chaparral hillside. LOA determined that the best ecological approach would be to deconstruct the middens and rebuild any that might be occupied. During the relocation efforts, LOA determined that 8 of the 26 middens were occupied; two of the woodrats had young. SCE acknowledges that Mitigation Measure B-18 was not properly implemented. SCE provided that they would put measures in place to ensure future compliance with project mitigation measures. SCE acknowledged that the CPUC notification delay was inappropriate. SCE instituted a communications protocol (as requested by the Project Memorandum) to avoid the recurrence of this error. In regard to the five middens that were left in the open meadow the intent was to have them hauled off with other debris. As provided by SCE, authorization to leave this debris behind should have involved coordination with the appropriate personnel from the Riverside County Regional Park and Open-Space District. Although work areas were clearly marked, SCE acknowledged that construction equipment went outside of the approved work boundary in the attempt to relocate several middens. SCE was unaware of this activity at the time and agreed that a variance should have first been obtained from the CPUC.

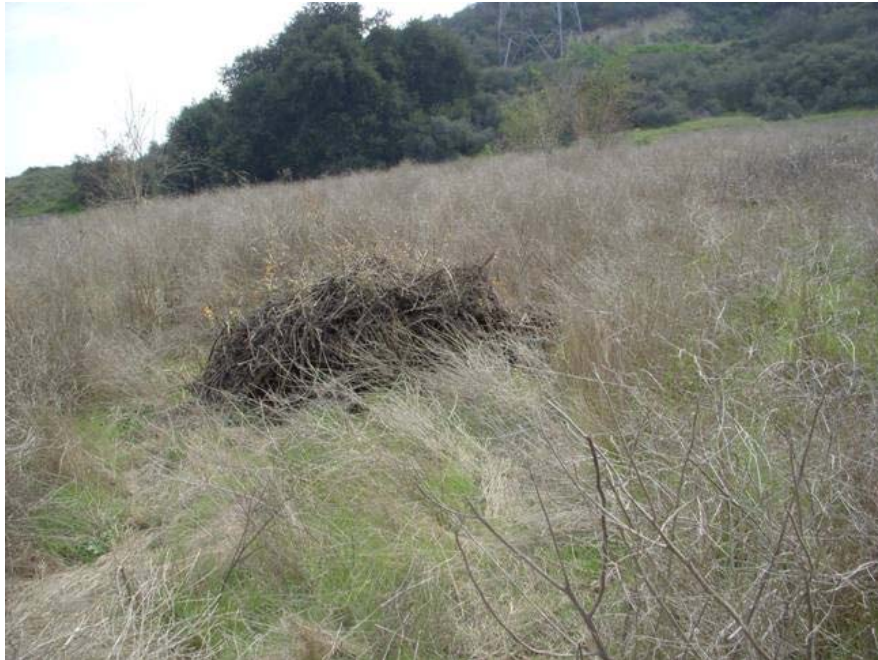
Figure 7: Abandoned woodrat middens at the El Casco Substation site were placed in adjacent fields by equipment within the Norton Younglove Reserve.
The photograph faces southeastward.
