**PROJECT MEMORANDUM
SCE EL CASCO SYSTEM PROJECT**

To: Lynne Mosley, CPUC
From: Vida Strong, Aspen Project Manager
Date: October 21, 2009
Subject: Report #10: October 11, 2009 – October 17, 2009

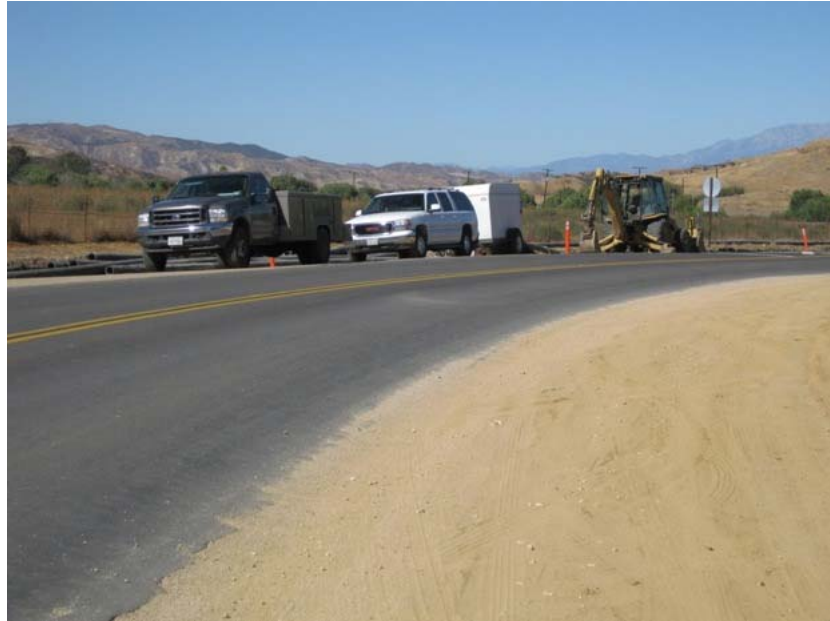
Figure 1: Construction began on the above-ground water pipeline being placed on the south shoulder of San Timoteo Canyon Road between a source well at the Fisherman's Retreat Campground and the entrance gate of the El Casco Substation site. The photograph faces westward.

During the subject week, construction began on the above-ground water pipeline between a source well at the Fisherman's Retreat Campground and the entrance gate of the El Casco Substation site (see Figure 1). This pipeline is being placed on the south shoulder of San Timoteo Canyon Road. It will connect to a temporary water tank just inside the entrance gate. Variance Request #2 permitting this pipeline and tower also permits the construction of another pipeline/tower system further east on San Timoteo Canyon Road. This second system will not be build unless needed.

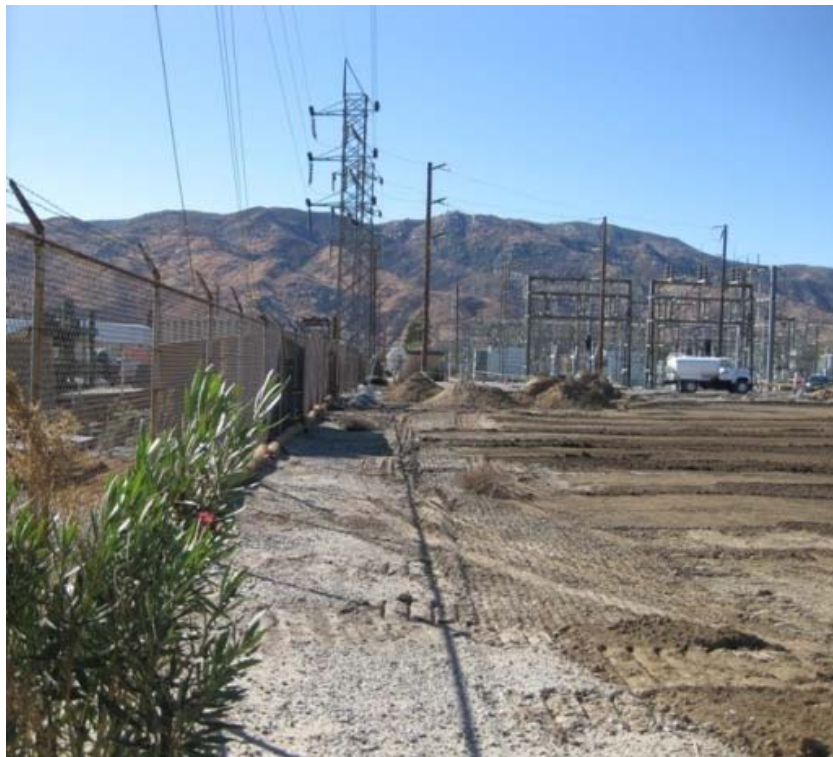
Figure 2: During the subject week, grading began at the Banning Substation in preparation for upgrading. The photograph was taken from the John Street entrance and faces southward.

Grading occurred within the northern section of the substation during the subject reporting period (see Figure 2). This area was previously unused by the substation. It will house the expansion of the substation required by the El Casco Systems Project.

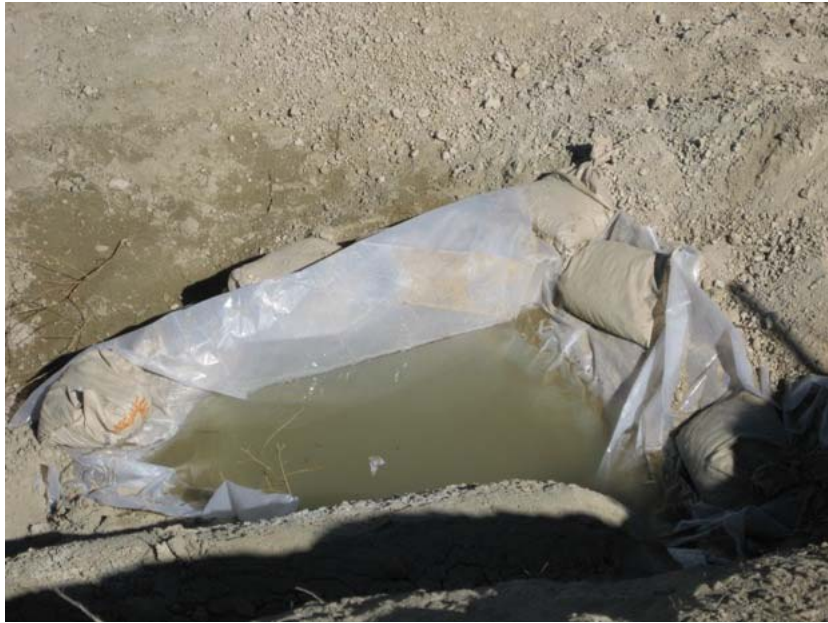
Figure 3: Small concrete wash-out basins were created at each terrace on the hillside at El Casco Substation.

- In addition to the concrete truck wash-out basin previously established on the top of the hill where terracing is occurring, smaller basins are being established on the terraces during shotcreting (see Figure 3). Some thin concrete spillage has coated the ground in some areas during the operations (see Figure 4). This concrete has dried quickly. It will eventually be buried during the backfill operation. No wet concrete used in the terracing activities will reach any watercourse.

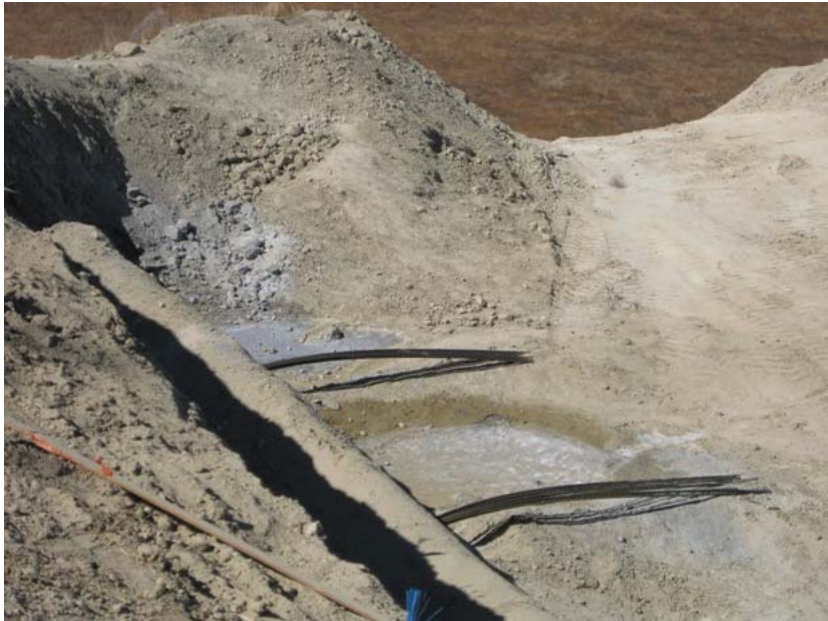
Figure 4: Some concrete spillage occurred at the terraces. The concrete will dry and be buried during the backfill operation.

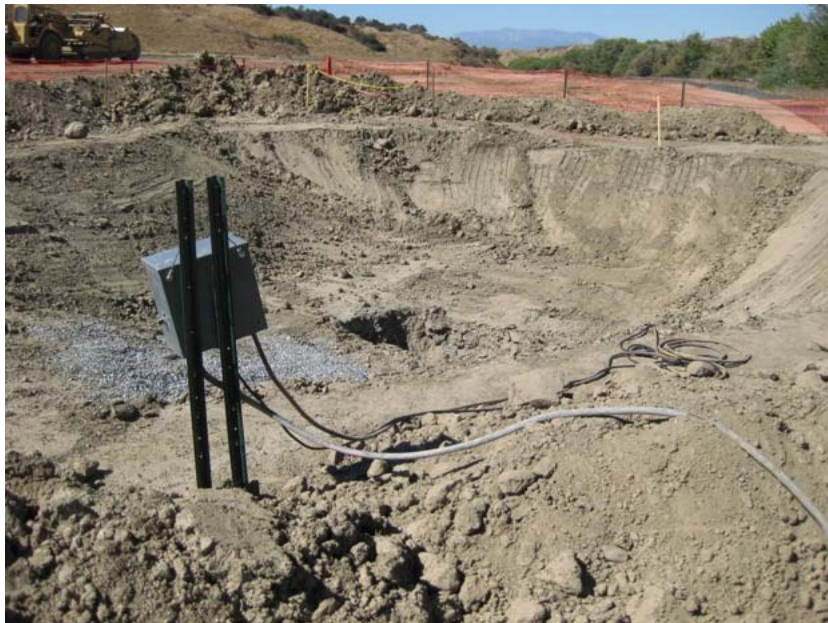
Figure 5: At the El Casco Substation site, a thirty-foot wide pit was dug within twenty-five feet of the San Timoteo Creek bank in order to determine ground water level.

- The contractor at the El Casco Substation has dug a pit approximately twenty-five feet away from the bank of San Timoteo Creek to determine depth of groundwater at the location where previous geotechnical testing identified soils prone to liquefaction and lateral spreading along this portion of the substation site (see Figure 5). Groundwater was discovered at approximately fifteen feet below the surface. A dewatering operation was set up during the subject week pumping groundwater from the pit with a temporary pump and storing it in a mobile tank (see Figures 6 and 7). SCE plans to continue the dewatering operation in this area until future over excavation and proper compaction occur.

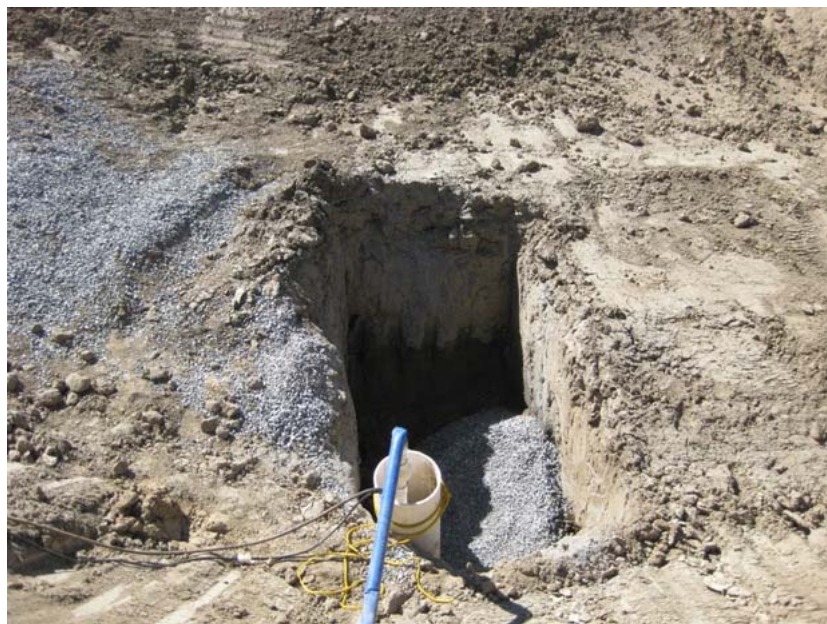
Figure 6: Water is currently being continually pumped out of the excavated pit.

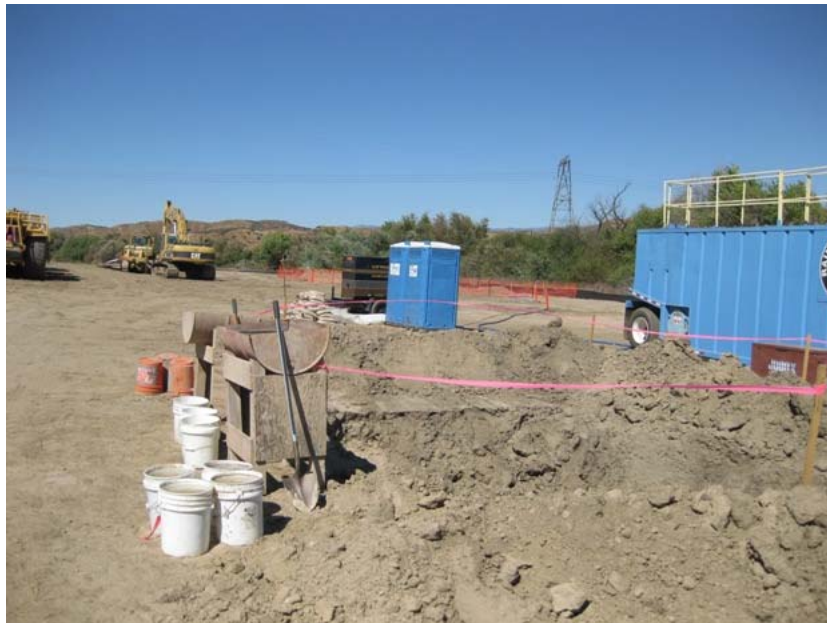
Figure 7: The excavated pit at El Casco Substation site is in the distance behind the orange fence. The blue tank on the right is storing the pumped groundwater. The generator supplying power is the dark structure behind the portable toilets. It has been placed within a spill containment structure.. The photograph faces northwestward.

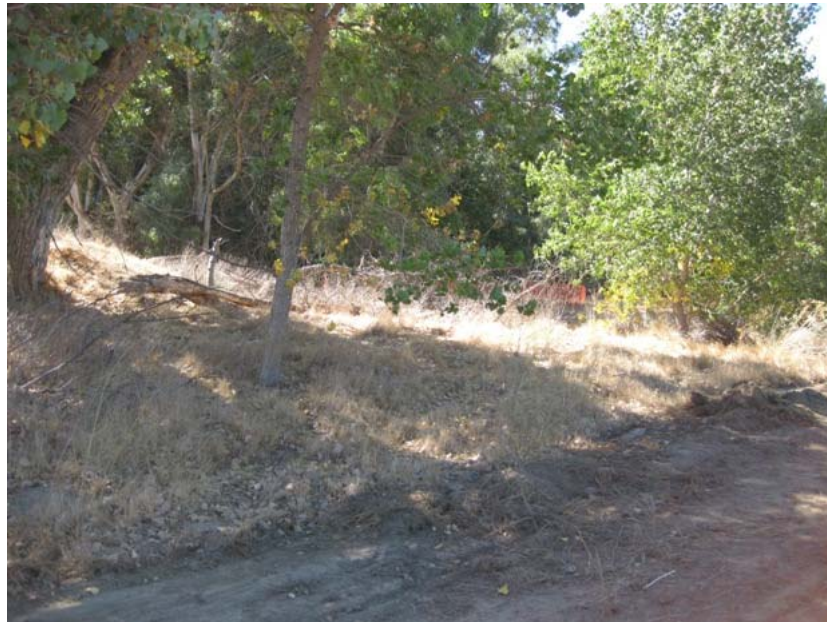
Figure 8: The contractor at the El Casco Substation site needs to remove two small cottonwood trees near the eucalyptus grove in order to build the new Access Road. The two trees are one multiple-branched one on the right and the small one just left of center. The larger cottonwood on the left would not be removed. The photograph was taken from the new Access Road site, and faces southwestward.

- On Friday of the subject week, SCE and contractor personnel informed the CPUC EM that two small cottonwood trees near the eucalyptus grove need to be removed for the access road building activity (see Figure 8). These trees apparently were not identified in the engineer drawings for the access road work. This issue will be discussed during the Wednesday, October 21 conference call with SCE and CPUC personnel. The trees are within the permanent disturbance zone for the access road building.
