**PROJECT MEMORANDUM
SCE EL CASCO SYSTEM PROJECT**

To: Lynne Mosley, CPUC
From: Vida Strong, Aspen Project Manager
Date: December 16, 2009
Subject: Report 17: December 6, 2009 – December 12, 2009

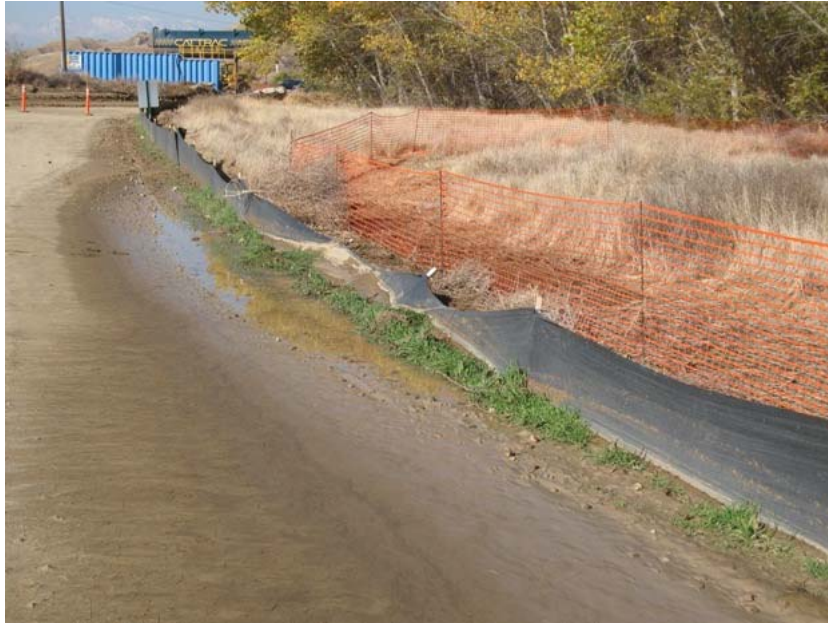
Figure 1: Several significant storm events occurred during the subject week. At El Casco Substation site the silt fencing along the pre-existing access road collapsed at one location. This section subsequently was repaired, and reinforced with sand bags. San Timoteo Creek, on the right, did not receive any siltation from the substation construction site. The orange fencing delineates a smooth tarplant population site. The photograph faces northwestward.

- Several significant storm events occurred during the subject week. At El Casco Substation site the silt fencing along the pre-existing access road collapsed at one location (see Figure 1), but was repaired. Straw wattling was placed on the cleared hillsides to prevent erosion, and sand bags were placed near the top of the terraced area to direct runoff water away from the cleared hillsides (see Figure 2). In addition, the newly constructed access road and over-excavation areas served to retain run off water (see Figure 3). Additional silt fencing was placed where needed (see Figure 4). No significant run off water or silt reached San Timoteo Creek from the Substation construction site. Storm-related issues did not occur at any other Project work site, except that construction activities were limited at all sites during the subject week. Weather predictions call for clear weather during the following week.

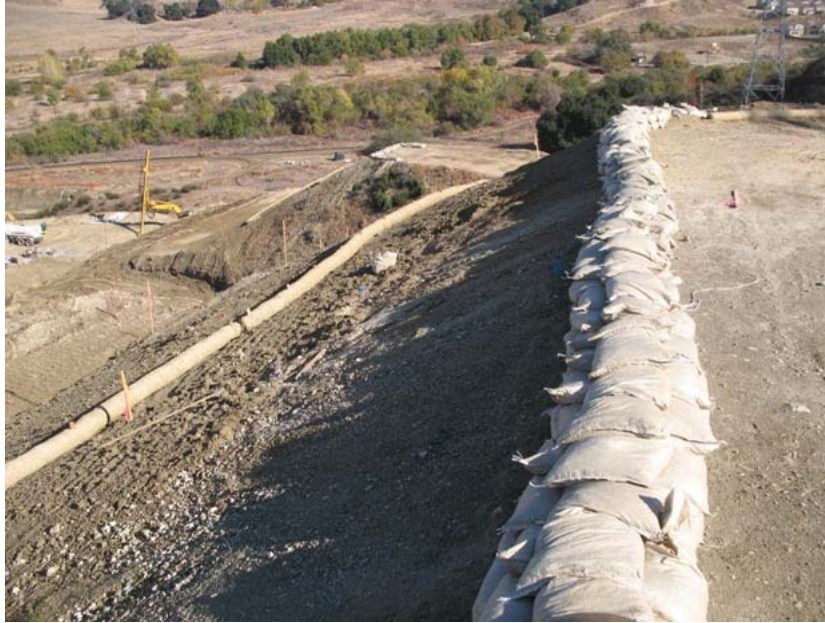
Figure 2: Straw wattling was placed on the cleared hillsides to prevent erosion, and sand bags were placed near the top of the terraced area to direct runoff water away from the cleared hillsides. No significant erosion occurred on these terraced slopes during the subject week.
The photograph faces northward.

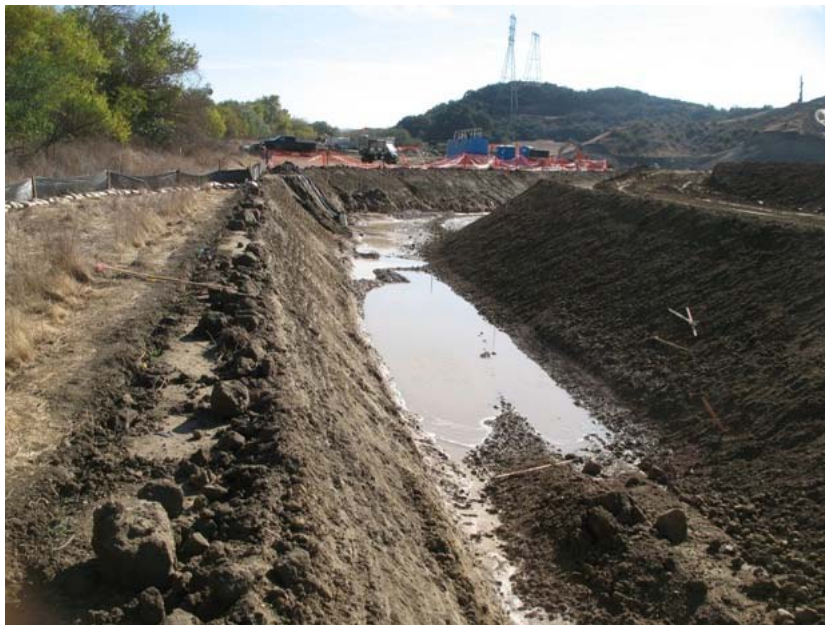
Figure 3: The over-excavation areas served to retain run off water. The silt fencing that had been moved closer to San Timoteo Creek to provide room for the over-excavation activity can be seen on the left.
The photograph faces eastward.

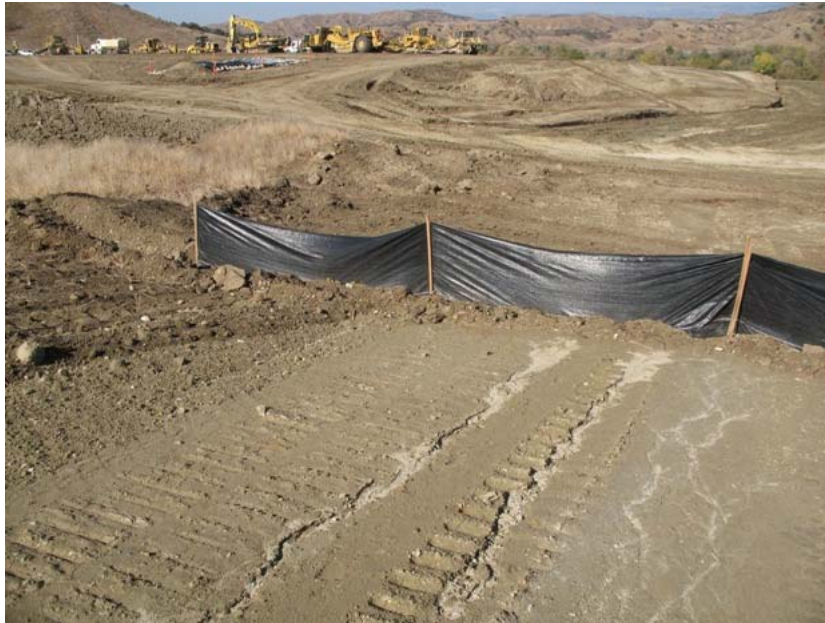
Figure 4: Additional silt fencing was placed where needed during the storm events of the subject week. No significant run off water or silt reached San Timoteo Creek from the substation construction site. The photograph faces northwestward.
