**PROJECT MEMORANDUM
SCE EL CASCO SYSTEM PROJECT**

To: Lynne Mosley, CPUC
From: Vida Strong, Aspen Project Manager
Date: December 23, 2009
Subject: Report 18: December 13, 2009 – December 19, 2009

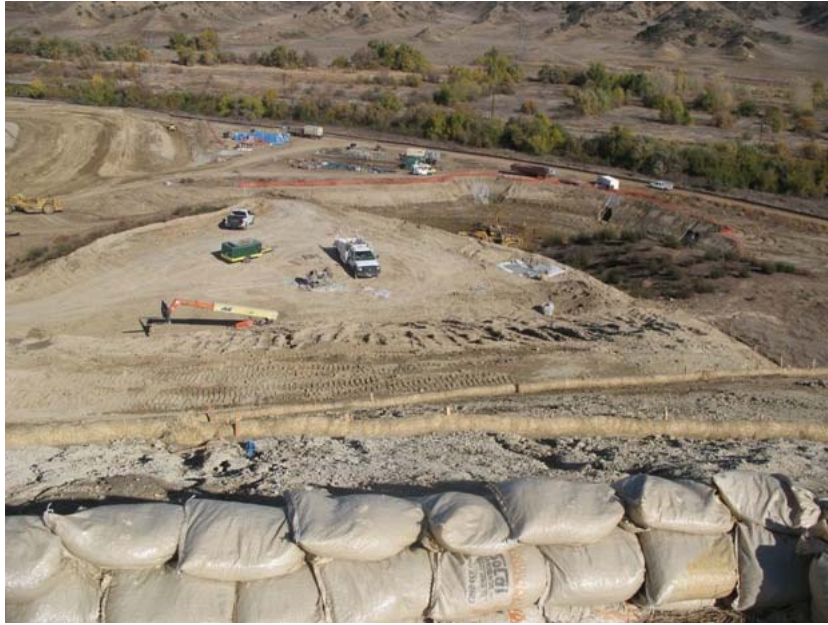
Figure 1: The westernmost over-excavated area (in the mid-distance to the left of the blue tank) has been over-excavated, lined with water resistant fabric and an underlying gravel blanket, and is being filled with firm material. A second over-excavation area further eastward (in front of the orange fencing) continued to be excavated during the subject week. The photograph was taken from one of the upper terraces and faces northward

Two areas within the footprint of the Substation site have been identified by geotech soil testing to have underlying unstable soil. The westernmost of the two has been over-excavated, lined with water resistant

fabric and an underlying gravel blanket, and is being filled with firm material. A second over-excavation area further eastward continued to be excavated during the subject week (see Figure 1).

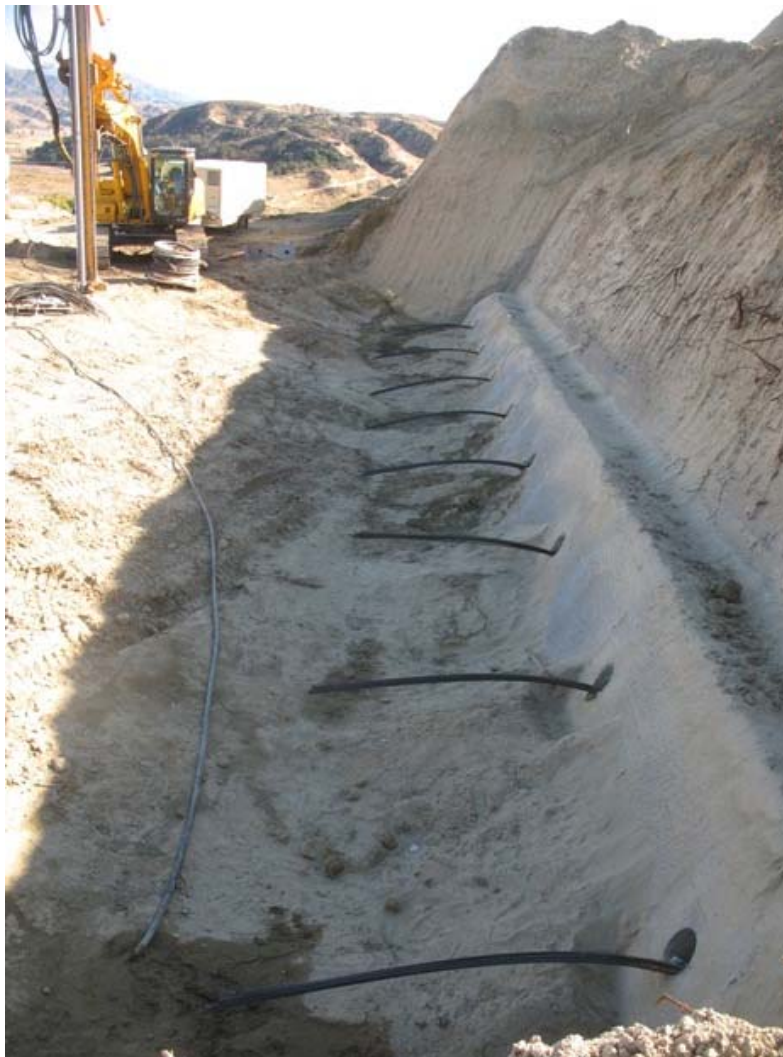
Figure 2: A tie-back wailer structure was under construction on the face of one of the terraces. The ends of the approximately 120-foot-long cable anchor can be seen emerging from the oblique bores dug into the hill. After completion of the wailer, the cables will be placed under tension.

Terracing of the hillside continued during the subject week. Geologists have determined there is a layer of clay within the hill that has approximately the same slope as the hillside. Building of the substation will require the removal of the toe of the slope. This removal may increase the likelihood of slippage of the material above the clay layer. A tension cable anchor system is being constructed on and into the hillside to put pressure on the clay layer and thereby prevent land slippage. Fourteen terraces will be constructed in stair step fashion on two prominent ridges of the hillside. There will be four terraces on the shorter ridge, and ten on another higher ridge. The face of each terrace will be fitted with one or more tie-back wailer structures that will provide anchors for several approximately 120-foot-long cables per wailer placed in oblique bores dug into the hill (see Figure 2). Each bore will have a concrete caisson at the bottom for the lower cable anchor. Each cable will then be tightened to create tension between the upper wailer tie-back and the lower caisson. The terrace will then be backfilled, and the operation moved to the next lower terrace. It is estimated that approximately two hundred anchors will be constructed in all.

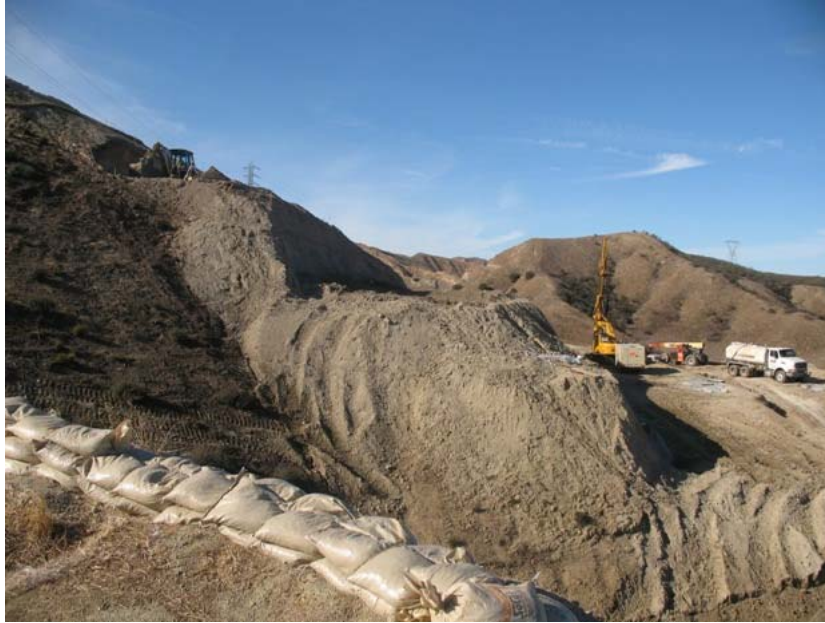
Figure 3: The upper five terrace systems on the higher western ridge have been completed. The contractor has temporarily skipped the sixth terrace location (middle empty bench) and worked on the seventh terrace (with the drill rig on the right) during the subject week. The photograph faces southward.

The lowest and last of the four terrace tension cable anchor systems on the eastern ridge was nearing completion during the subject week. The upper five terrace systems on the higher western ridge have been completed. The contractor has temporarily skipped the sixth terrace location and worked on the seventh terrace during the subject week (see Figure 3).

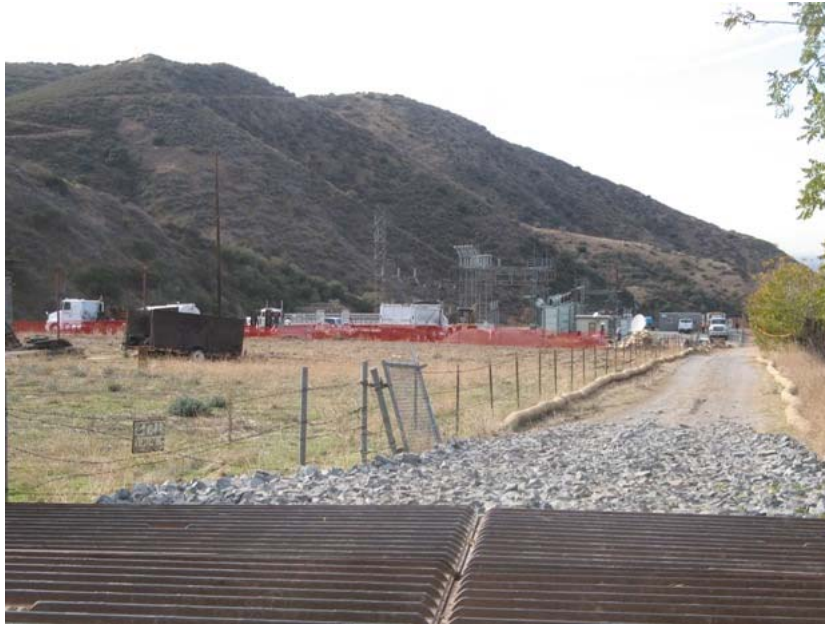
Figure 4: Construction at the Zanja Substation began during the prior week. Construction will consist of paving the access road, expansion of the substation perimeter fence (behind the orange fencing), placement of additional electrical equipment, and construction of a tower. Note the shaker plate, gravel bed, and erosion control straw wattles on the access road. The photograph faces westward.

Construction began during the prior week. Environmental training of the crew, implementation of Storm Water Pollution Prevention Plan procedures, installation of shaker plates, and beginning of excavation of the eastern berm for expansion of the substation have occurred so far (see Figure 4).
