**PROJECT MEMORANDUM  
SCE EL CASCO SYSTEM PROJECT**

**To:** Lynne Mosley, CPUC  
**From:** Vida Strong, Aspen Project Manager  
**Date:** January 5, 2010  
**Subject:** Report 19: December 20, 2009 – January 2, 2010

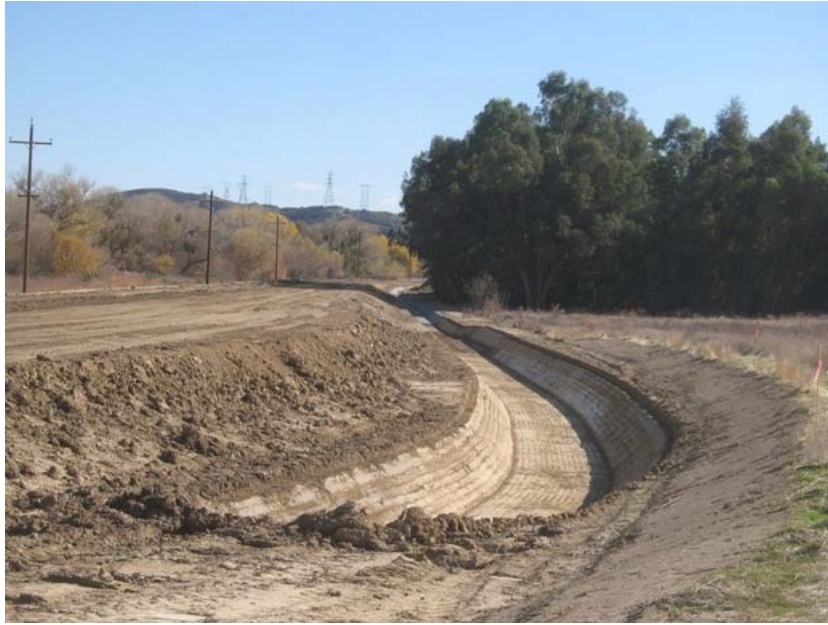
A V-ditch was in the process of being constructed on the south side (uphill) of the new access road (see Figure 1). Excavation had been completed for more than half the length of the access road by the end of the subject period, and concrete placement in the ditch had begun (see Figure 2).

**Figure 1:** A V-ditch is being constructed on the south side (uphill) of the new El Casco Substation access road. The photo faces eastward.

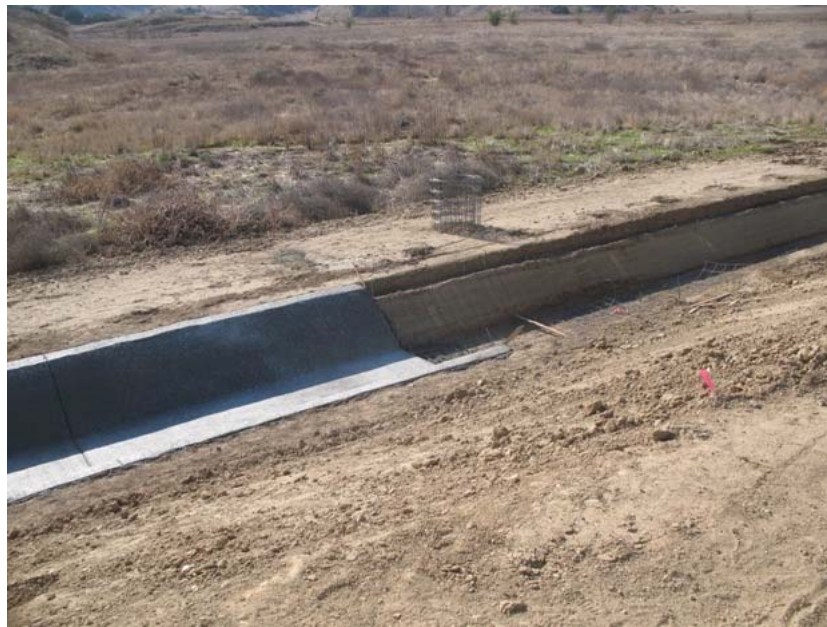
**Figure 2:** Concrete placement in the V-ditch alongside the El Casco Substation began during the subject period.

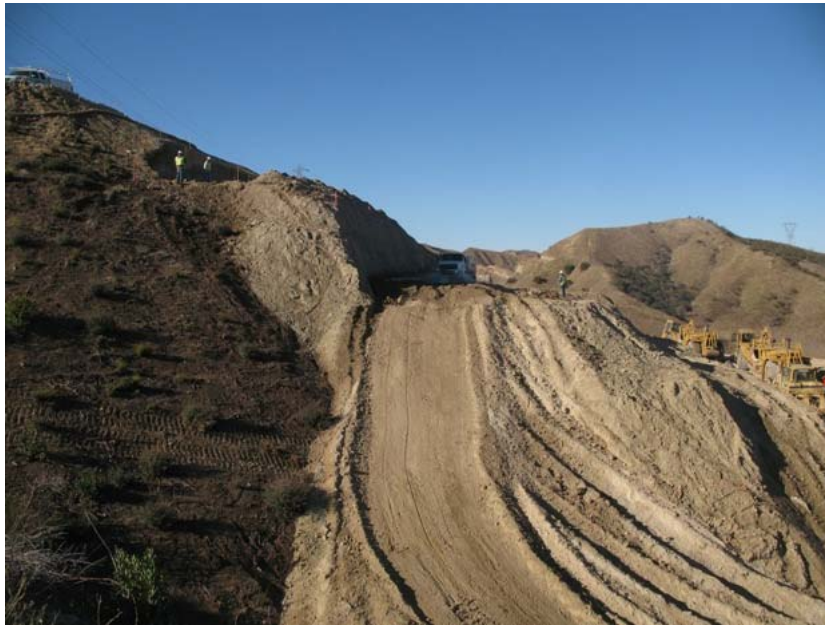
Terracing of the eastern ridge of the hillside has been completed. Several tension cable anchor systems have been constructed into four terraces on that hillside to put pressure on an underlying clay layer and thereby prevent land slippage. Work continued on the ten terraces being constructed on the western ridge. Excavation of the lower terraces and of the toe of the slope is now being accomplished with scrapers (see Figure 3).

**Figure 3:** Excavation of the lower terraces at the El Casco Substation site is now being accomplished with scrapers. The photograph is shows the lower portion of the western ridge, and faces southward.

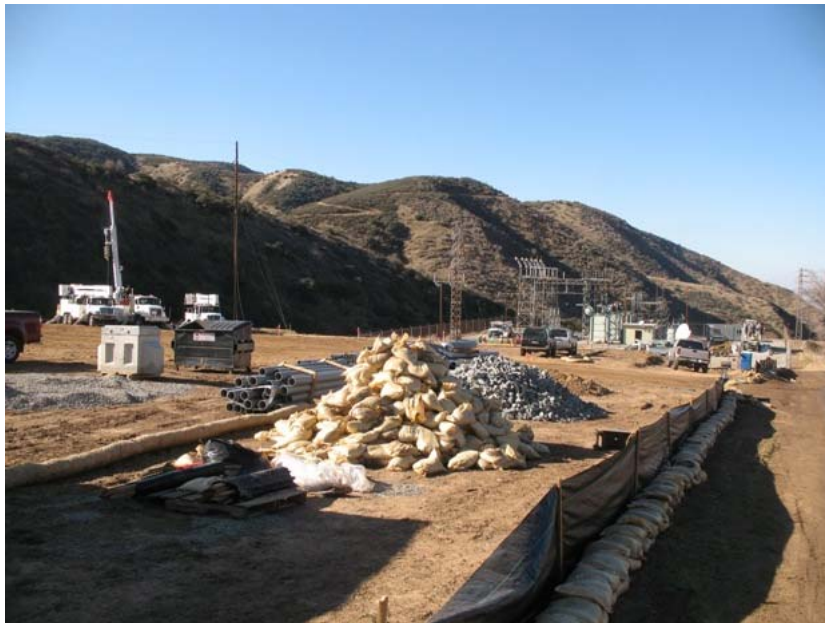
Construction continued during the subject period. The slope east of the substation has been removed in preparation for the expansion of the substation in that direction. The spoils were spread on adjacent SCE land (see Figure 4).

**Figure 4:** Construction continued during the subject period on the expansion and upgrading of the Zanja Substation (in the distance). The slope east of the substation has been removed in preparation for the expansion and has been spread on adjacent SCE land in the foreground where construction materials are being stored. The photograph faces westward.

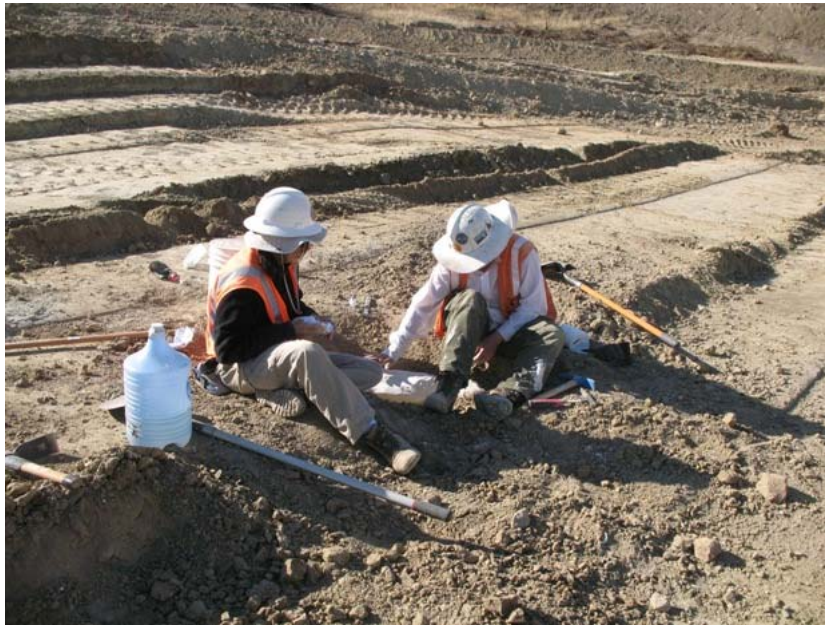
- During the subject reporting period, fossils continued to be located, recovered, and processed at several locations at the El Casco Substation site. To date, a wide variety of plant, mammal, bird, and invertebrate material has been recovered. The fossils have been found during excavation in the eastern over-excavation pit, within excavation at the toe of the eastern ridge and in some of the hillside terraces. The fossils are within the San Timoteo Formation and thought to be between 0.9 and 6.1 million years old. The San Timoteo Formation is known to be particularly rich in significant fossil resources from the medial Pleistocene and the later Pliocene epochs. This formation, found throughout the San Timoteo Badlands, contains an important sequence of North American land flora and fauna of that time period. All excavation activity, especially in the areas containing the San Timoteo Formation, was continually monitored by paleontologists. Also material samples were collected from the terrace excavations and from all areas where fossils have been discovered. These samples were then processed by wet screening to uncover small and difficult to detect fossil material. These activities will continue as long as construction activity uncovers material within the fossiliferous San Timoteo Formation. When fossils were discovered, each area was immediately roped off, with construction activity temporarily diverted to other areas, while the paleontologists packaged and removed the fossils (see Figure 5). All parties, including the monitors, SCE staff, and the contractor have worked together to facilitate the recovery of fossils, and to minimize construction delay. CPUC/Aspen personnel have been kept informed of discovery events as they have happened. It is expected that fossil discovery and removal will continue for some time at the site. To date, the monitoring of construction activities and treatment of fossil discoveries have followed the El Casco Paleontological Treatment Plan.

**Figure 5:** During the subject reporting period, fossils continued to be located, recovered, and processed at several locations at the El Casco Substation site. When fossils were discovered, construction activity was temporarily diverted to other areas, while paleontologists packaged and removed the fossils. Also material samples were collected from discovery sites. These samples were then processed by wet screening to uncover small and difficult to detect fossil material. In this photograph, a large mammal bone fragment has been packaged for removal.
