**PROJECT MEMORANDUM  
SCE EL CASCO SYSTEM PROJECT**

**To:** Lynne Mosley, CPUC  
**From:** Vida Strong, Aspen Project Manager  
**Date:** January 27, 2010  
**Subject:** Report 21: January 10, 2010 – January 23, 2010

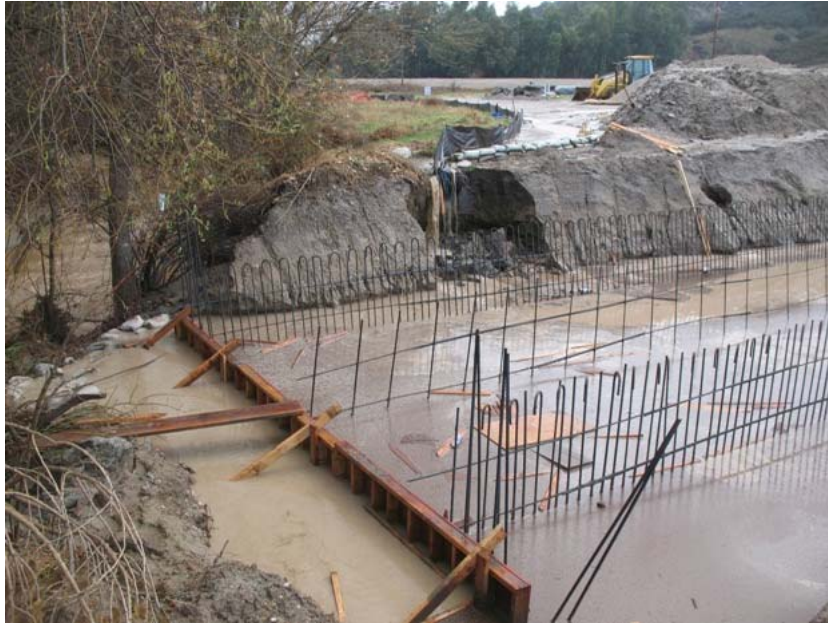
**Figure 1:** The partially completed box culvert at the El Casco Substation access road was inundated with stormwater, which then poured into San Timoteo Creek. The photograph faces southeastward.

During the first week of the subject period, work began on the box culvert across the access road near the entrance gate (see Figure 1). Concrete placement occurred.

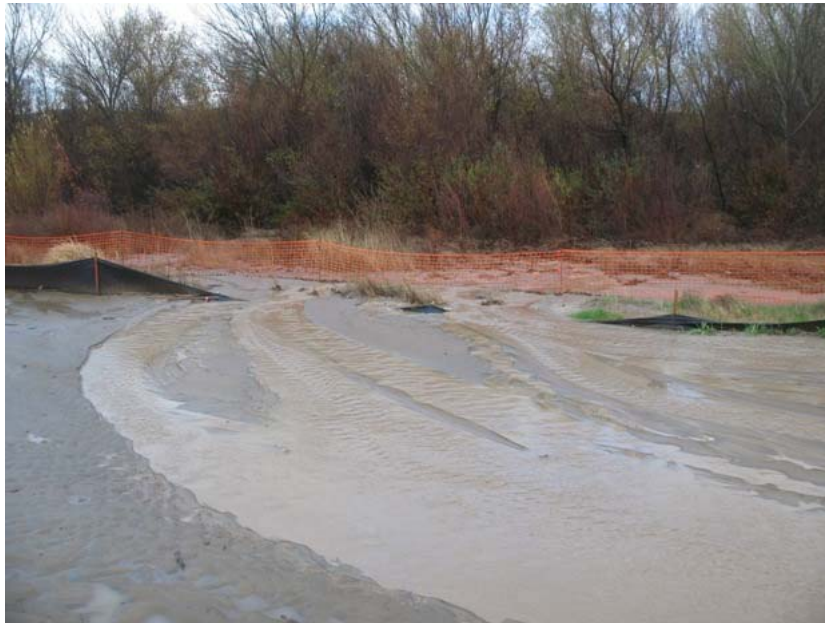
**Figure 2:** Silt fencing and other erosion control devices were compromised in several locations at the El Casco Substation site. The photograph faces northwestward, with San Timoteo Creek in the background.

- During the second week of the subject reporting period, four storms occurred throughout the project sites. At least seven inches of rain was recorded at El Casco Substation. The higher portions of the Project area, including Beaumont, Banning, Calimesa, Yucaipa, and Mentone received up to four inches of snow in addition to significant amounts of rain. Numerous erosion control problems were observed at El Casco Substation. The partially completed box culvert was inundated with water, which then poured into San Timoteo Creek (see Figure 1). Silt fencing was compromised in several locations (see Figure 2). Also, the swollen San Timoteo Creek eroded its bank, threatening to destroy some of the silt fencing (see Figure 3). Erosion gully formation occurred in several areas including the terraces, access roads, and engineered slopes. None of the erosion was severe enough to require emer-

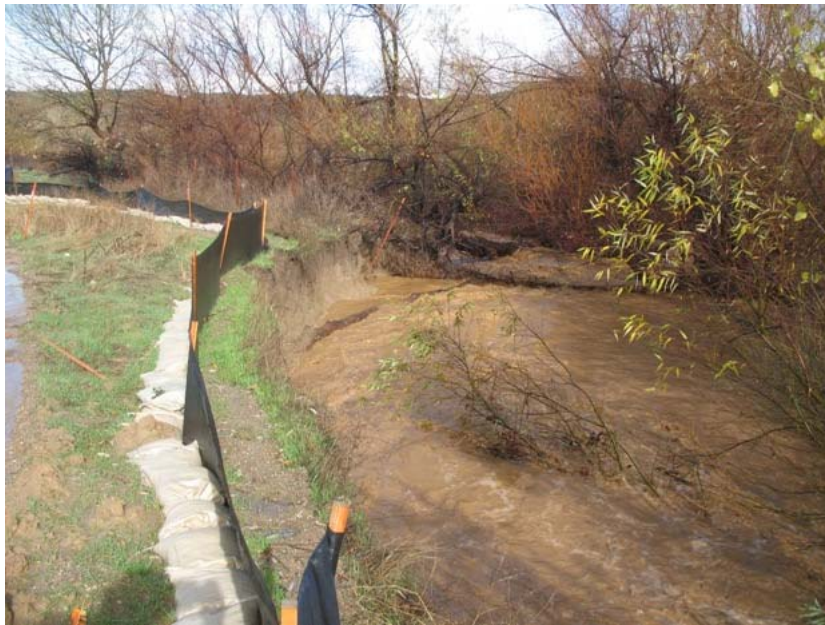
**Figure 3:** The swollen San Timoteo Creek eroded its bank, threatening to destroy some of the silt fencing at the El Casco Substation site. The photograph faces northwestward.

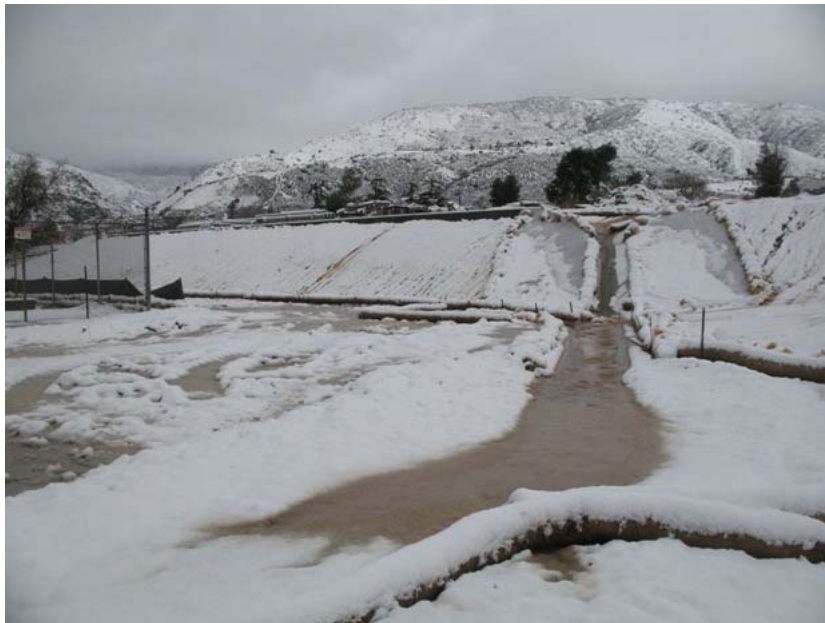
gency measures, but much remedial action will need to occur soon before the next predicted series of storms. At Zanja Substation, erosion control measures were mostly effective, but some erosion gully formation was observed (see Figure 4). Banning Substation had adequate erosion control measures in place, and the FOC work sites had no erosion problems.

**Figure 4:** At Zanja Substation, erosion control measures were mostly effective, but some erosion gully formation was observed. In the photograph, which faces northeastward, runoff water is shunted around the substation (on the left) through two newly constructed V-ditches.
