**PROJECT MEMORANDUM  
SCE EL CASCO SYSTEM PROJECT**

**To:** Lynne Mosley, CPUC  
**From:** Vida Strong, Aspen Project Manager  
**Date:** April 8, 2010  
**Subject:** Report 24: March 21, 2010 –April 3, 2010

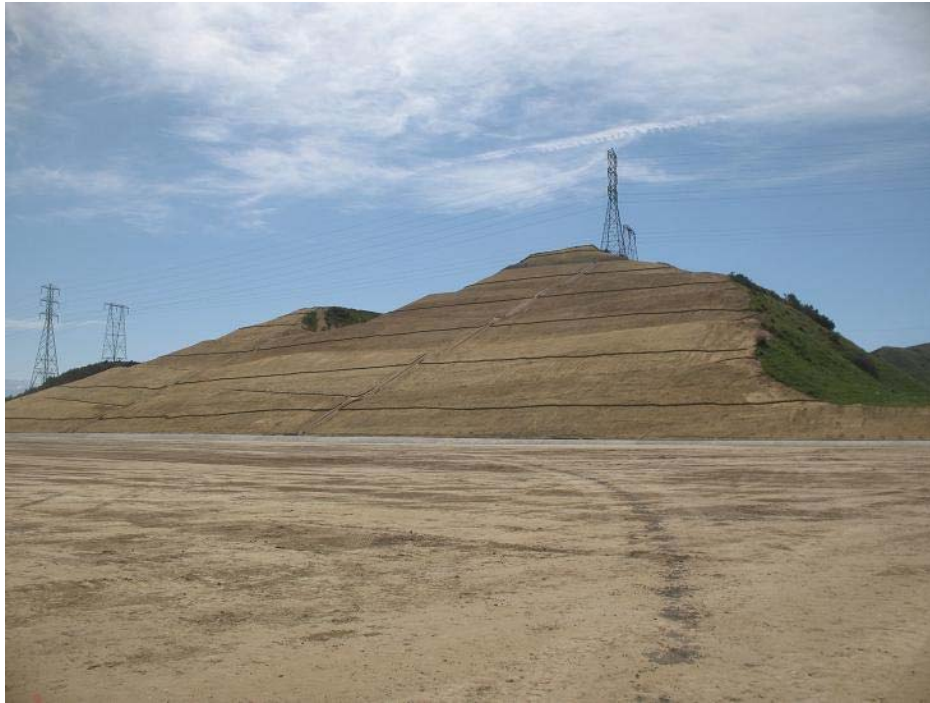
Both of the terraced slopes have been completed. The V-ditches were the last component to be completed which was completed during the subject period (see Figure 1).

**Figure 1:** View of completed terraced slope at El Casco Substation.  
The photograph faces southeast.

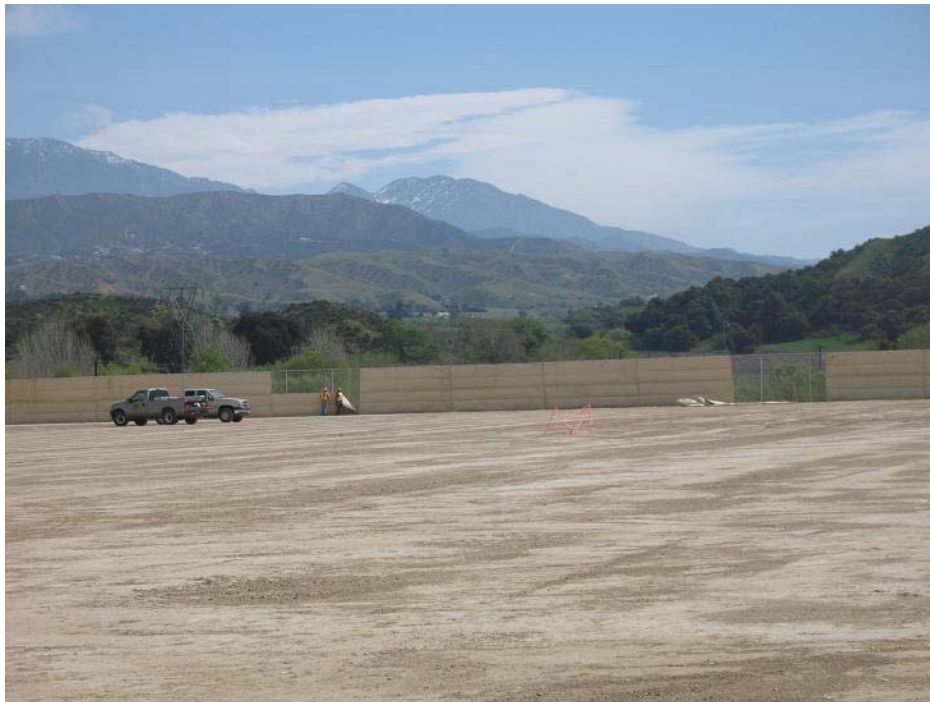
Installation of the chain link fencing along the access road and substation pad was completed during the subject period. Installation of the shade cloth and sound barrier was completed during the subject period. High winds during the subject period ripped portions of the sound barrier off the fence and repairs were made to the fence to make it operational again (see Figure 2). During the time that the sound barrier was down, no work was permitted in the substation with the exception of some minor grading near the trailers.

**Figure 2:** View of damaged sound barrier at El Casco Substation.  
The photograph faces northeastward.

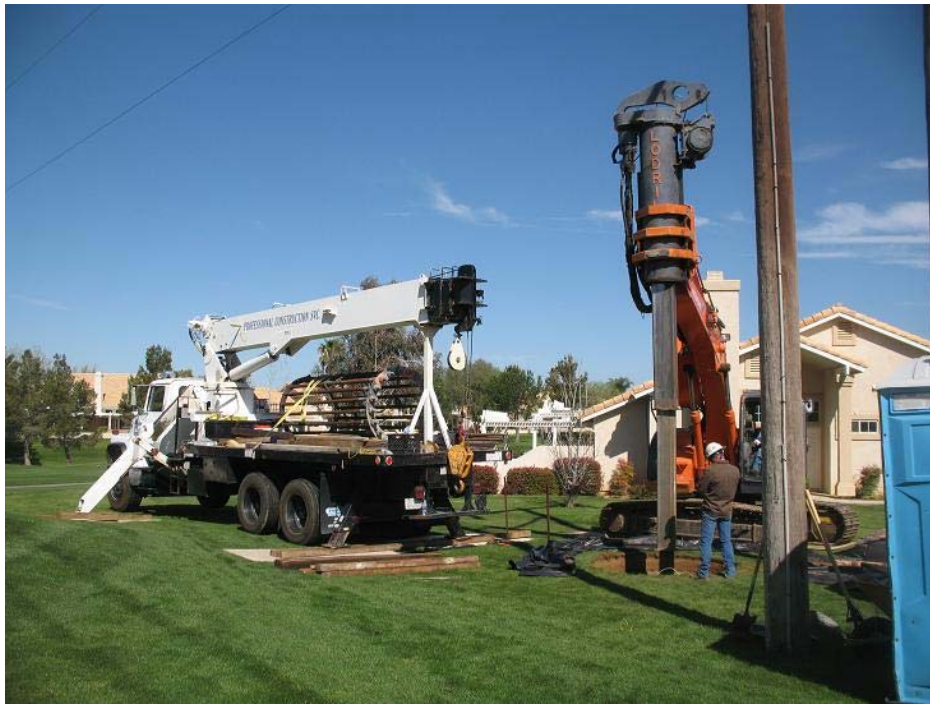
Work started on segment 3 on March 22<sup>nd</sup> at the east end of the segment. Crews are installing foundations for the new steel poles that will be installed to replace the existing wood poles. Crews are using a large drill to excavate a hole, a steel reinforced structure is then placed in the hole, and then concrete is poured (see Figures 3 & 4). The crews have been averaging one foundation per day.

**Figure 3:** View of crews installing new pole foundations for Segment 3 of the sub-transmission line through the Sun Lakes development. The photograph faces northwestward.

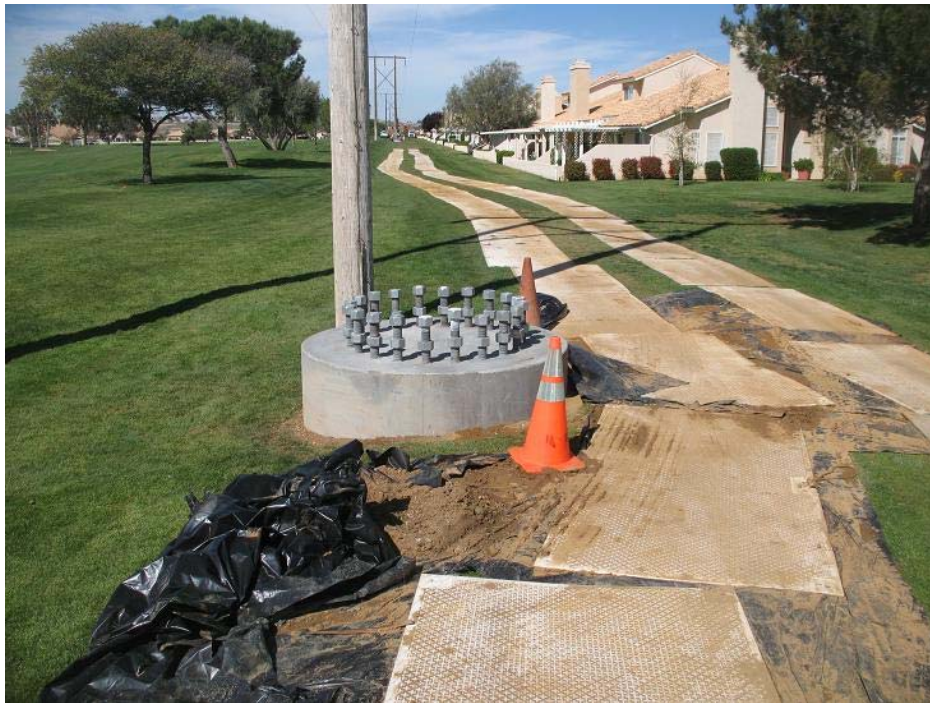
**Figure 4:** View of completed pole foundation. The photograph faces westward.
