**PROJECT MEMORANDUM  
SCE EL CASCO SYSTEM PROJECT**

**To:** Lynne Mosley, CPUC  
**From:** Vida Strong, Aspen Project Manager  
**Date:** February 11, 2011  
**Subject:** Report 43: January 23, 2011 – February 5, 2011

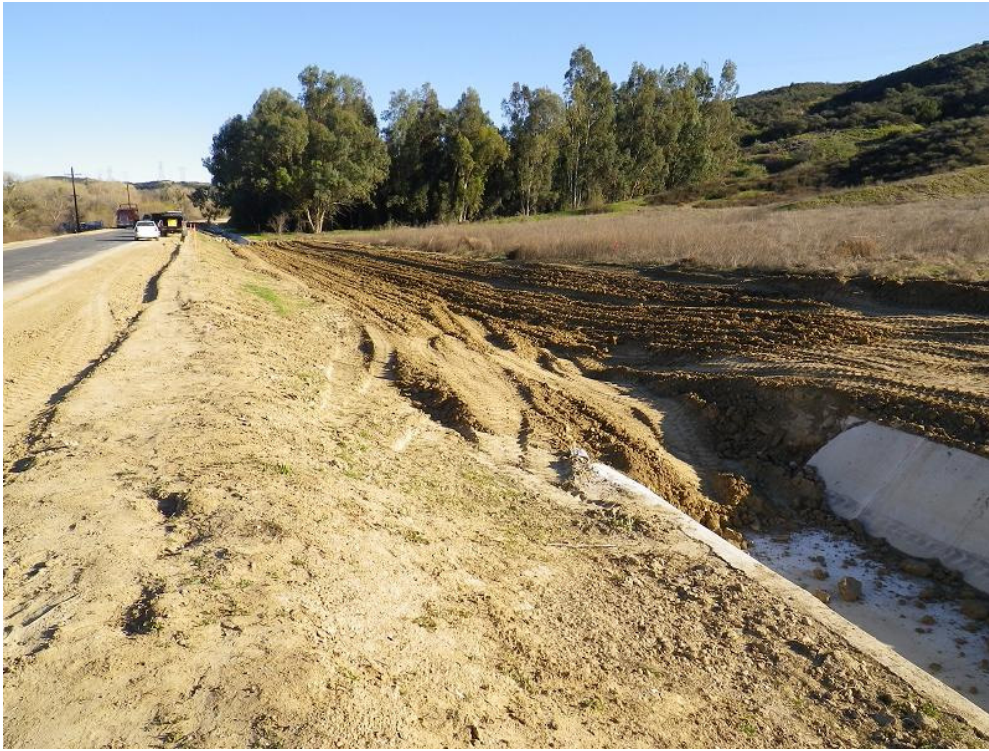
**Figure 1:** View showing the v-ditch after removal along the El Casco Substation access road. The photograph faces east.

During the subject period, work on the substation pad continued. Crews continued the testing of electrical equipment and doing various tasks within the substation limits. Crews have not yet paved the access roads within the substation walls. Crews have started with the changes to the v-ditches adjacent to the main access road. Two sections of the v-ditch have been removed and the new sections should be installed in the coming week or two per the new design with more gradual slopes (see Figure 1). Three culverts have been installed under the new access road to allow wildlife to pass under the recently paved road (see Figure 2). During all road work activities vehicles are using the old access road to enter the substation. The perimeter walls of the substation pad have been completed and access is limited to three points.

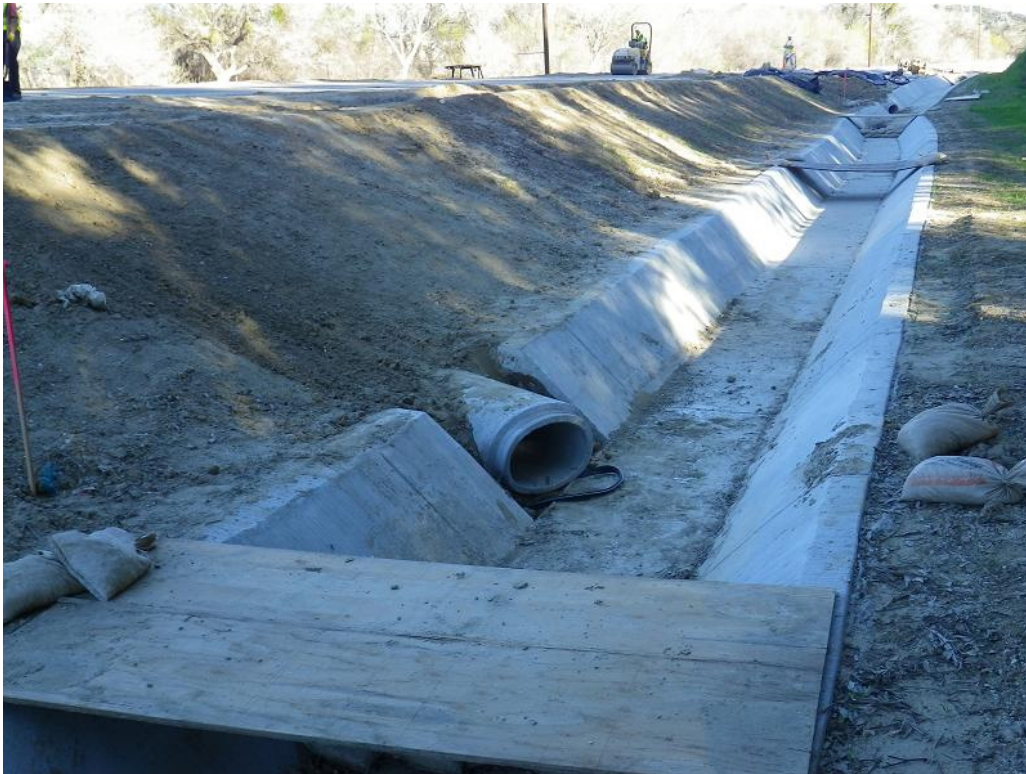
**Figure 2:** View of recently installed wildlife culverts under the main El Casco Substation access road. The photograph faces east.

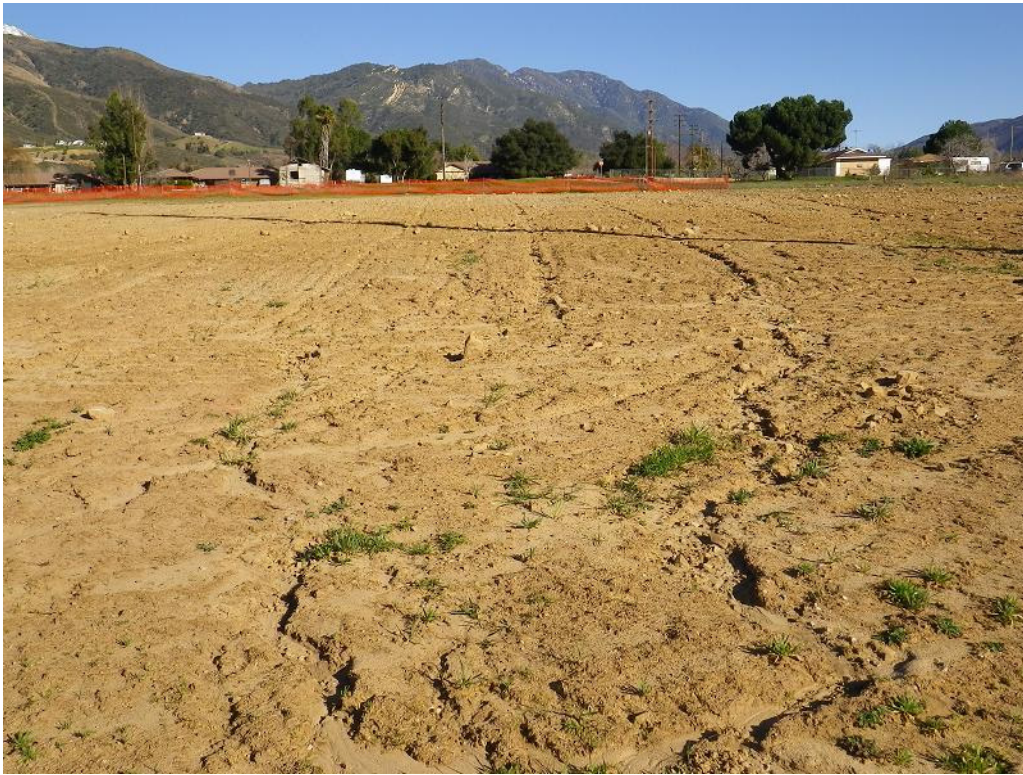
Erosion control hydroseeding with a native plant mix was applied on September 17<sup>th</sup> and the week of December 6<sup>th</sup>. The hydroseed has had very little success of native seed germination and also experienced some

erosion during recent rain events. A third application is being scheduled in order to achieve acceptable coverage percentages (see Figure 3).

**Figure 3:** View of temporary work area at Zanja Substation. Note the lack of emerging native seedling and also erosion from past rain events. The photograph faces east.

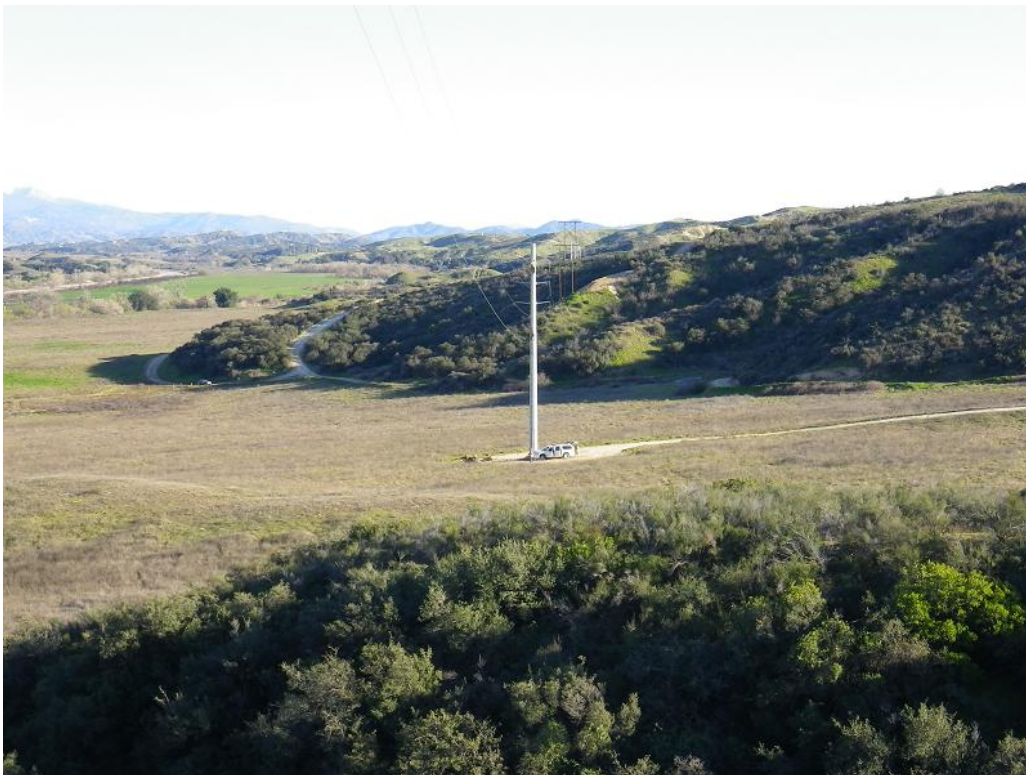
Notice to Proceed #8 for construction of Segments 5 through 8 was issued by CPUC on July 19<sup>th</sup>. Work on Segment 8 began on October 26<sup>th</sup>. All pole foundations on Segment 8 are complete; crews continued setting poles along Segment 8 during the subject period (see Figures 4). Foundation installation for Segment 7 is scheduled to start shortly. No schedule has been established for Segments 5 and 6.

**Figure 4:** View of crews installing new poles just east of the El Casco Substation. The photograph faces east.
