PROJECT MEMORANDUM
SCE EL CASCO SYSTEM PROJECT

To: Lynne Mosley, CPUC
From: Vida Strong, Aspen Project Manager
Date: November 18, 2011
Subject: Report 48: April 31 – October 7, 2011

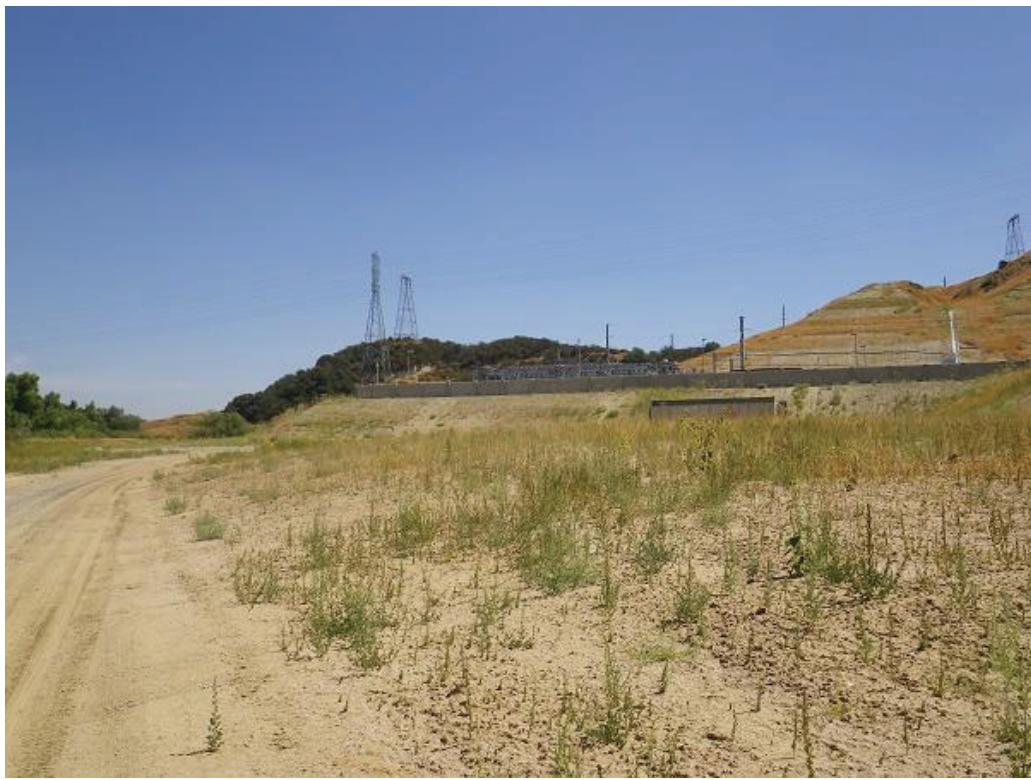
Figure 1: View of hydroseeded temporary work areas near the El Casco Substation.
The photograph faces east.

During the subject period, minimal work occurred within the substation walls but some work did occur in the vicinity of the substation. Crews resumed working on the restoration of the temporary work areas including weeding of the hydroseed areas, preparing to install landscape trees, installing irrigation lines and preparation of the well pump for operation (see Figure 1). Crews have also continued to work in the smooth tarplant mitigation site trying to gain control of the non-native species (see Figure 2).

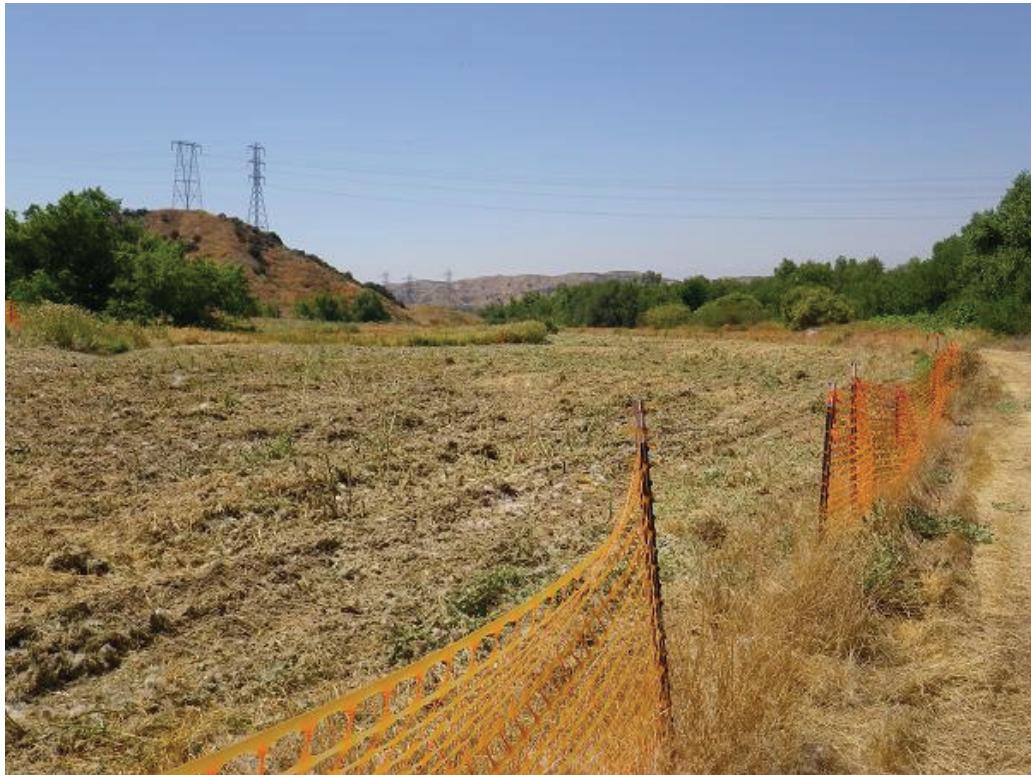
Figure 2: View of the smooth tarplant mitigation site. The photograph faces west.

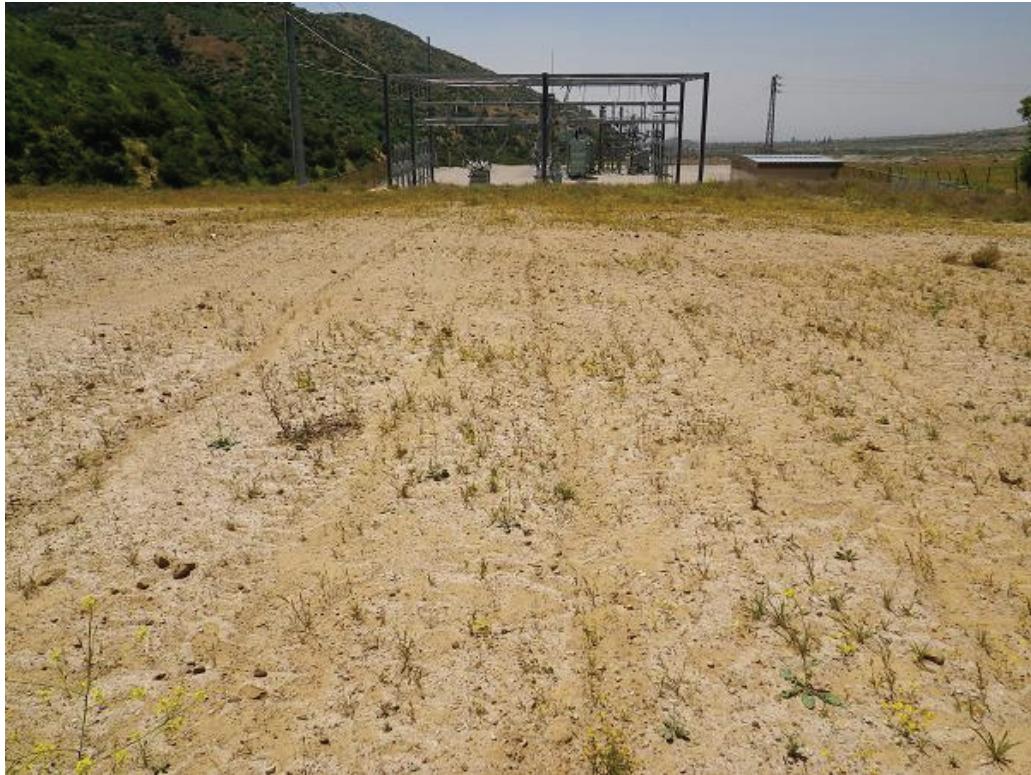
Erosion control hydroseeding with a native plant mix was applied on September 17th and the week of December 6th 2010. The hydroseeded area has had very little success and additional hydroseeding may be necessary in the future (see Figures 3 & 4).

Figure 3: View of hydroseeded temporary work area at Zanja Substation. The photograph faces west.

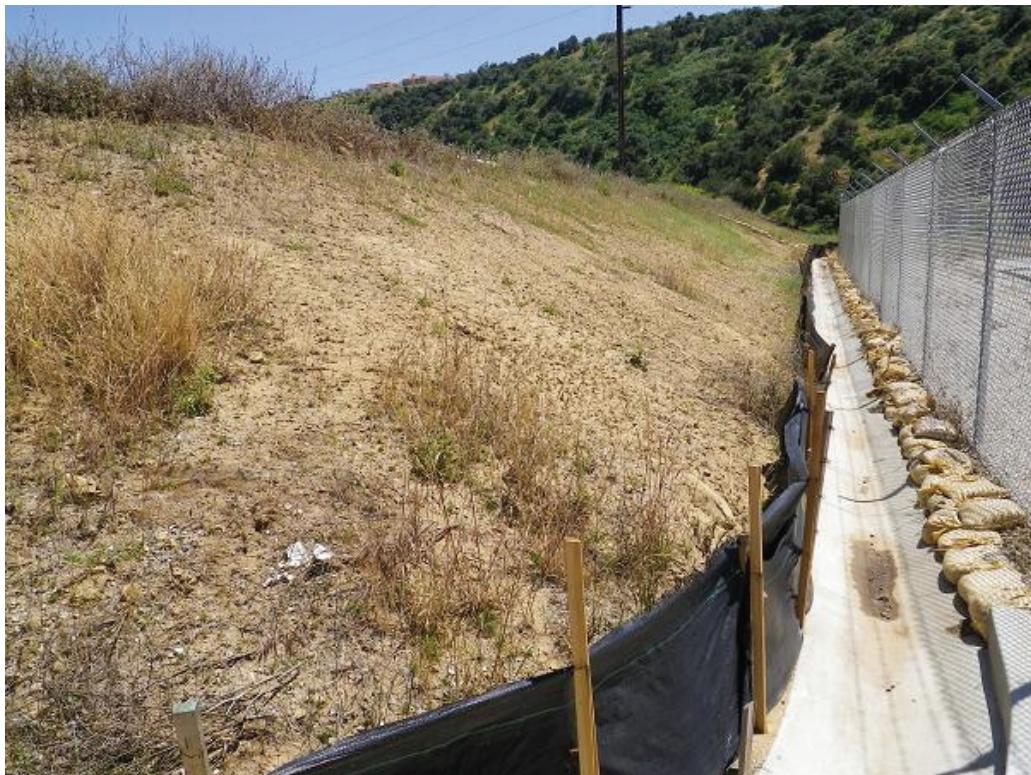
Figure 4: View of hydroseeded temporary work area at Zanja Substation. The photograph faces south.
