PROJECT MEMORANDUM

PG&E EMBARCADERO-POTRERO 230 KV TRANSMISSION PROJECT

To: Billie Blanchard, Project Manager, CPUC
From: Vida Strong, Aspen Project Manager
Date: December 4, 2014
Subject: Monitoring Report #10 – November 17 to November 23, 2014

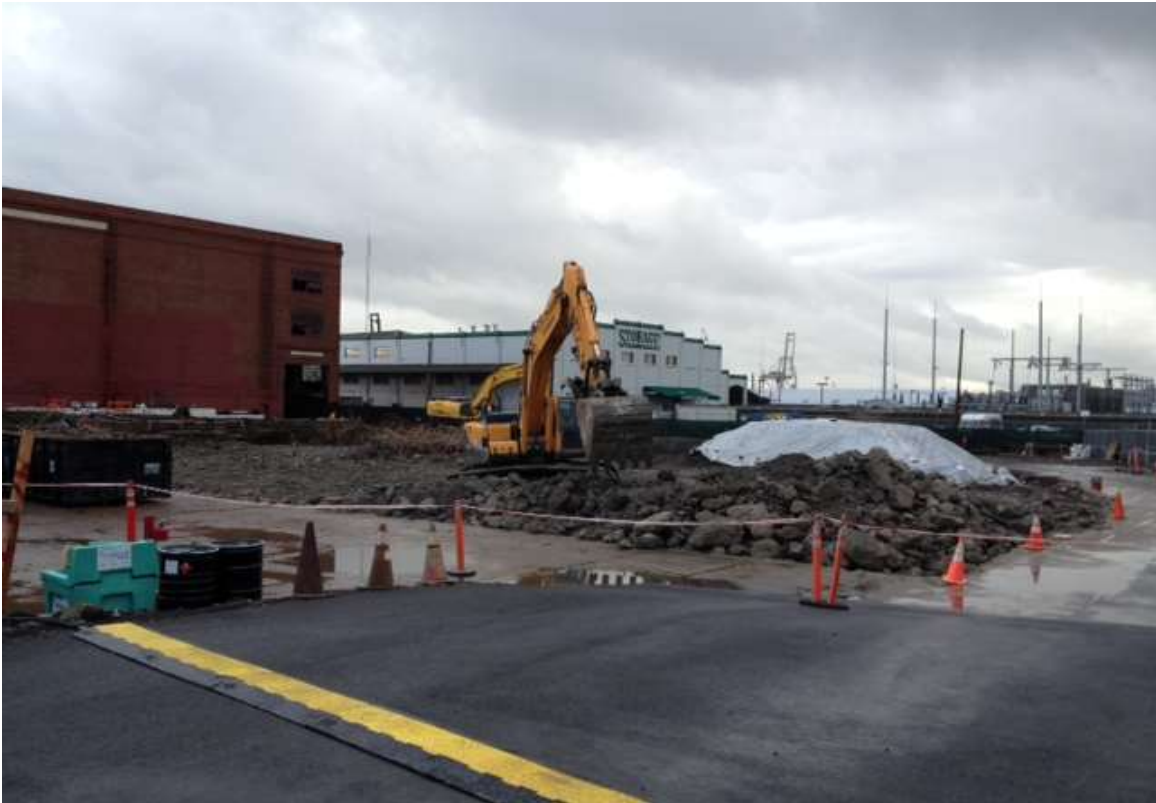
Figure 1 – Demolition of foundations at Potrero Switchyard. View southeast, November 20, 2014.

1. Foundation demolition and excavation activities occurred Monday through Saturday (see Figure 1).
2. Foundation concrete was removed from the site Monday through Thursday.
3. Removal of rebar from concrete for recycling occurred Monday through Saturday.
4. Removal of excavated soil from the site occurred Monday through Wednesday, and Friday.
5. Street sweeping occurred Monday through Saturday.
6. At the time of the CPUC EM site visit on Thursday, November 20th, foundation demolition and excavation were occurring with the use of excavators. The area was being watered to keep the dust down as they excavated.
7. No work was conducted on Sunday.

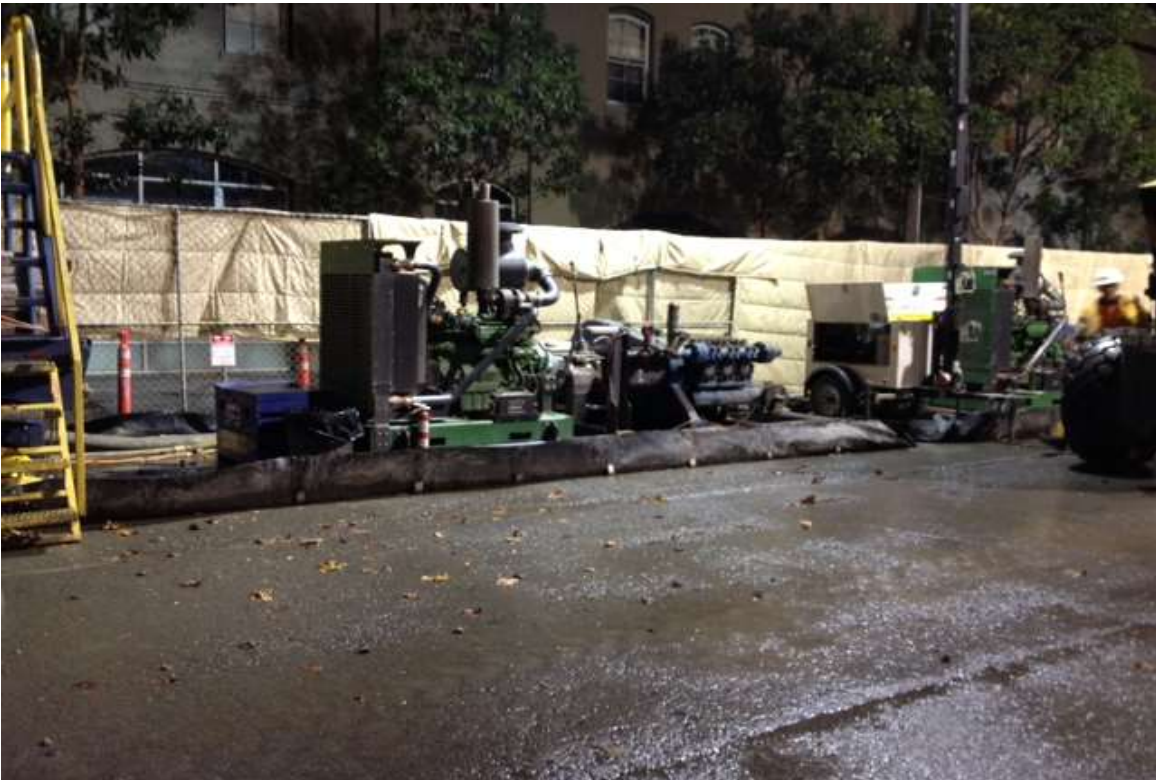
Figure 2 – HDD night work on Spear Street. View south, November 20, 2014.

1. HDD drilling activities continued at Bore 3 Monday through Sunday (see Figure 2).
2. Traffic controls have been established at the corner of Spear Street and Harrison Street by Bay Area Traffic Solutions (BATS). Limited access is provided to Spear Street (a dead end street) including deliveries and people with parking garage permits, as well as construction personnel.
3. An 8-foot-tall chain link fence with sound blankets are in place around the HDD equipment and work area.
4. Street sweeping occurred Monday through Sunday.
5. At the time of the CPUC EM site visit in the afternoon on November 20th, no HDD drilling was occurring because a part on their equipment had broken and they were welding pipe to the bore machine carriage. They had drilled around 1430 feet total, but had only gone 15 feet that day.

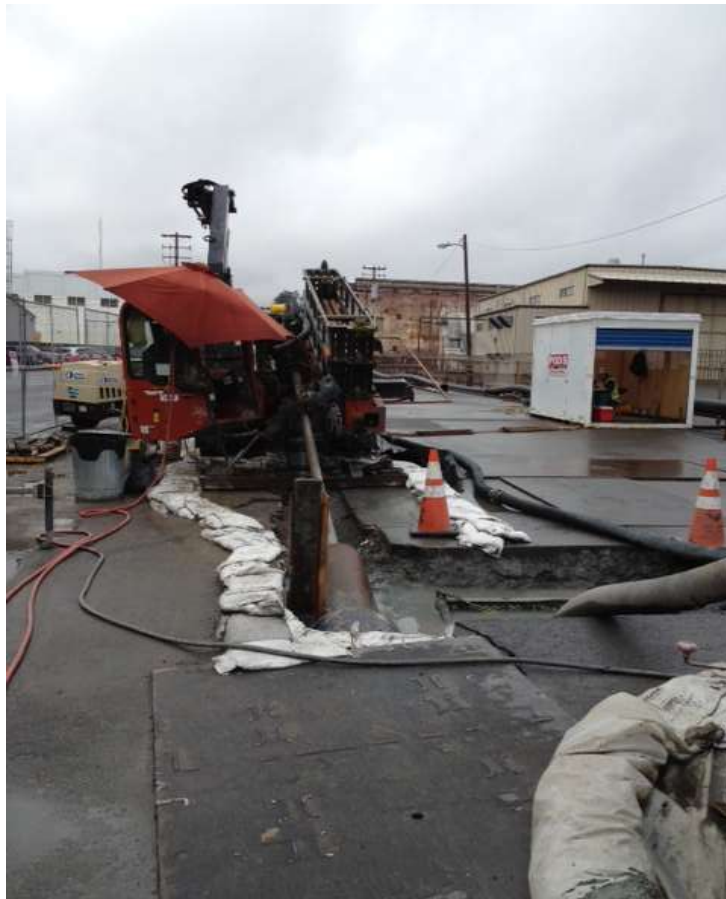
Figure 3 – HDD South on 23rd Street. View west, November 20, 2014.

1. Equipment delivery occurred on Monday.
2. High density polyethylene (HDPE) pipe was hydro-tested on Monday and Wednesday.
3. HDD drilling activities continued at Bore 1 Monday through Wednesday. The drill entered the receiving pit on Thursday (see Figure 3).

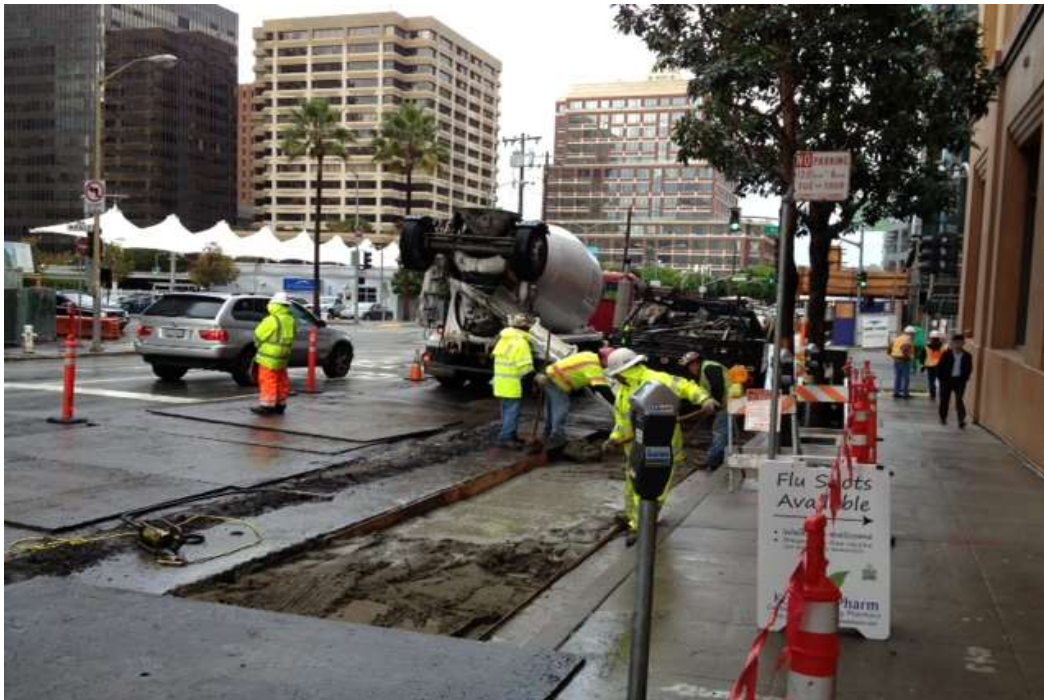
Figure 4 –Pouring cement slurry in duct bank trench on Folsom Street. View north, November 20, 2014.

1. Duct bank installation occurred Monday on Folsom Street and cement was poured into the duct bank excavation Tuesday through Saturday (see Figure 4). Some pavement pieces that fell into the trench were removed and part of the trench was backfilled with sand on Friday.

5. At the time of the CPUC EM site visit on November 20th, cement slurry was being poured in the trench with the installed conduit on Folsom Street between Beale Street and Zeno Place. The trenches were plated at the end of the work day. In the evening, the CPUC EM conducted a site visit of the work area on Spear Street between Harrison Street and Folsom Street for the 12 kV relocation work. Crews had already stopped work for the day.

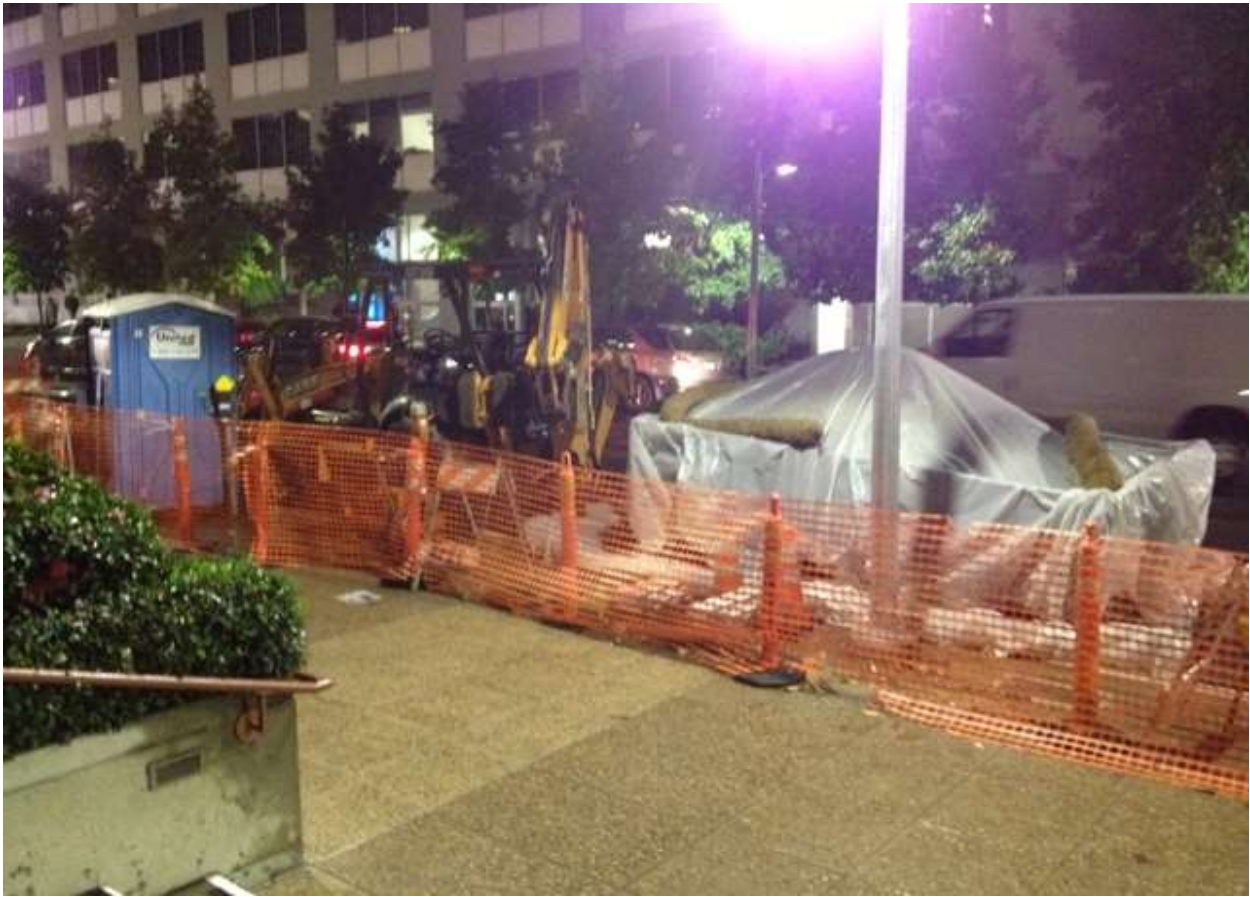
Figure 5 – 12 kV relocation equipment and materials staged on Spear Street. View southeast, November 20, 2014.

2. Traffic control setup occurred on Monday through Saturday on Folsom Street.
3. Street sweeping occurred Monday through Friday.
4. 12 kV relocation work on Spear Street occurred Monday through Friday, with excavating on Monday and Tuesday, backfilling excavation on Wednesday and Thursday, and paving on Friday (see Figure 5).
