**PROJECT MEMORANDUM**

**PG&E EMBARCADERO-POTRERO 230 kV TRANSMISSION PROJECT**

**To:** Billie Blanchard, Project Manager, CPUC  
**From:** Vida Strong, Aspen Project Manager  
**Date:** September 30, 2015  
**Subject:** Monitoring Report #54 – September 21 to September 27, 2015

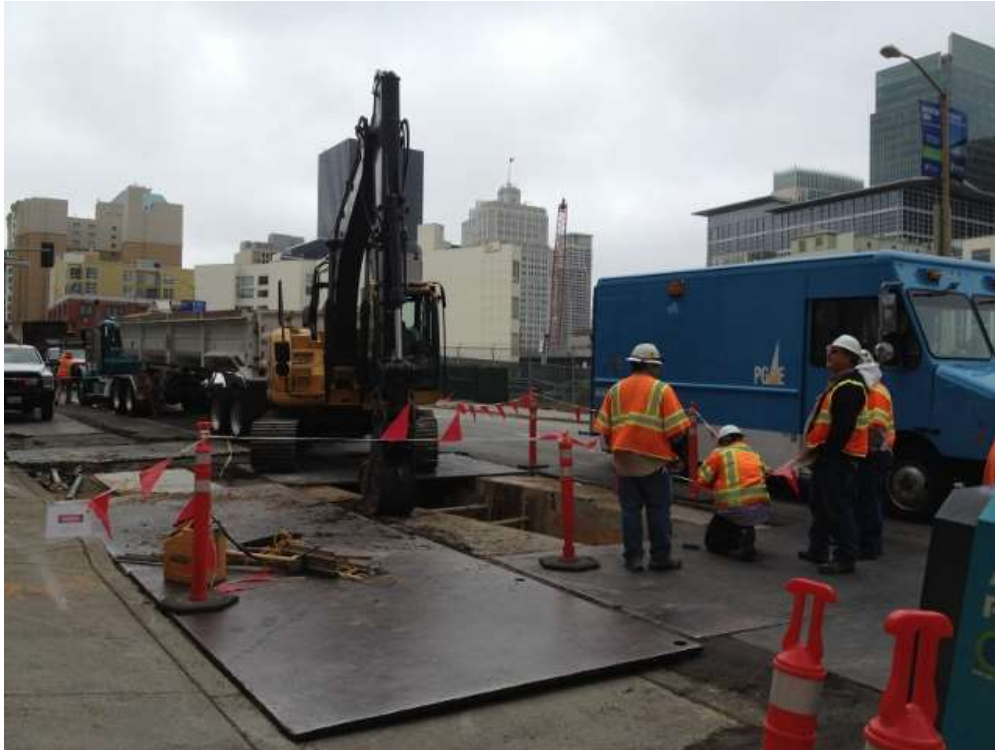
1. Underground Construction Co. excavated duct bank trench between 1<sup>st</sup> Street and Fremont Street Monday through Saturday.
2. Underground Construction Co. installed shoring in the duct bank trench between 1<sup>st</sup> Street and Fremont Street Monday through Wednesday and Saturday, and potholed for utilities Monday and Wednesday.
3. Underground Construction Co. removed a wood panel related to the Embarcadero Substation between 1<sup>st</sup> Street and Fremont Street on Wednesday.
4. A PG&E crew was onsite repairing the 12 kV utility line break Tuesday through Thursday.
5. At the time of the CPUC EM site visit on September 22<sup>nd</sup>, PG&E, BVCI and Underground Construction Co. were assessing the damage that had taken place just prior from the 12 kV line break (see Figure 1).

Figure 1 – Location where 12 kV line was hit while excavating duct bank trench on Folsom Street between 1<sup>st</sup> Street and Fremont Street. View southwest, September 22, 2015.

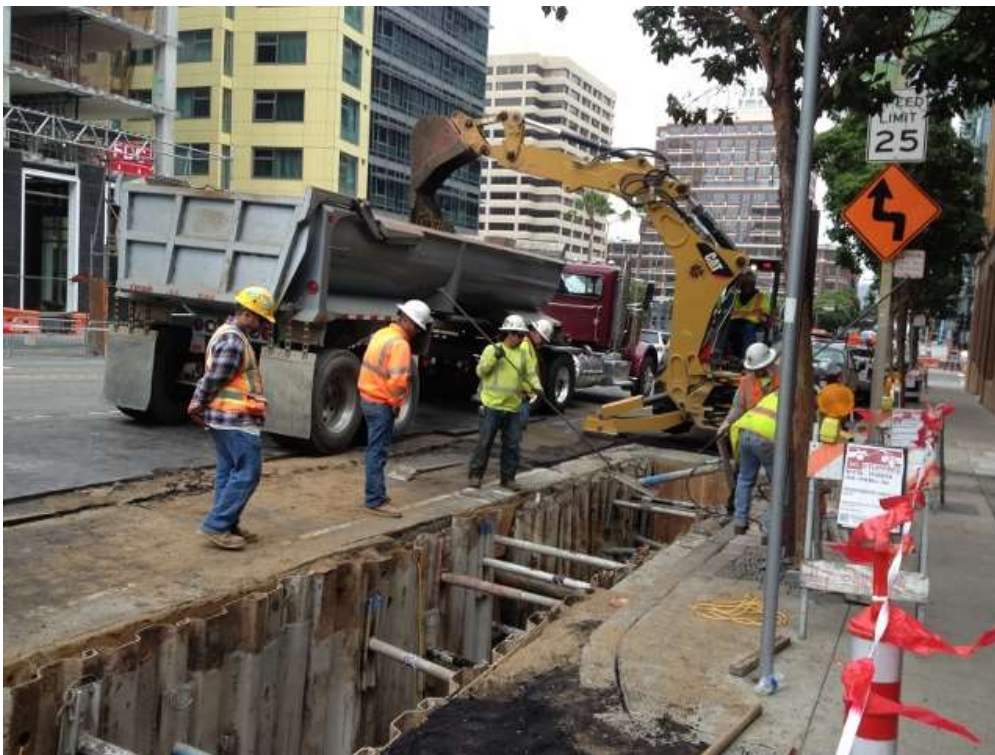
6. Underground Construction Co. jackhammered and removed pavement between Fremont and Beale Streets on Monday.
7. Underground Construction Co. excavated duct bank trench between Fremont and Beale Streets Monday through Thursday.
8. Underground Construction paved between Fremont and Beale Streets on Tuesday.
9. Underground Construction Co. added base rock in the duct bank trench between Fremont and Beale Streets on Wednesday.
10. Underground Construction Co. installed and tied rebar between Fremont and Beale Streets Wednesday through Saturday.
11. Underground Construction Co. installed conduit pipe between Fremont and Beale Streets on Friday.
12. At the time of the CPUC EM site visit on September 22<sup>nd</sup>, a crew was excavating the duct bank trench between Fremont and Beale Streets (see Figure 2).

Figure 2 – Excavating on Folsom Street between Fremont and Beale Streets. View northwest, September 22, 2015.

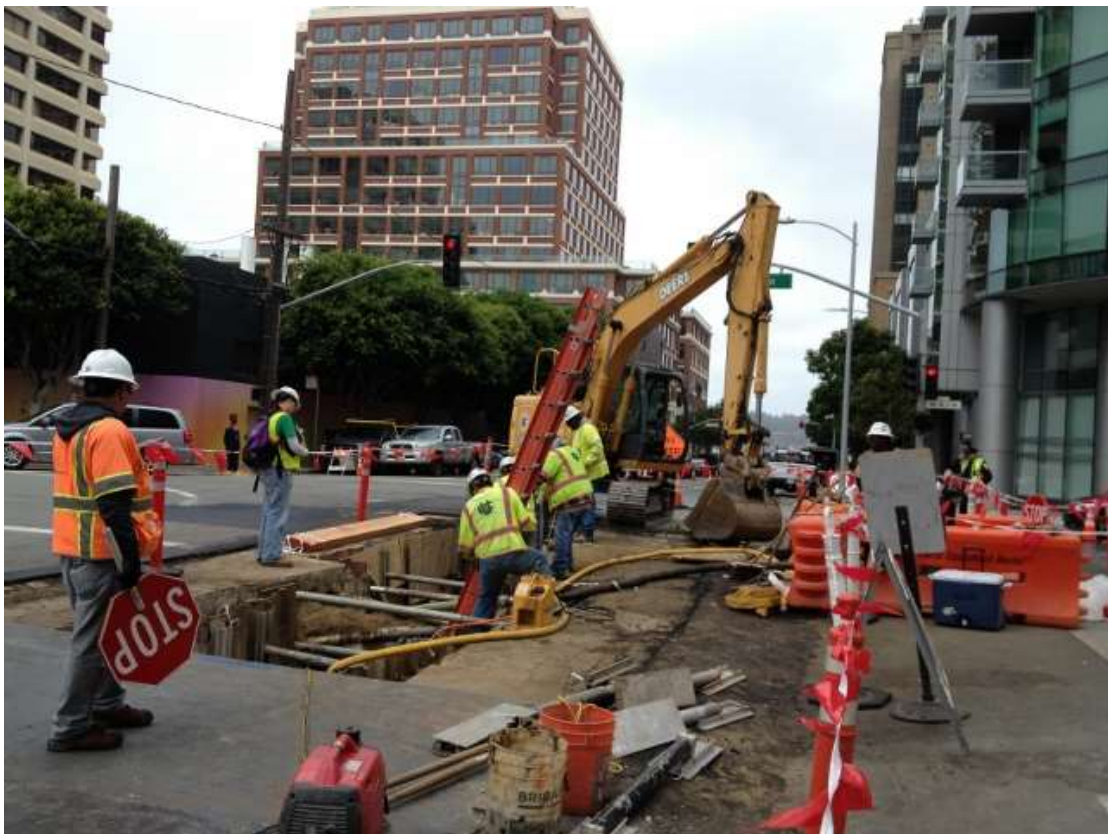
16. Underground Construction Co. potholed for utilities between Beale and Main Streets on Tuesday and Saturday.
17. Underground Construction Co. backfilled with concrete between Beale and Main Streets on Wednesday.
18. Underground Construction Co. added base rock in the duct bank trench and installed conduit pipe between Beale and Main Streets on Friday.
19. Underground Construction Co. installed rebar between Beale and Main Streets on Friday and Saturday.
20. At the time of the CPUC EM site visit on September 22<sup>nd</sup>, a crew was excavating the duct bank trench between Beale and Main Streets (see Figure 3).

Figure 3 – Excavating on Folsom Street between Beale and Main Streets. View northwest, September 22, 2015.

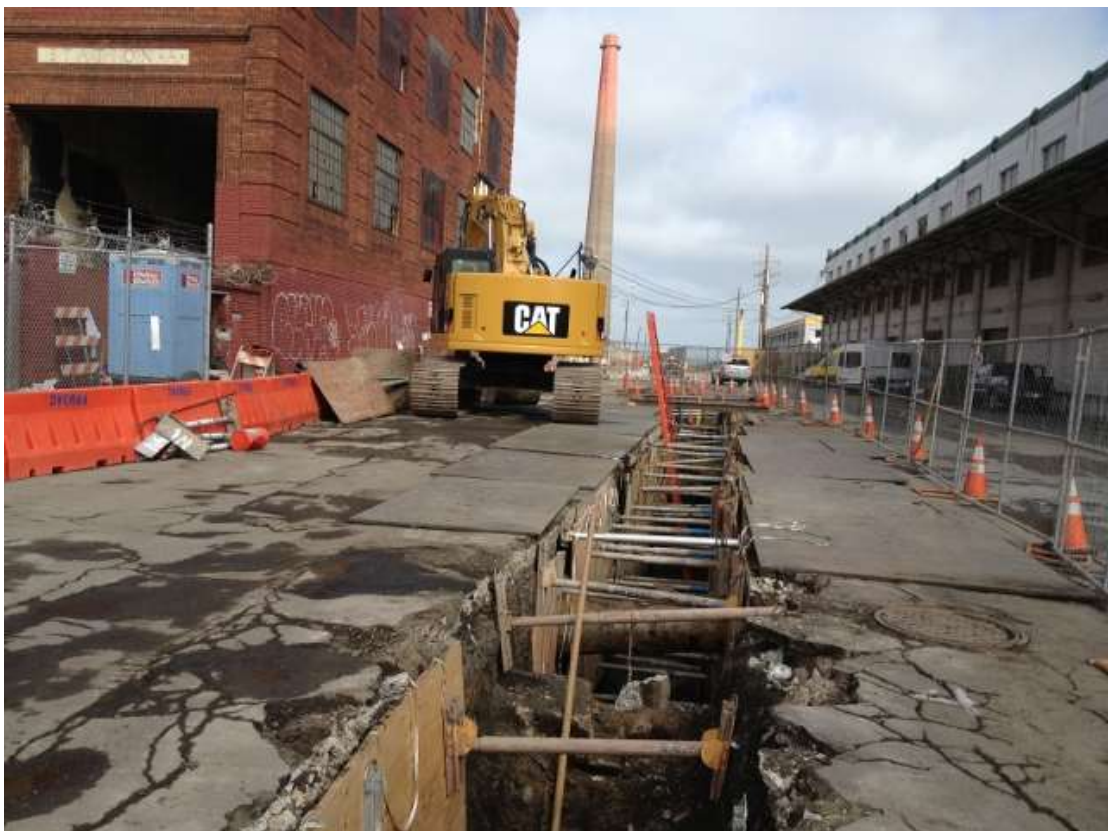
1. Underground Construction Co. excavated the duct bank trench and installed shoring Monday through Thursday.
2. Underground Construction Co. removed old pipe on Monday, Wednesday and Thursday.
3. Underground Construction Co. installed rebar in the duct bank trench on Thursday and Friday.
4. Underground Construction Co. added base rock in the duct bank trench on Thursday and installed conduit pipe on Friday.
5. PSC dewatered old utility pipe on Wednesday and Thursday.
6. Clean Harbors hauled off excavated material for disposal Monday through Thursday.
7. Street sweeping was conducted Monday through Friday.
8. At the time of the CPUC EM site visit on September 22<sup>nd</sup>, a crew was excavating the duct bank trench (see Figure 4).
9. No construction activities occurred on Saturday or Sunday.

Figure 4 – Excavated on 23<sup>rd</sup> Street. View east, September 22, 2015.
