**PROJECT MEMORANDUM**

**PG&E EMBARCADERO-POTRERO 230 kV TRANSMISSION PROJECT**

**To:** Billie Blanchard, Project Manager, CPUC  
**From:** Vida Strong, Aspen Project Manager  
**Date:** October 8, 2015  
**Subject:** Monitoring Report #55 – September 28 to October 4, 2015

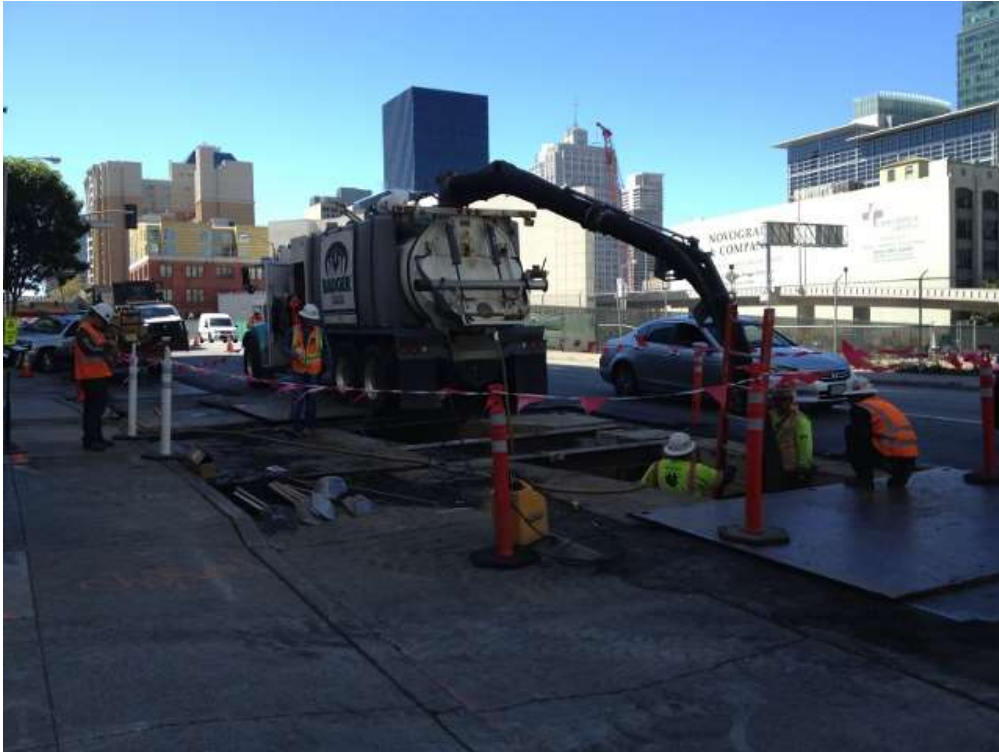
1. Underground Construction Co. jackhammered and removed pavement Monday through Thursday, and saw cut and removed pavement on Friday.
2. Underground Construction Co. excavated using a Vac-truck Monday through Saturday.
3. Underground Construction Co. installed shoring Tuesday through Thursday, and removed shoring on Friday.
4. Underground Construction Co. backfilled with concrete on Friday.
5. Underground Construction Co. conducted street sweeping Monday through Saturday.
6. Clean Harbors hauled off excavated material for disposal Monday through Saturday.
7. At the time of the CPUC EM site visit on October 1<sup>st</sup>, Underground Construction Co. was excavating the trench with a Vac-truck (see Figure 1).

Figure 1 – Excavating the duct bank trench with a Vac-truck on Folsom Street between 1<sup>st</sup> Street and Fremont Street. View southwest, October 1, 2015.

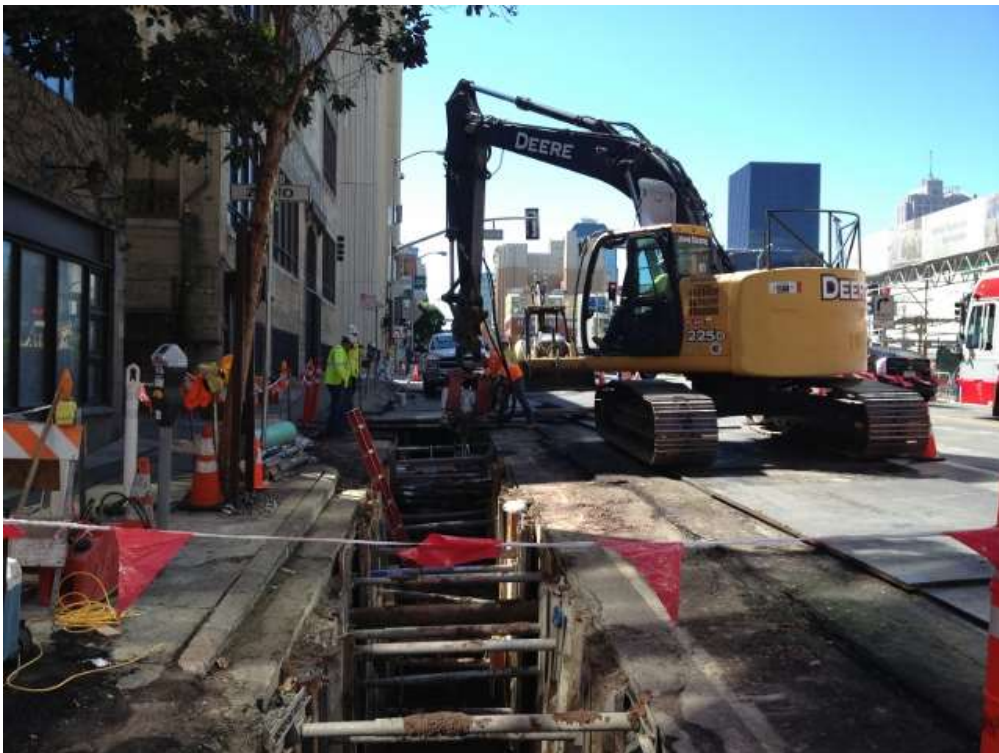
16. At the time of the CPUC EM site visit on October 1<sup>st</sup>, a crew was removing shoring and backfilling the duct bank trench with concrete between Fremont and Beale Streets (see Figure 2).

Figure 2 – Removing shoring from trench on Folsom Street between Fremont and Beale Streets. View south, October 1, 2015.

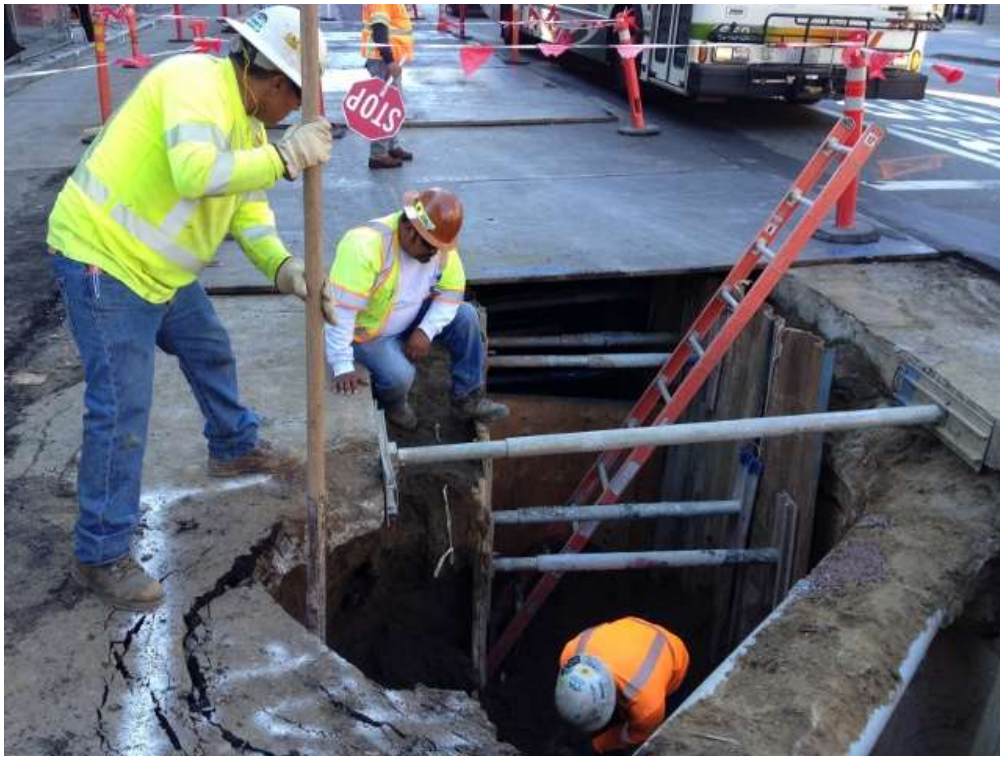
21. Underground Construction Co. potholed for utilities on Wednesday.
22. Underground Construction Co. saw cut pavement on Wednesday.
23. Underground Construction Co. installed shoring on Wednesday and Friday, and removed shoring on Thursday and Saturday.
24. Underground Construction Co. installed a storm drain on Thursday and Friday.
25. Underground Construction Co. conducted street sweeping Monday through Saturday.
26. Clean Harbors hauled off excavated material for disposal Monday through Saturday.
27. PSC dewatered excavation Monday through Friday.
28. At the time of the CPUC EM site visit on October 1<sup>st</sup>, a crew was potholing for utilities at Main Street (see Figure 3).

Figure 3 – Potholing for utilities on Folsom Street at Main Streets View southwest, October 1, 2015.

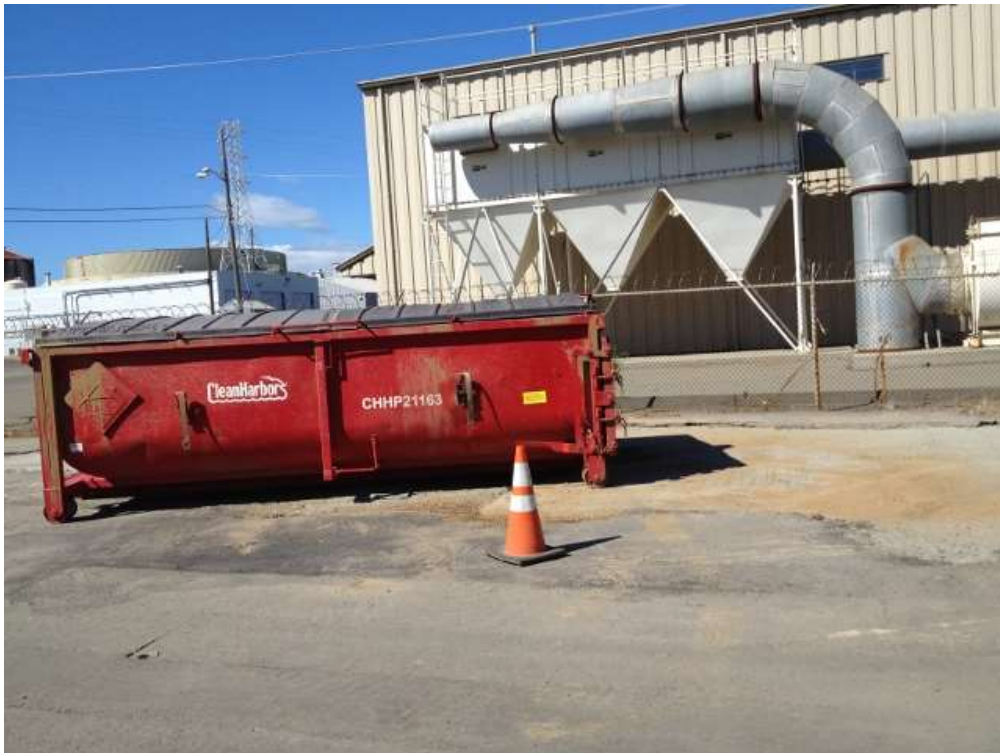
5. The CPUC EM noted where the spoils had spilled from the roll off bin staged on 23<sup>rd</sup> Street (see Figure 4). Other than that, the CPUC EM noted that the site was neat and clean, and that SWPPP measures were in place. All observed work activities were in compliance with the mitigation measures (MMs), Applicant Proposed Measures (APMs), and other permit requirements.

Figure 4 – Dried spoils spill from roll off bin on 23<sup>rd</sup> Street. View north, October 1, 2015.
