**PROJECT MEMORANDUM**  
**PG&E EMBARCADERO-POTRERO 230 kV TRANSMISSION PROJECT**

**To:** Billie Blanchard, Project Manager, CPUC  
**From:** Vida Strong, Aspen Project Manager  
**Date:** February 17, 2016  
**Subject:** Monitoring Report #73 – February 8, 2016 to February 14, 2016

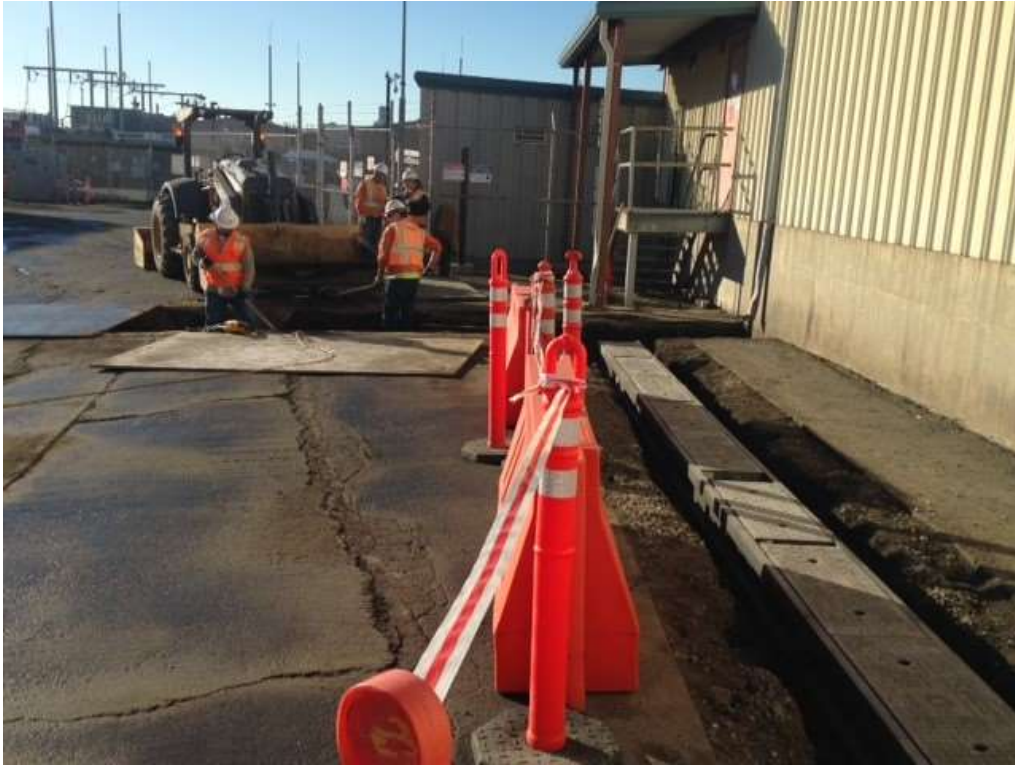
7. MEI conducted grounding work in the GIS building on Wednesday and Friday.
8. CMC conducted rebar layout in the GIS building on Monday and Tuesday.
9. APEC excavated for cable trench on Monday, Tuesday, and Friday (see Figure 1).

Figure 1 – APEC excavating for cable trench in Switchyard. View south, February 8, 2016. Photo courtesy of PG&E.

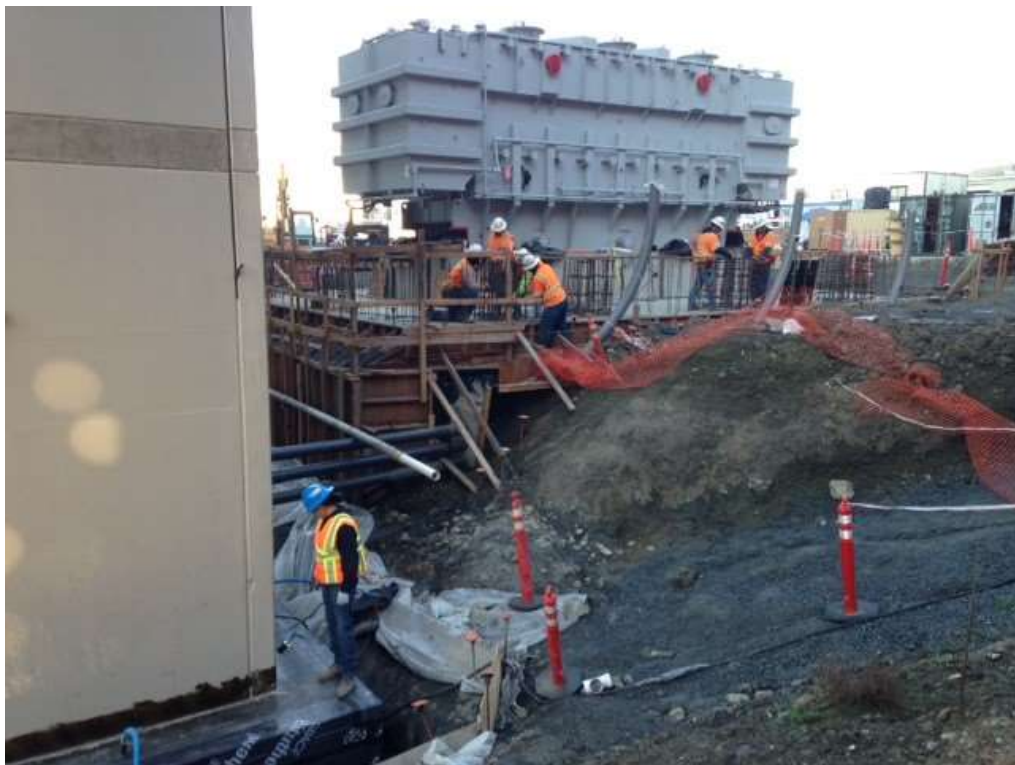
10. APEC installed forms and rebar at the transformer pad on Tuesday (see Figure 2).
11. ERS conducted waterproofing work on the GIS building Monday through Saturday (see Figure 2).

Figure 2 – APEC installing forms at transformer pad and ERS waterproofing GIS building. View northwest, February 9, 2016. Photo courtesy of PG&E.

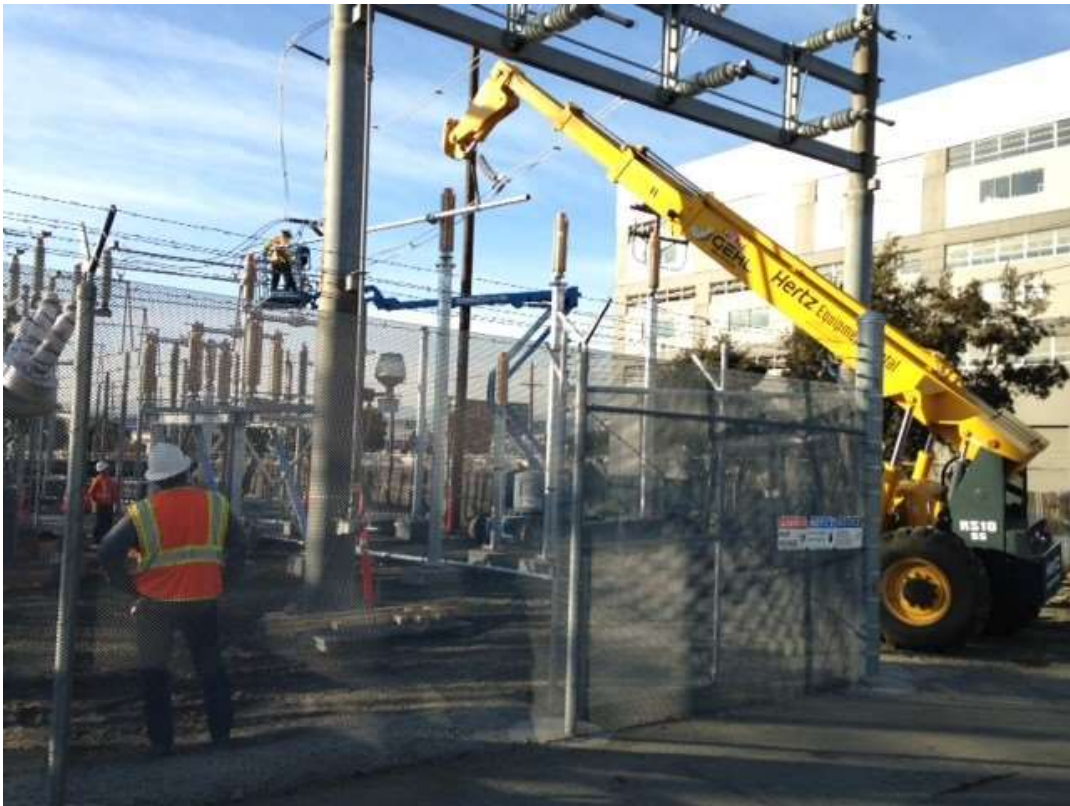
1. CCE QEW monitored work in the substation Monday through Friday.
2. APEC conducted housekeeping and dust control activities Monday through Friday.
3. APEC excavated Monday through Friday.
4. CCE installed new infrastructure to new foundations on Monday and Tuesday (see Figure 3).
5. Contra Costa installed new aboveground infrastructure on the new foundations on Sunday.

Figure 3 – CCE installing infrastructure in substation. View northwest, February 9, 2016. Photo courtesy of PG&E.

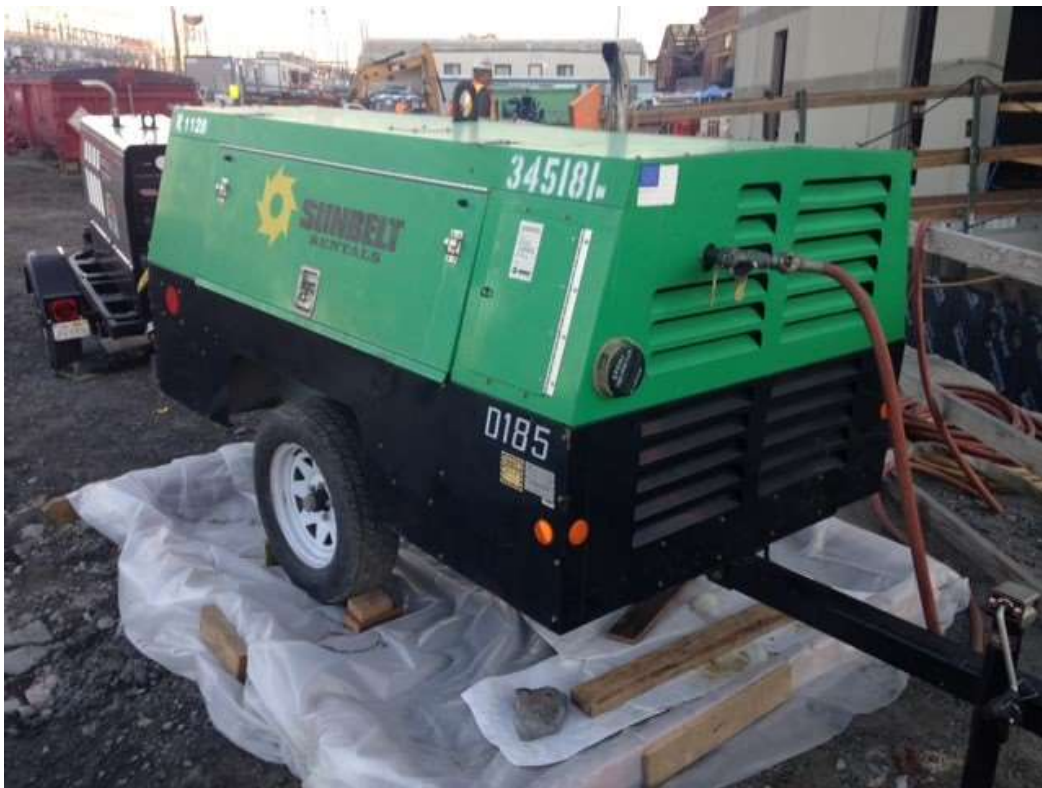
- On February 8<sup>th</sup>, the PG&E Environmental Inspector observed an air compressor leaking antifreeze (approximately 1/3 cup) into secondary containment underneath it west of the new GIS building (see Figure 4). Cleanup of the antifreeze from the secondary containment and replacement or servicing of the compressor were recommended. The compressor was replaced that afternoon.

Figure 4 – Air compressor leaking antifreeze onto secondary containment. February 8, 2016. Photo courtesy of PG&E.
