**PROJECT MEMORANDUM**

**PG&E EMBARCADERO-POTRERO 230 kV TRANSMISSION PROJECT**

**To:** Billie Blanchard, Project Manager, CPUC  
**From:** Vida Strong, Aspen Project Manager  
**Date:** March 11, 2016  
**Subject:** Monitoring Report #76 – February 29, 2016 to March 6, 2016

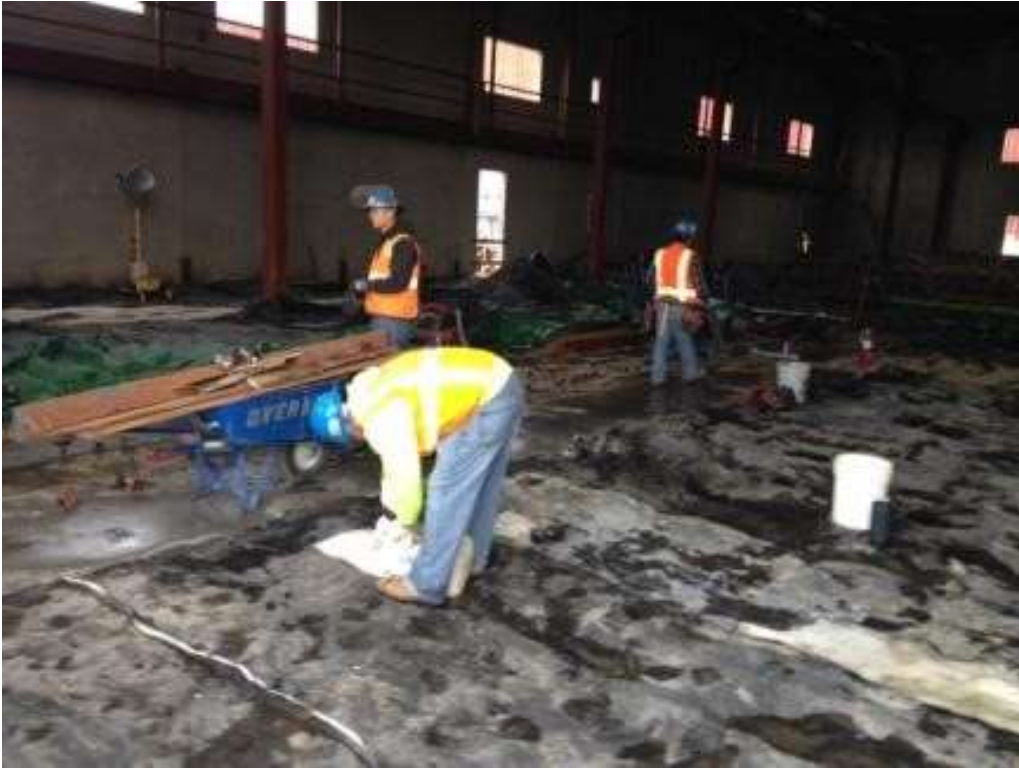
4. Overaa adjusted concrete curing blankets in the GIS building on Monday (see Figure 1).
5. Metal Set welded in the GIS building Monday through Friday.

Figure 1 – Crews adjusted concrete curing blankets in the GIS building. View northeast, February 29, 2016. Photo courtesy of PG&E.

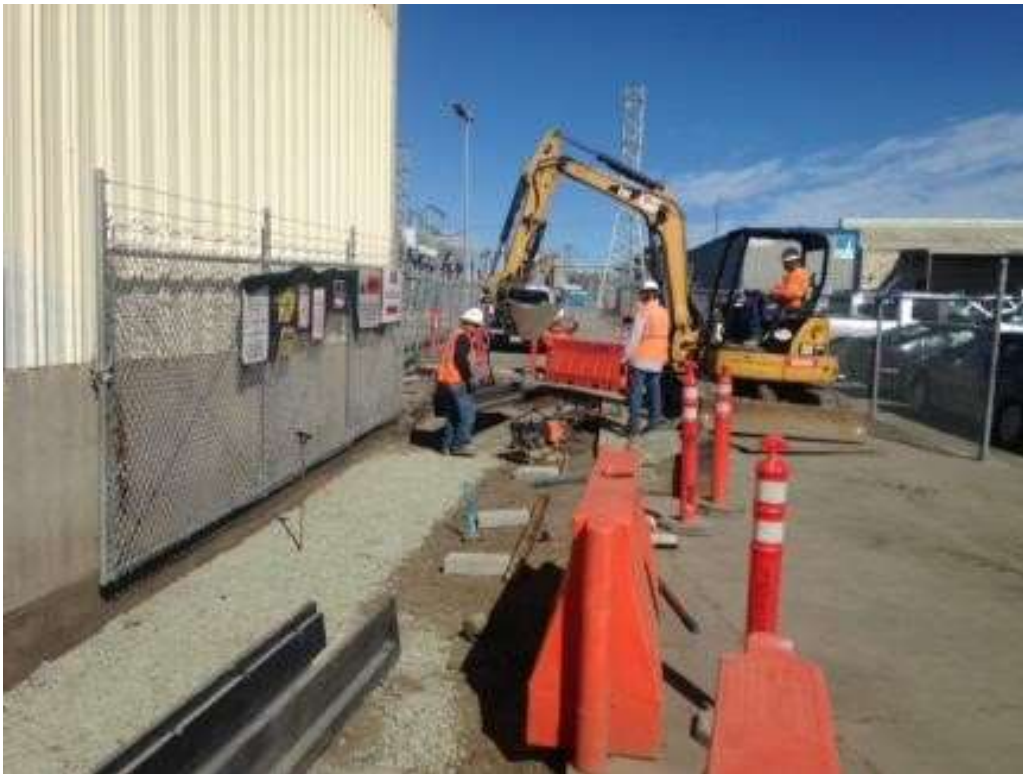
6. APEC excavated and installed cable trays for the cable trench Monday through Friday (see Figure 2).
7. APEC removed forms at the transformer pad Monday through Wednesday.

Figure 2 – Crews installing cable trays for the cable trench. View north, March 1, 2016. Photo courtesy of PG&E.

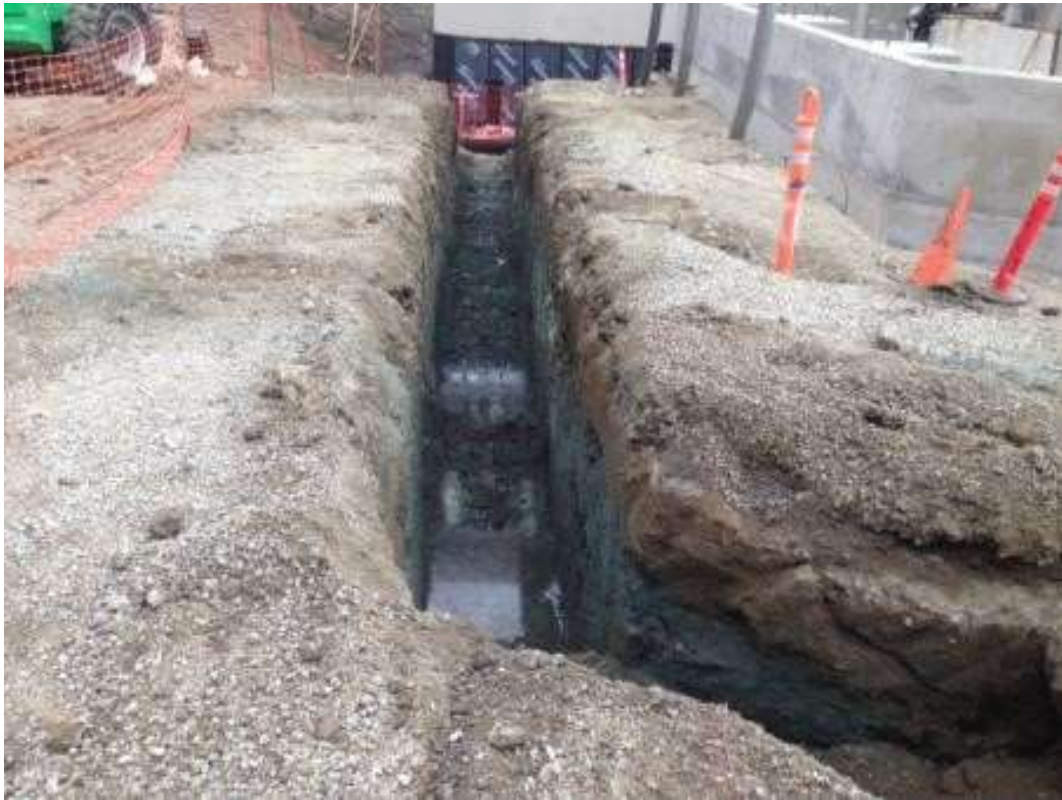
8. APEC excavated near the transformer pad Wednesday through Saturday (see Figure 3).
9. MEI worked on penetrations of the roof of the GIS building on Thursday.

Figure 3 – Crews excavated near the transformer pad. View east, March 3, 2016. Photo courtesy of PG&E.

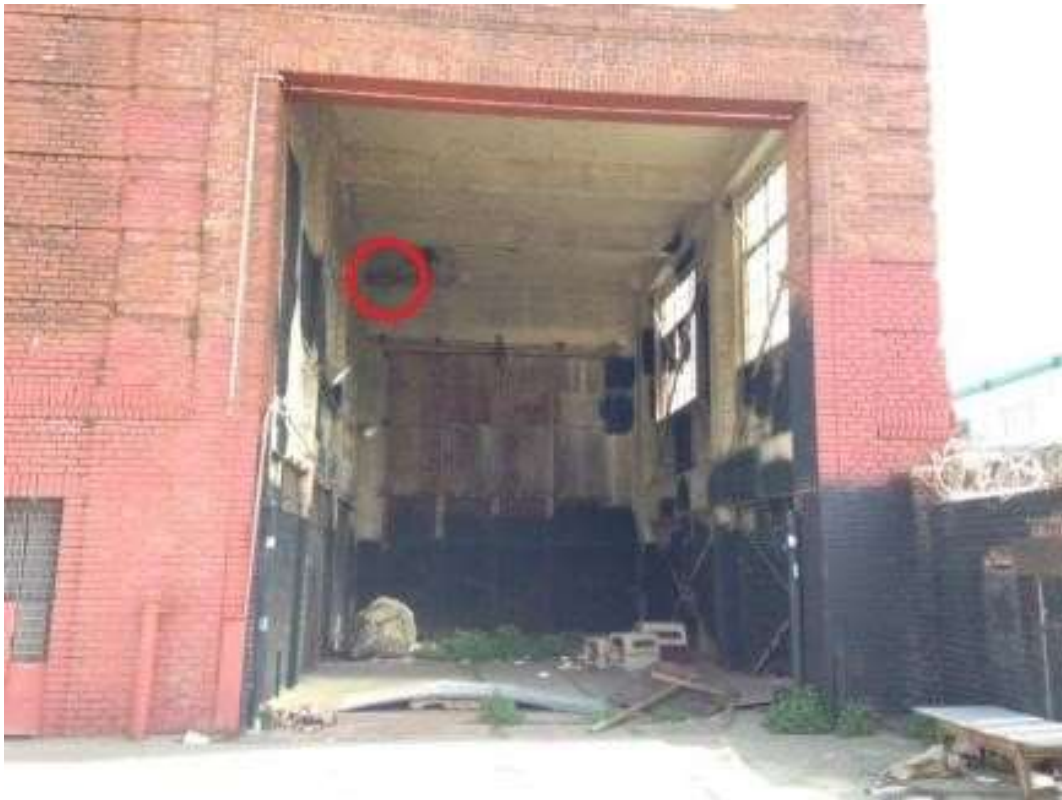
- On March 2<sup>nd</sup>, the PG&E Environmental Inspector observed a common raven building a nest in Station A just outside the southeast corner of the work area (see Figure 4). The nest start was not active; only a few sticks were present and no incubation was observed. The nest start was about 50 feet from the work boundary, but access to the nest for the adults was only 20 feet from the work boundary and faces the work area. The nest start location was visible from the work area. No work is being conducted in this corner currently; only very light foot traffic is occurring. PG&E stated that in a couple of weeks, heavy work with equipment is planned in that corner of the yard in plain view of the nest. This future work would likely impact the nesting pair

Figure 4 – Common raven nest start in Station A building adjacent to southeast corner of Potrero Switchyard. View east, March 2, 2016. Photo courtesy of PG&E.

if the nest becomes active. Due to this, the PG&E Environmental Inspector recommended deterrent measures or nest removal so the nest start would not become active. On March 3<sup>rd</sup>, the nest start was removed by Overaa.

- On March 4<sup>th</sup>, the PG&E Environmental Inspector observed that the pair of common ravens were rebuilding the nest that had been removed the previous day in Station A. Nest construction had just begun and only a few small sticks were in place. The PG&E Environmental Inspector informed PG&E and recommended that they remove the new nest start as soon as possible.
