PROJECT MEMORANDUM

PG&E EMBARCADERO-POTRERO 230 kV TRANSMISSION PROJECT

To: Billie Blanchard, Project Manager, CPUC
From: Vida Strong, Aspen Project Manager
Date: July 21, 2016
Subject: Monitoring Report #95 – July 11, 2016 to July 17, 2016

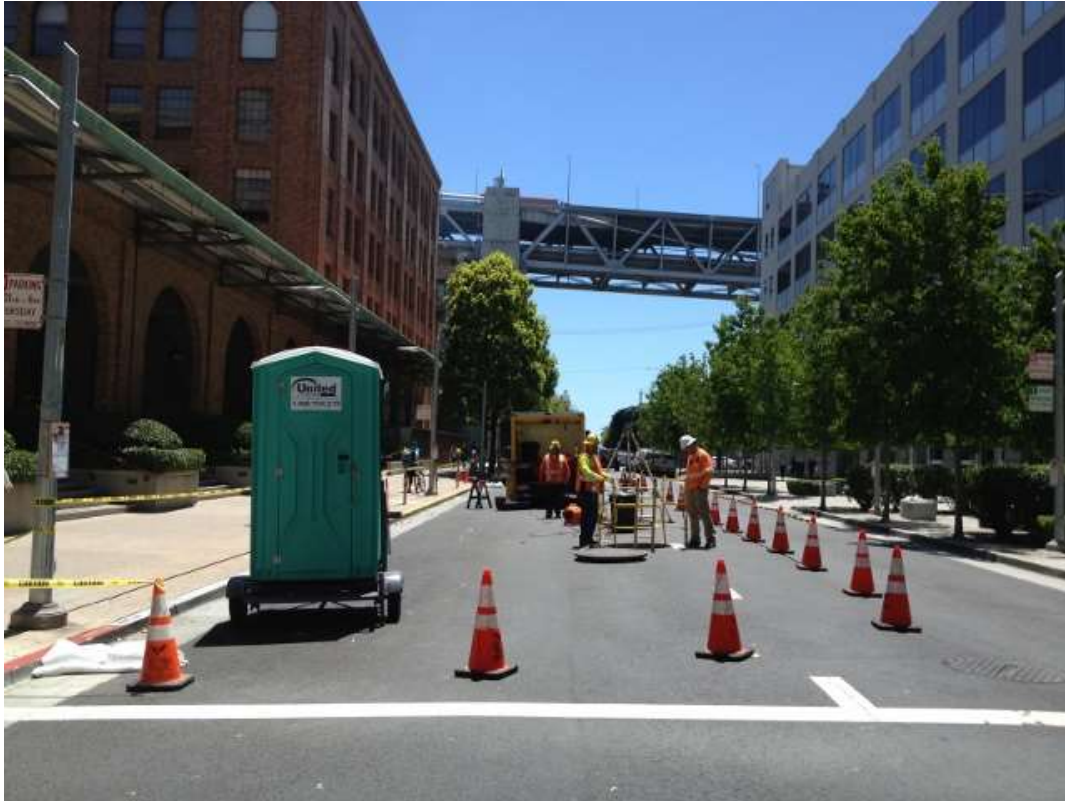
Figure 1: Preparing for cable pull into the vault on Spear Street, July 12, 2016.

1. Sumitomo and NRE swabbed conduit from inside the transition vault on Spear Street Monday through Wednesday (see Figure 1).
2. Sumitomo and NRE pulled cable in the transition vault Thursday through Saturday.
3. At the time of the CPUC EM site visit on July 12th, crews were preparing to pull cable in the transition vault.

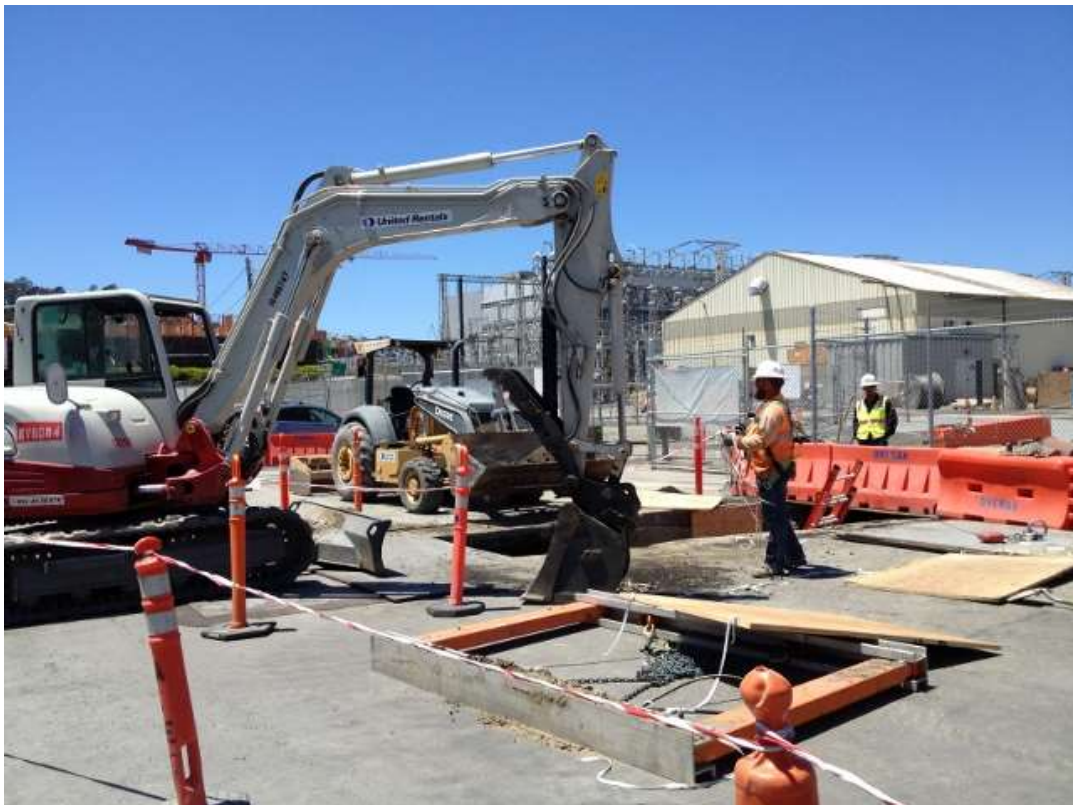
Figure 2: APEC conducting water and sewer line tie-in work on 23rd Street, July 12, 2016.

1. APEC excavated for the water and sewer line tie-in Monday through Saturday (see Figure 2).
2. Sumitomo and NRE staged equipment and vehicles Monday through Saturday in preparation for the transition vaults pulling of conductor cable, which will commence after the cable is pulled from Embarcadero Substation and the Spear Street transition vault.
3. At the time of the CPUC EM site visit on July 12th, APEC was working on the water and sewer tie-in on 23rd Street.

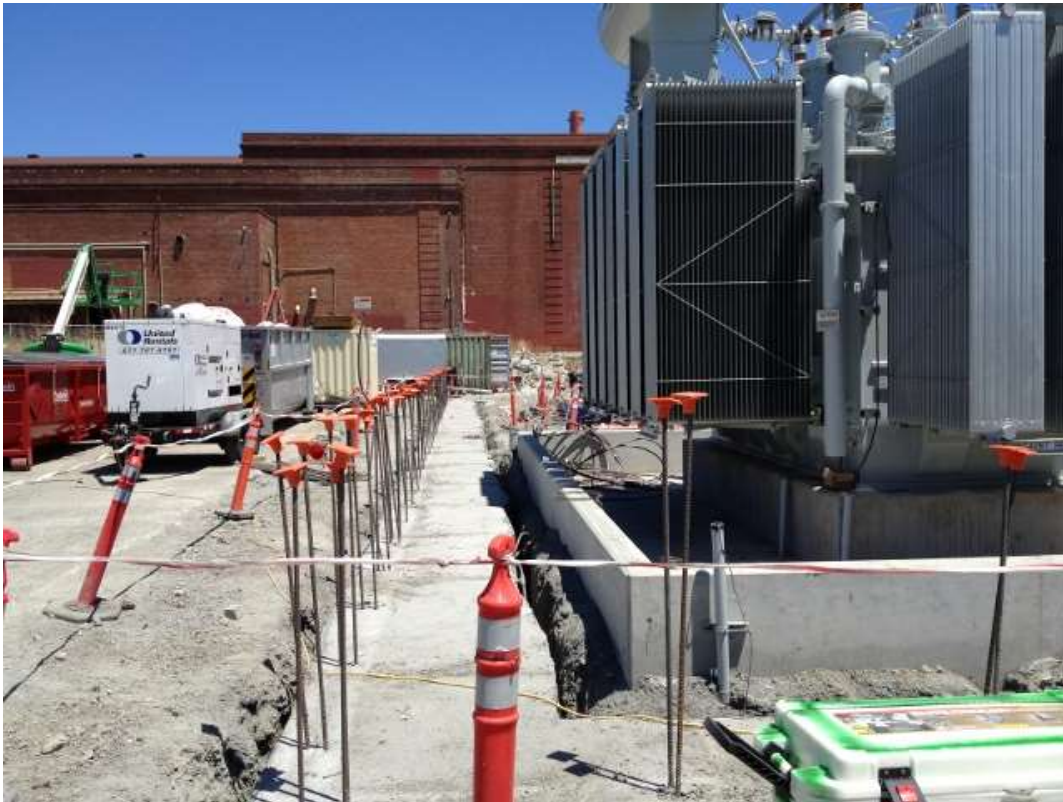
Figure 3: Overaa installing rebar and forms for perimeter wall at Potrero Switchyard, July 12, 2016.

1. Office trailer use occurred Monday through Sunday.
2. Overaa aided other work crews and conducted housekeeping and dust control activities Monday through Saturday.
3. Overaa poured concrete for the perimeter wall on Monday, and installed rebar and forms in the excavation Monday through Thursday (see Figure 3).
4. MEI conducted electrical work in the GIS building Monday through Sunday.
5. Mitchell conducted plumbing in the GIS building Monday through Sunday.
6. SSI installed scaffolding in the GIS building Monday through Friday.

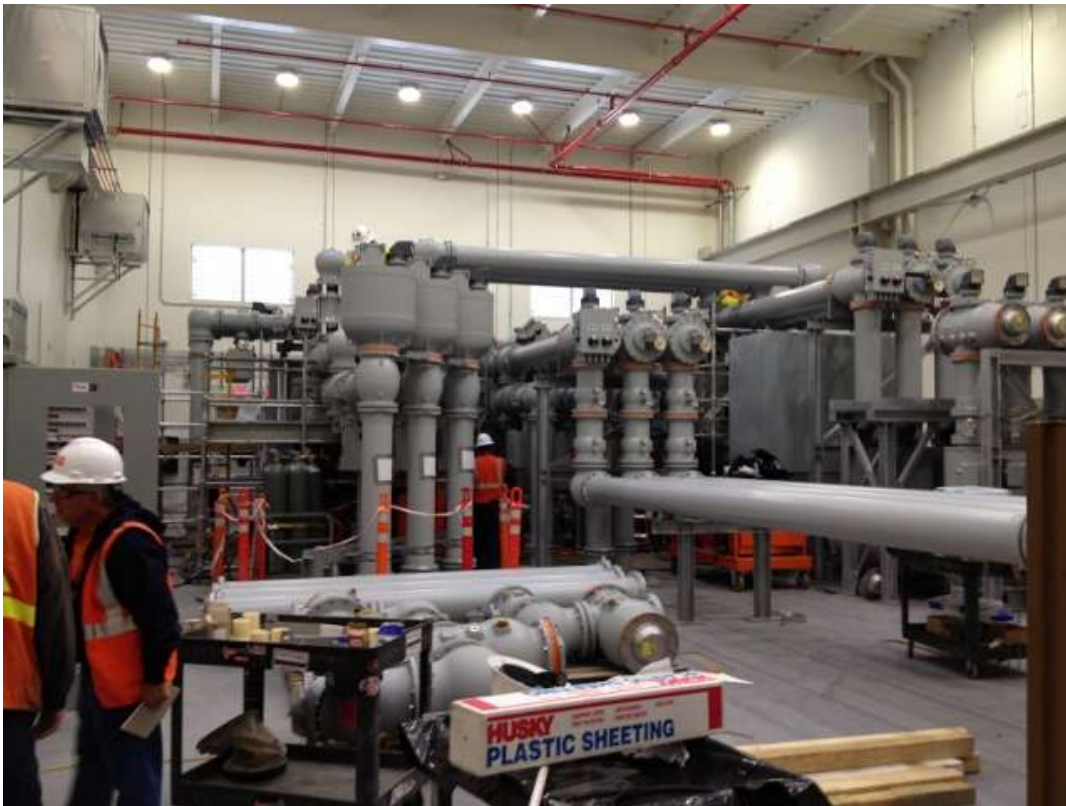
Figure 4: CCE installing infrastructure and electrical work in GIS building in Potrero Switchyard, July 12, 2016.

1. CCE conducted electrical work in the control building Monday through Friday.
2. CCE QEW monitored work in the substation Monday through Friday.
3. CCE constructed metal infrastructure for use in the GIS building Monday through Saturday.
4. Nexans conducted electrical work on the 115 kV bus Monday through Friday.
5. At the time of the CPUC EM site visit on July 12th, crews were conducting electrical work on the 115 kV bus.
