**PROJECT MEMORANDUM  
PG&E JEFFERSON-MARTIN 230KV TRANSMISSION PROJECT**

**To:** Billie Blanchard, CPUC  
**From:** Vida Strong, Aspen Project Manager  
**Date:** January 6, 2006  
**Subject:** Monthly Report #5: December 1, 2005 – December 31, 2005  
**CPUC Environmental Monitor (EM):** Jody Fessler

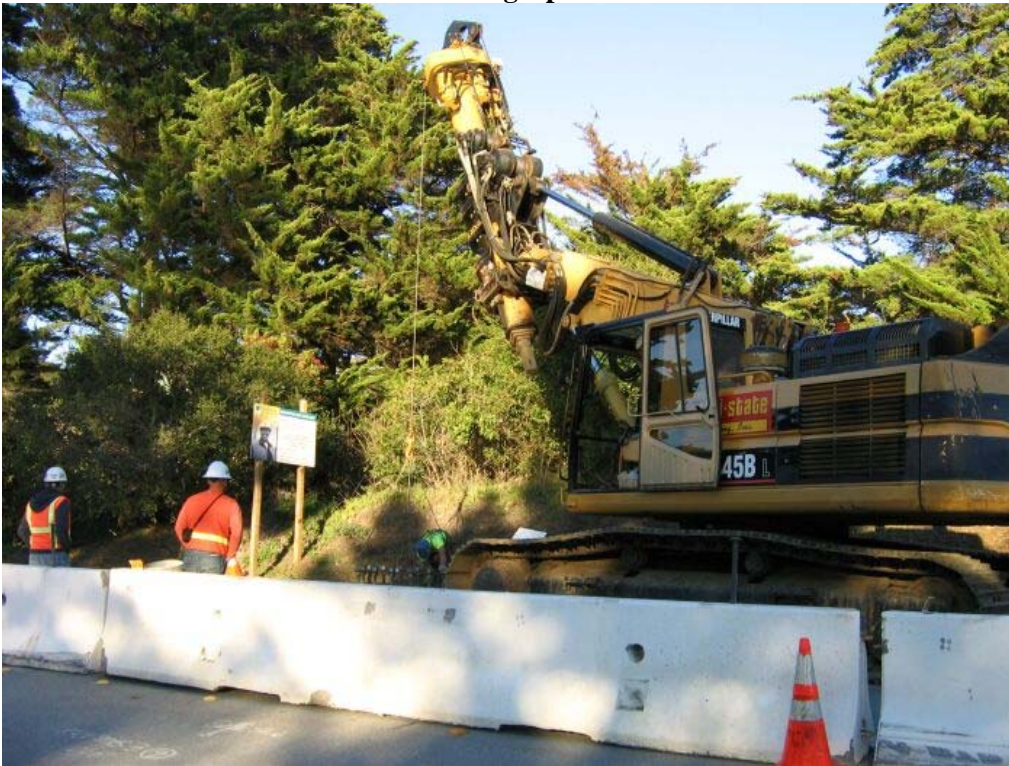
**Figure 1** – Crews finishing the foundation for the transition tower on the north side of Crystal Springs Dam, Segment 1, December 6, 2005.

During the second week of December, ILB crews installed foundations for the transition towers on either side of Crystal Springs Dam (see Figure 1). During the third week of December, crews installed ground rods on the foundation structures.

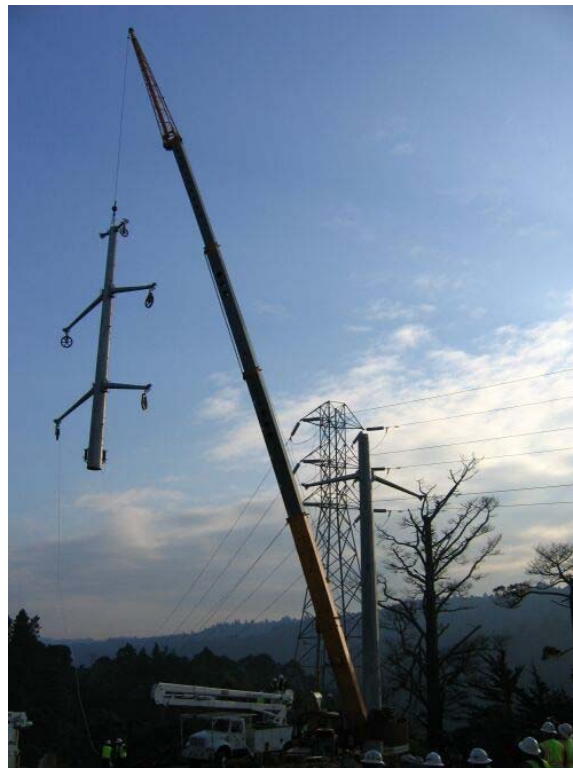
**Figure 2** – Crane setting the top of the new Tower #73, Segment 2 Overhead, December 8, 2005.

Table 3A presents the overhead construction activities along Segment 2 Overhead in the SFPUC Watershed during December. The erosion control crew (road crew), utility locators, line builder crew (ILB), and tree clearing crews worked Monday through Friday of each week and some Saturdays. The drilling crew finished its foundation work in the Watershed the first week of December and de-mobilized from the site. During the first week of December, ILB conducted grounding and dead-ending activities. During the second, third, and fourth weeks of December, ILB erected new towers, moved transmission lines from the old towers to the new towers, and removed some of the old lattice towers (see Figures 2 through 4).

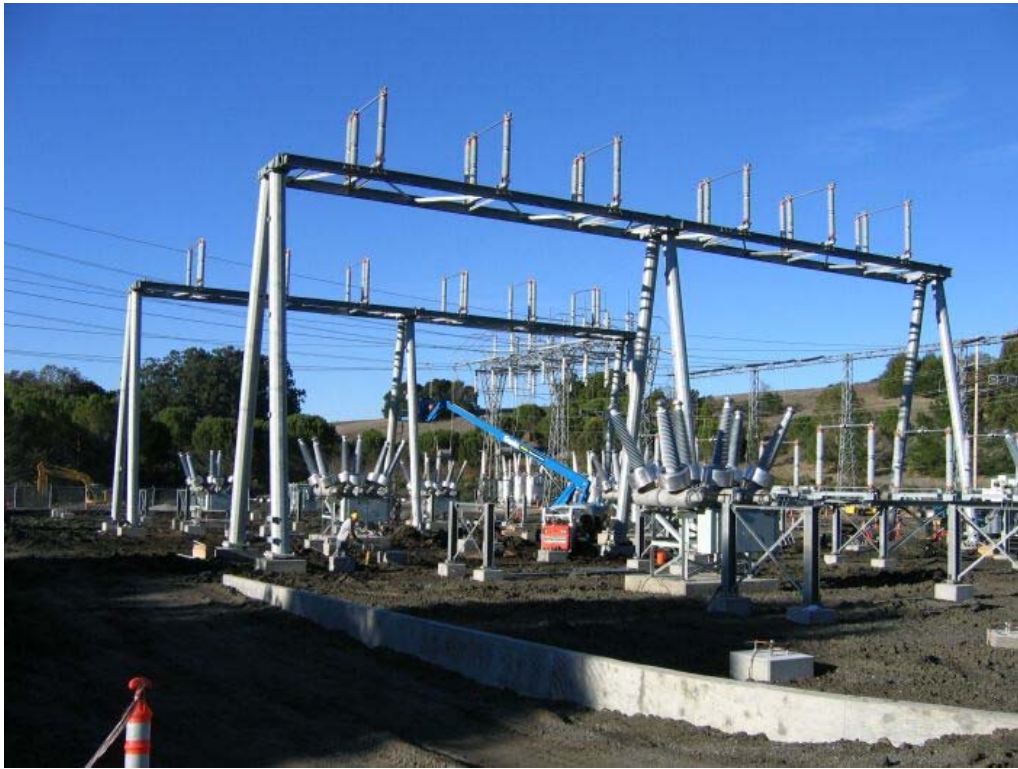
**Figure 5** – New structures being worked on in the Jefferson Substation, December 6, 2005.

During the month of December, crews continued to work at the Jefferson Substation Mondays through Saturdays. Trenching activities continued from Manhole #1 southeast into the substation. Work within the substation also continued and included the installation of breakers, switches, a switch box, a switch box tower, excavation for foundations, conduit installation and electrical work (see Figure 5). A full-time Biological Monitor was present during all work. A PG&E EI also visited the site periodically to ensure environmental compliance with project requirements.

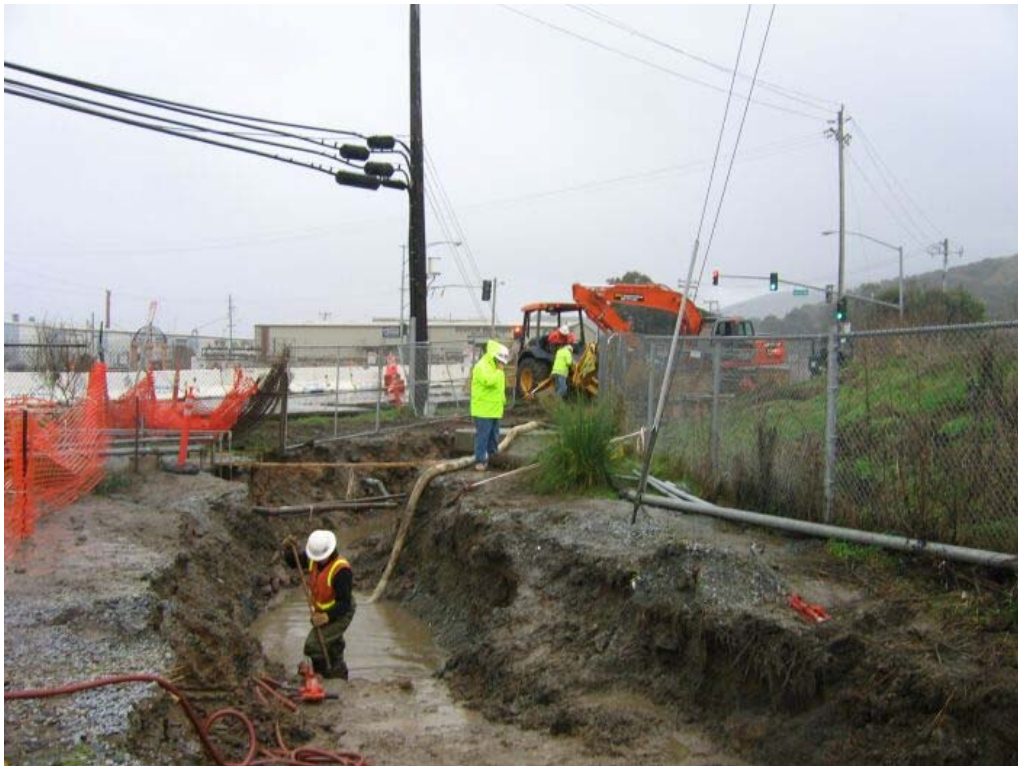
**Figure 6** – Excavating trench, removing floated conduit and cement slurry, Martin Substation, December 21, 2005.

During the month of December, crews continued to work at the Martin Substation, Monday through Fridays. Work at the Martin Substation included trenching, conduit installation, riser form installation, and new structure work for the future substation components (see Figure 6).
