PROJECT MEMORANDUM PG&E JEFFERSON-MARTIN 230KV TRANSMISSION PROJECT

To: Billie Blanchard, CPUC
From: Vida Strong, Aspen Project Manager
Date: February 15, 2005
Subject: Weekly Report #4: February 6, 2005 – February 12, 2005
CPUC Environmental Monitor (EM): Jody Fessler

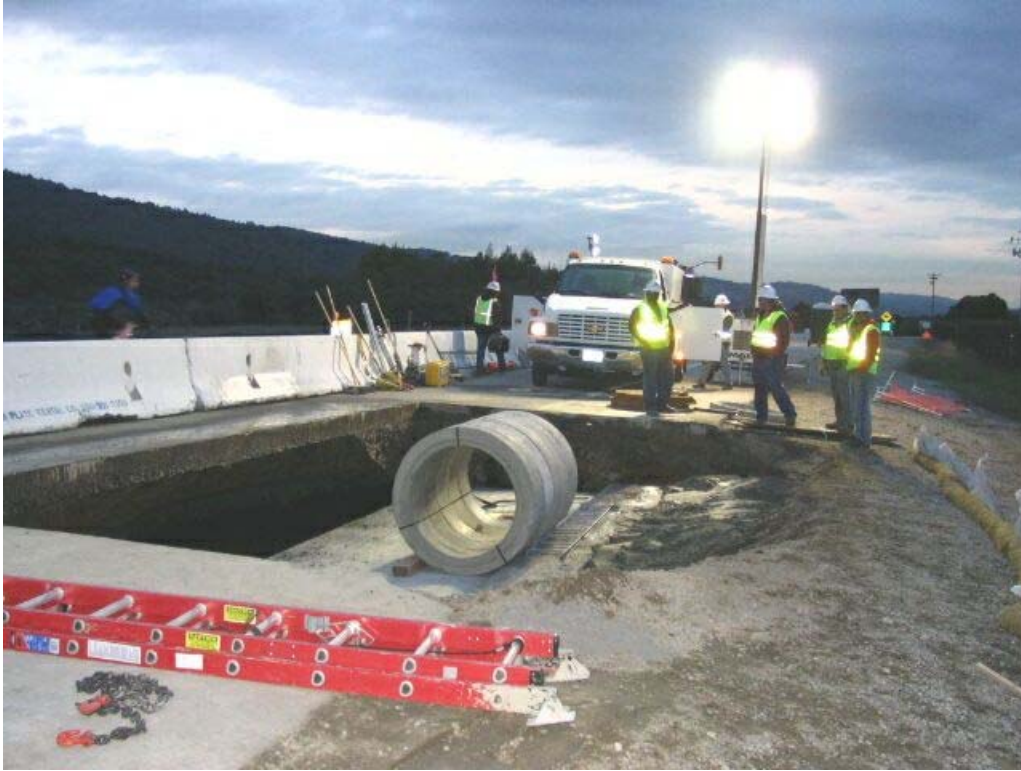
Figure 1 – Manhole #3 on Cañada Road, Segment 1, February 8, 2005.
Vault installed and ready to excavate cave-in on west side of vault.

1. On February 7, crews started excavating Manhole #3 (Station #37+00) and Manhole #4 (Station #54+25) on Cañada Road. The soil from the Manhole #3 pit and Manhole #4 pit was transported to Ox Mountain landfill in Half Moon Bay (Class 3 facility). Groundwater was a big problem at Manhole #3 and the west side of the pit kept caving in. Crews shored the pit on the first day of excavation and poured cement slurry on the east side of the shoring to help stabilize the shoring. They did this because when soil caved in from the west side of the pit, it would push the shoring to the east and destabilize it. Manhole #4 had no groundwater problems and it was shored on Monday and the bottom of the pit leveled with pea gravel. The manhole vault pits were dug to a level of approximately 12 to 13 feet. On Tuesday, a large crane was used to lower the vaults into the excavated pits. Once the vaults were set, crews poured cement slurry around and over the manhole vaults. After the load of cement slurry was emptied, the trucks washed out in the vault pits. Crews were still dealing with the cave-in issue at Manhole #3 on Tuesday evening (see Figure 1). They had to cut the asphalt and remove it over the cave-in so they could excavate the cave-in soils. On Wednesday, manhole rings were being set for both vaults. Cement slurry was finished being poured around the vaults on Wednesday (see Figure 2). On Thursday, the crew finished with the pouring of the asphalt and compacting the road. All materials and traffic controls were removed from these sites at the end of the day Thursday.

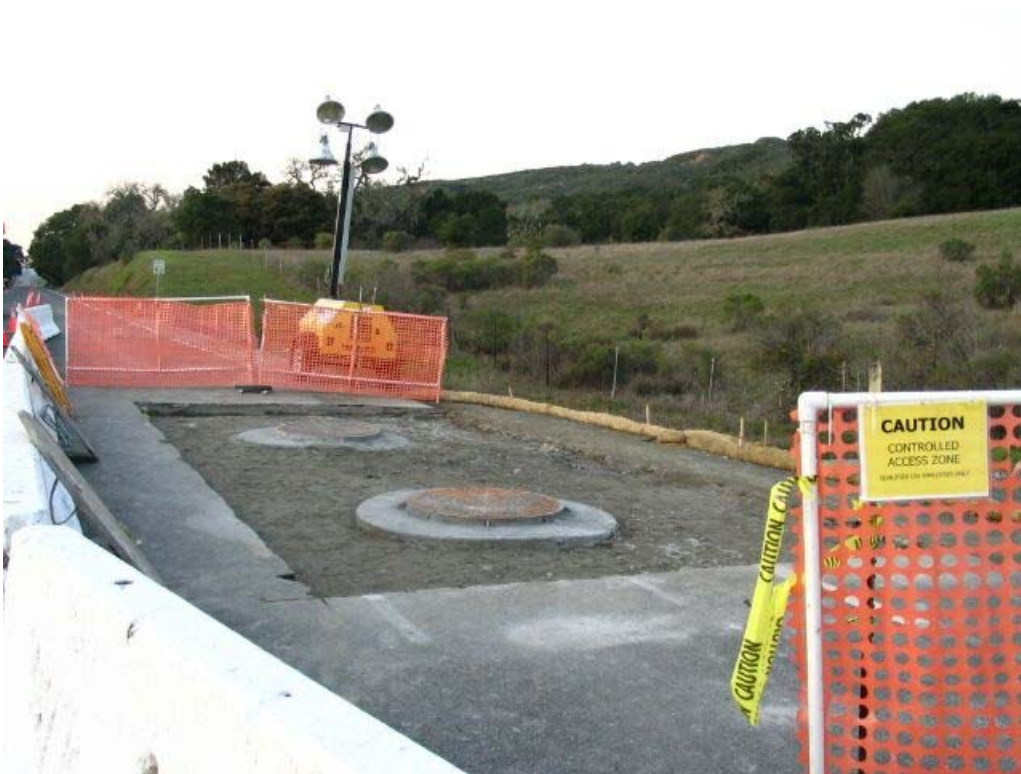
Figure 2 – Manhole #4 on Segment 1, February 9, 2005.

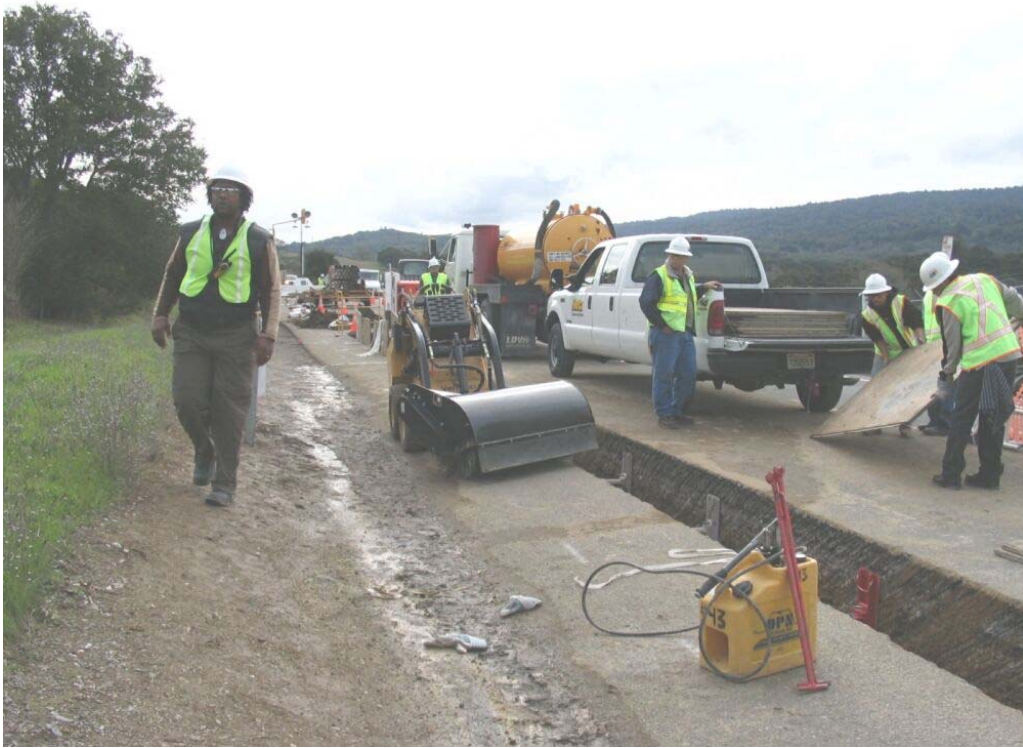
Figure 3 – Spoil spill due to trenching activities at Station #106+00 on Cañada Road, Segment 1, February 8, 2005.

2. Trenching activities began between Manhole #7 and Manhole #8 on Monday. Muddy soil was encountered, which caused work to progress very slowly. Groundwater had seeped into the trench around Station #106+00. On Tuesday morning around 10:30 AM, right after the Segment 1 and Segment 5 meetings in Hayward, the CPUC EM received a voice message from one of PG&E's EIs that muddy spoils from trenching activities had spilled into a vegetated drainage on the east side of Cañada Road (see Figures 3 and 4). The CPUC EM conducted a site visit of the area around 11:30 AM. Trenching had stopped in the area causing the problem of spoil spillage (approximately Station #106+00 to 106+50), and moved further north to an area that was not saturated with groundwater. The Segment 1

Construction Manager asked permission to do shoring of the trench in the problem area for safety reasons. The CPUC EM gave permission for safety work to proceed. The CPUC EM gave PG&E two hours to notify CDFG, USFWS, and the SFPUC of the incident as per the condition in NTP #1. PG&E's EIs notified Bob Masuoka of PG&E of the spoil spill. Bob notified Joe Naris at the SFPUC on the day of the incident, but did not notify CDFG or USFWS until February 10 in an email. The issue of immediate notification of the agencies was discussed during the February 10 conference call with PG&E, Black & Veatch, CH2M Hill, Opus Environmental, and Aspen Environmental Group. It was explained by Aspen to the interested parties that a phone call would suffice for immediate notification to the agencies so the agencies have the opportunity to come out and look at any breach of construction into vegetated areas off the side of Cañada Road. The phone notification could then be followed up later with a more detailed description of what occurred at the site. Dave Johnston of CDFG came out to look at the site on Wednesday after receiving a call from the CPUC EM to verify that he had been notified about the incident. Mary Hammer of USFWS called the CPUC EM on Friday to inform the CPUC EM that she had not received notification of the incident until Thursday, February 10. The CPUC issued a Project Memorandum on February 9 regarding the breach into vegetated areas by trenching activities.

On February 8, the CPUC EM observed that trenching activities from approximately Station #106+00 to 106+50 had breached the road and un-vegetated road side and spilled muddy spoils into the vegetated drainage along the east side of Cañada Road. On February 9, the CPUC issued a Project Memorandum regarding this incident. On February 10, PG&E responded to the Project Memorandum and described how they would address the situation.

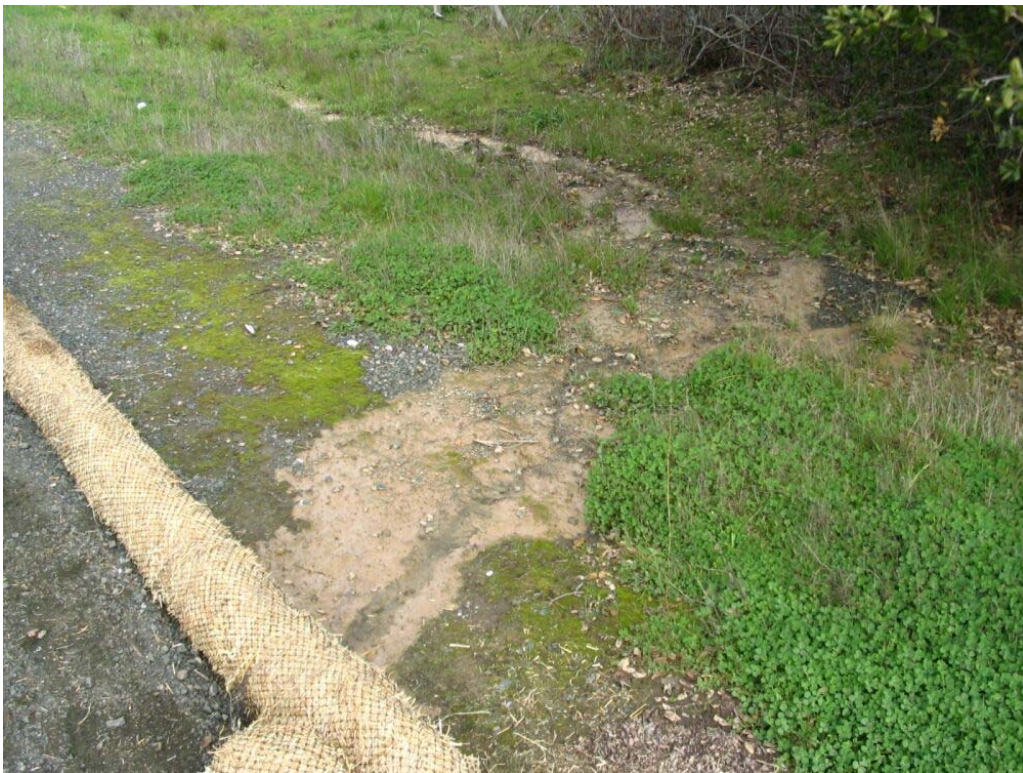
Figure 4 – Spoil spill into vegetated drainage at Station #108+00 on Cañada Road, Segment 1, February 8, 2005

Trenching continued north and south of the spoil spill site from approximately Station #105+00 to 108+80. More groundwater and saturated soil was encountered and cave-ins occurred along the trenching segment. PG&E's Lead EI left the CPUC EM a voice message on February 10 around 8:30 AM informing her that there had been a break in the excavator's hydraulic fluid line and that about 2 gallons of hydraulic fluid had spilled onto the road and into the trench. The CPUC EM conducted a site visit of the area later in the morning and observed that cleanup had commenced. The asphalt around the spill had been cut and was removed and taken away with the contaminated soil. The CPUC EM will obtain information about where the contaminated soil and asphalt were taken and how it was disposed of. Conduit was installed in the trench from approximately Station #105+00 to 106+50 and a customized cement slurry was poured over the conduit for insulation purposes on February 10. From approximately Station #106+50 to 108+80, another type of cement slurry was poured into empty trenches because of the requirement to have all trenches and pits paved over by the weekend because of recreational uses along Cañada Road. The cement slurry will be excavated out of this area on Monday, February 14, so conduit can be installed. Crews paved over the trenched area on Friday and finished around 3:30 PM.

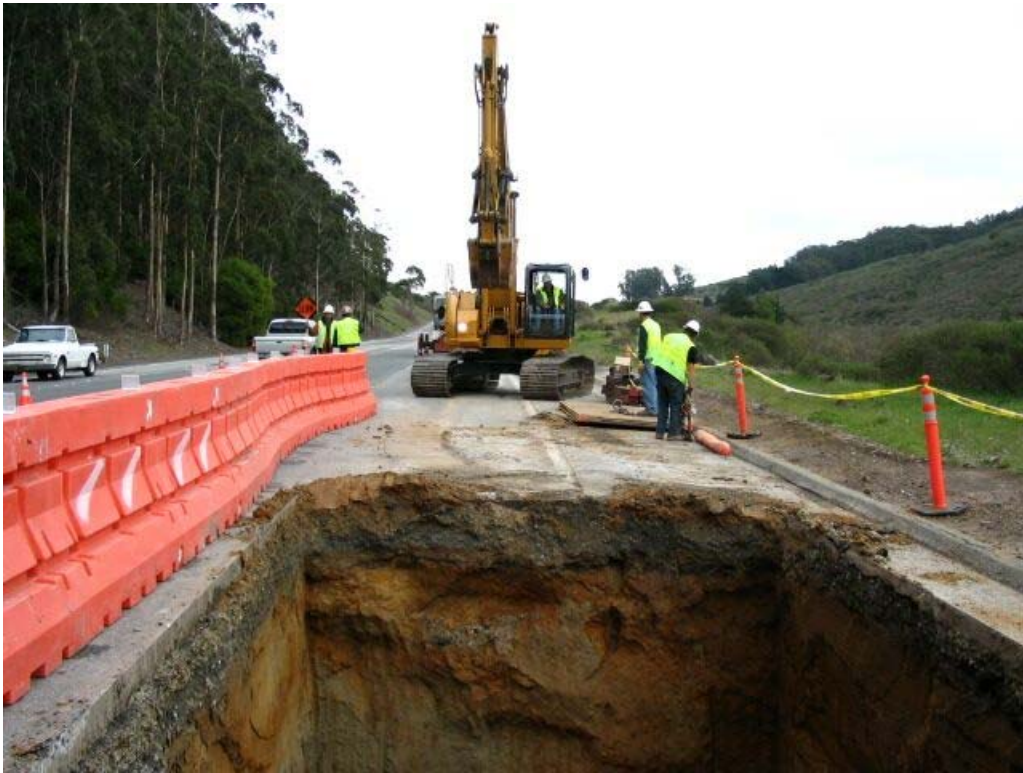
Figure 5 – Preparing for shoring to arrive at MH #68 on Segment 5, February 8, 2005.

1. Excavation of Manhole #68 (Station #1271+45) vault pit began February 7 along Guadalupe Canyon Parkway on San Bruno Mountain. Crews finished excavating the manhole to about 15 feet on Tuesday (see Figure 5) and the vault was installed on Wednesday. Cement slurry was poured on Thursday and final paving was completed on Friday (see Figure 6).

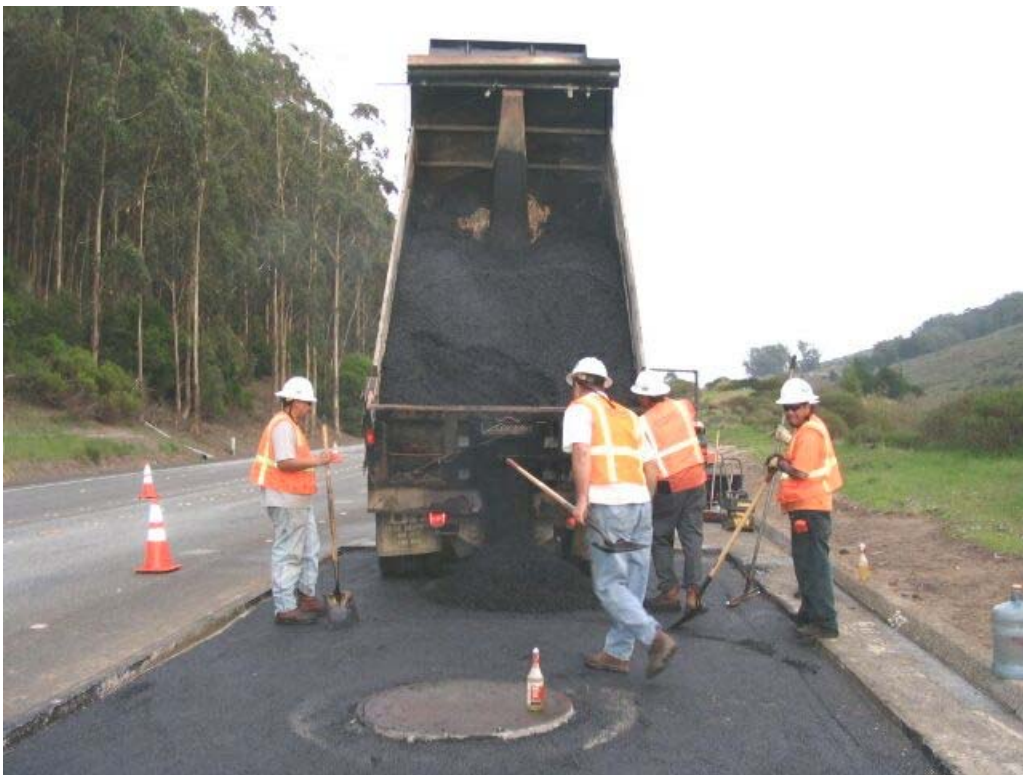
Figure 6 – Manhole #68 paving complete on Segment 5, February 11, 2005.
