PROJECT MEMORANDUM PG&E JEFFERSON-MARTIN 230KV TRANSMISSION PROJECT

To: Billie Blanchard, CPUC
From: Vida Strong, Aspen Project Manager
Date: February 23, 2005
Subject: Weekly Report #5: February 13, 2005 – February 19, 2005
CPUC Environmental Monitor (EM): Jody Fessler

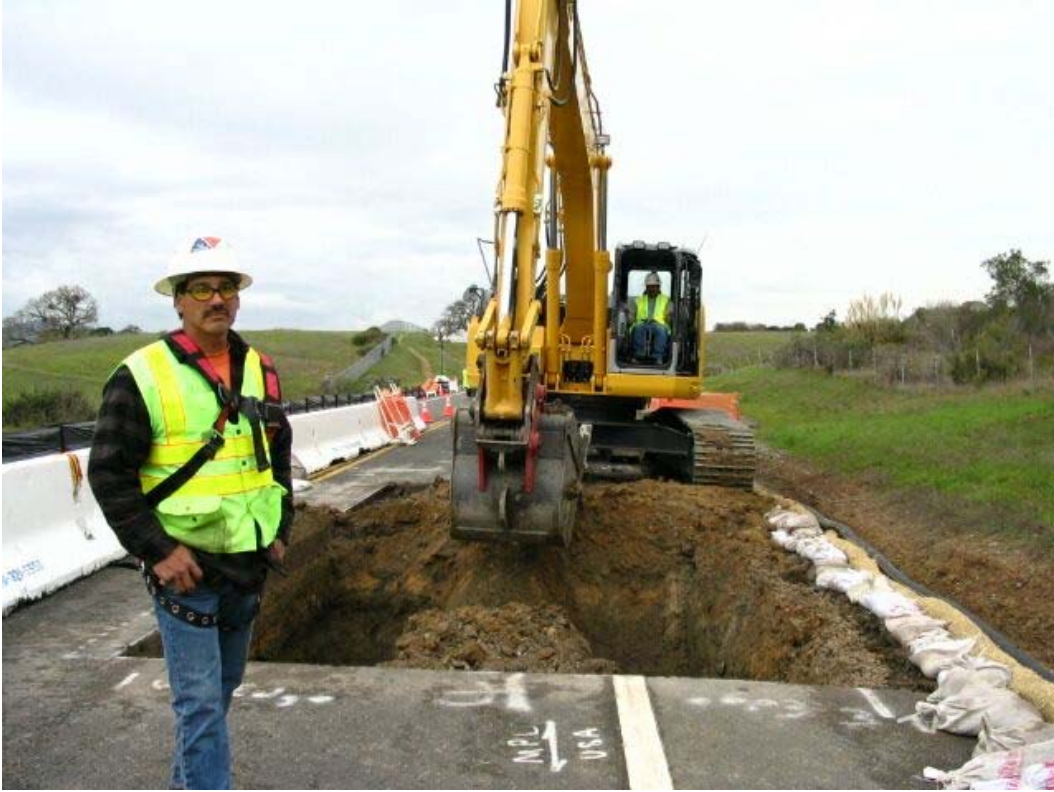
Figure 1 – Manhole #5 excavation along Cañada Road, Segment 1, February 14, 2005

1. On February 14, crews started excavating at Manhole #5 (Station #69+50 to 74+00) and Manhole #6 (Station #87+50 to 92+00) on Cañada Road (see Figure #1). The soil from the Manhole #5 pit and Manhole #6 pit was transported to Ox Mountain landfill in Half Moon Bay (Class 3 facility). Groundwater was a problem at Manhole #6 and the west side of the pit kept caving in. Crews shored the pits on the first day of excavation. The manhole vault pits were dug to a level of approximately 12 to 13 feet. On Tuesday, a large crane was used to lower the vaults into the excavated pits. Once the vaults were set, crews poured cement slurry around and over the manhole vaults. After a load of cement slurry was emptied, the trucks washed out in the vault pits. Crews were still dealing with the cave-in issue at Manhole #6 on Tuesday evening. They had to cut the asphalt and remove it over the cave-in so that they could excavate the cave-in soils. On Wednesday, manhole rings were set for both vaults. The cement slurry pour around the vaults was finished on Wednesday (see Figure #2). On Thursday, the crew completed the asphalt paving on the road. A moth (unidentified species) was noted on the exclusion fencing near Manhole #5 (see Figure #3). All materials and traffic controls were removed from these sites at the end of the day Thursday.

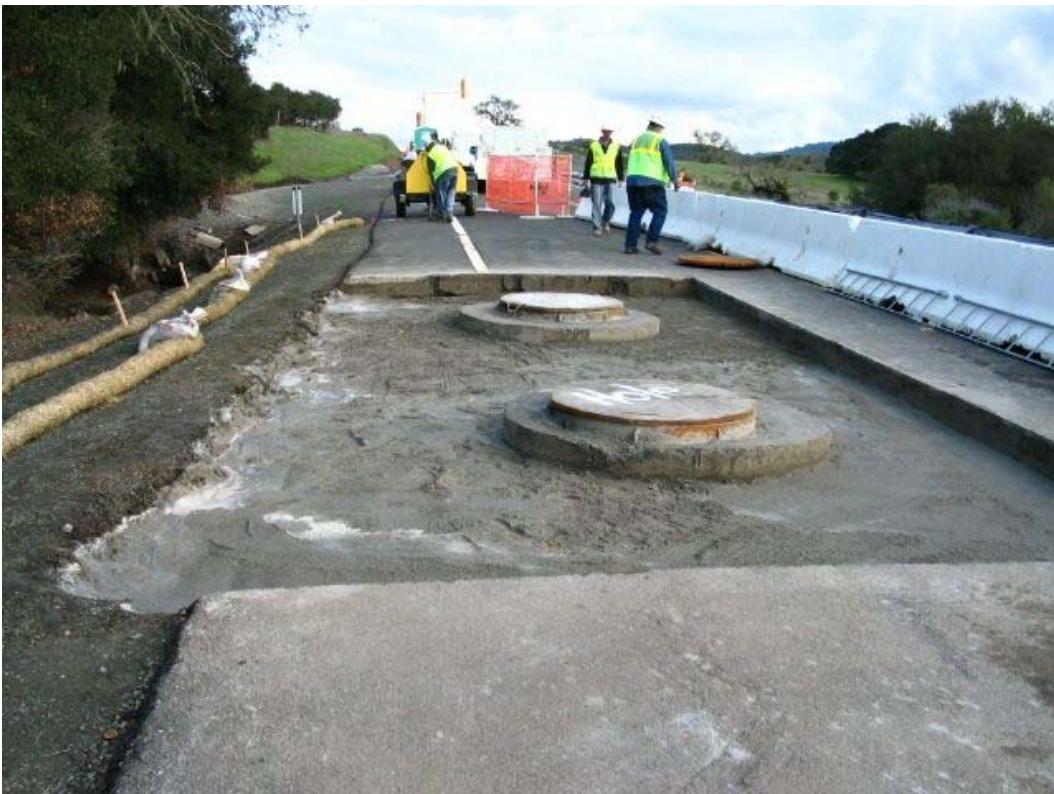
Figure 2 – Manhole #6 cement slurry poured and rings set, Segment 1, February 16, 2005

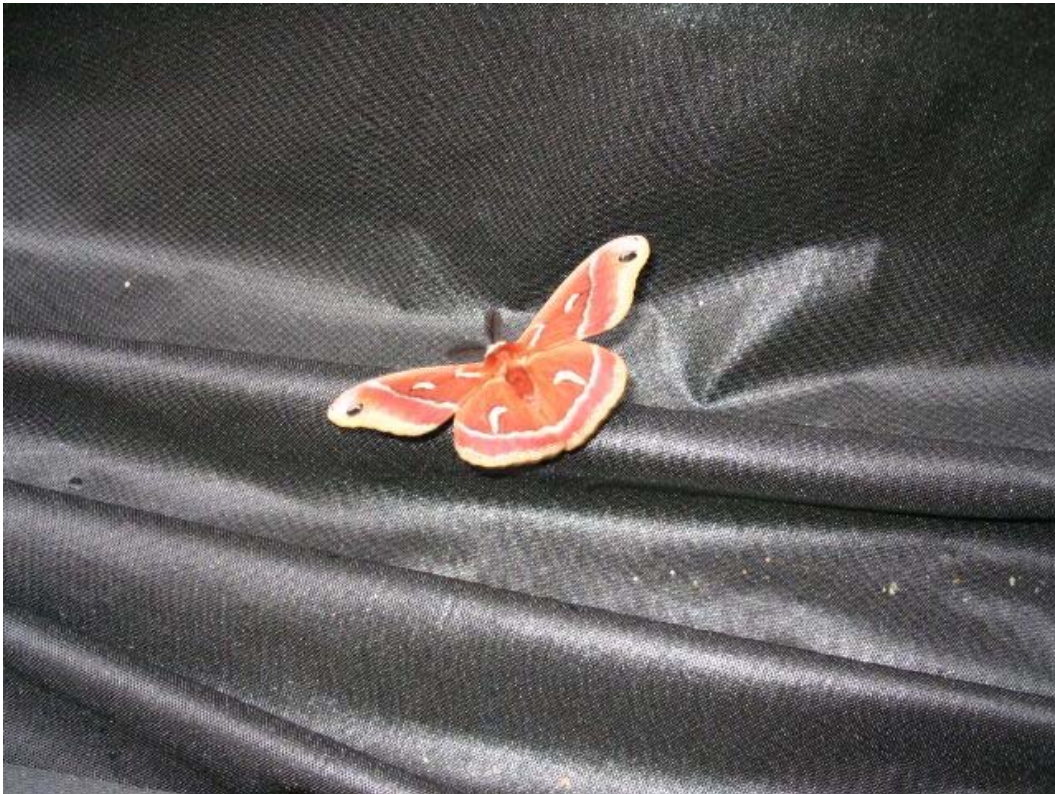
Figure 3 – Moth on biological exclusion fencing near Manhole #5, Segment 1, February 17, 2005

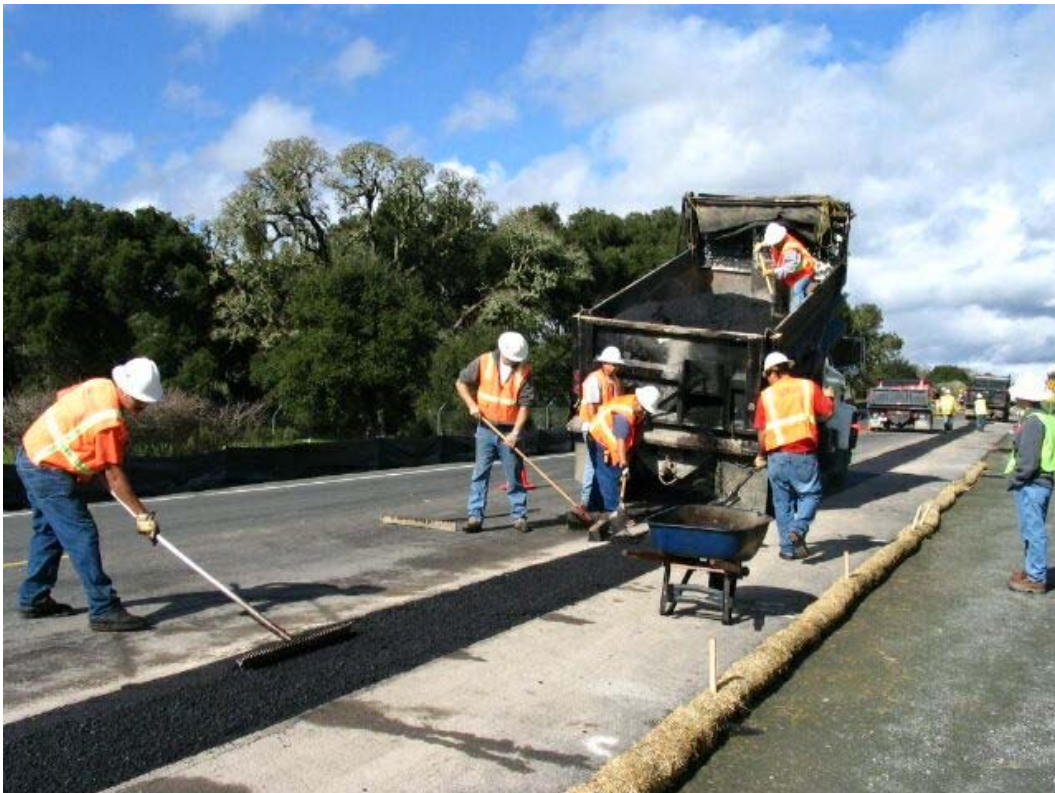
Figure 4 – Trench being paved between Manhole #7 and #8, Segment 1, February 18, 2005

2. Trenching activities began between Manhole #7 and Manhole #8 on Monday. Groundwater was still a problem just north of Manhole #7 (Station #106+00) where crews were trying to install conduit stub-outs from the vault. Crews were having a hard time excavating and shoring the area because of cave-ins. Throughout the week, trenching was also occurring from approximately Station #106+50 to 112+00. Crews were excavating, installing conduit, and pouring thermal cement slurry as they trenched north. Conduit was installed in the trench from approximately Station #106+50 to 112+00. Crews paved over the trenched area on Friday and finished around 1:30 PM (see Figure #4).

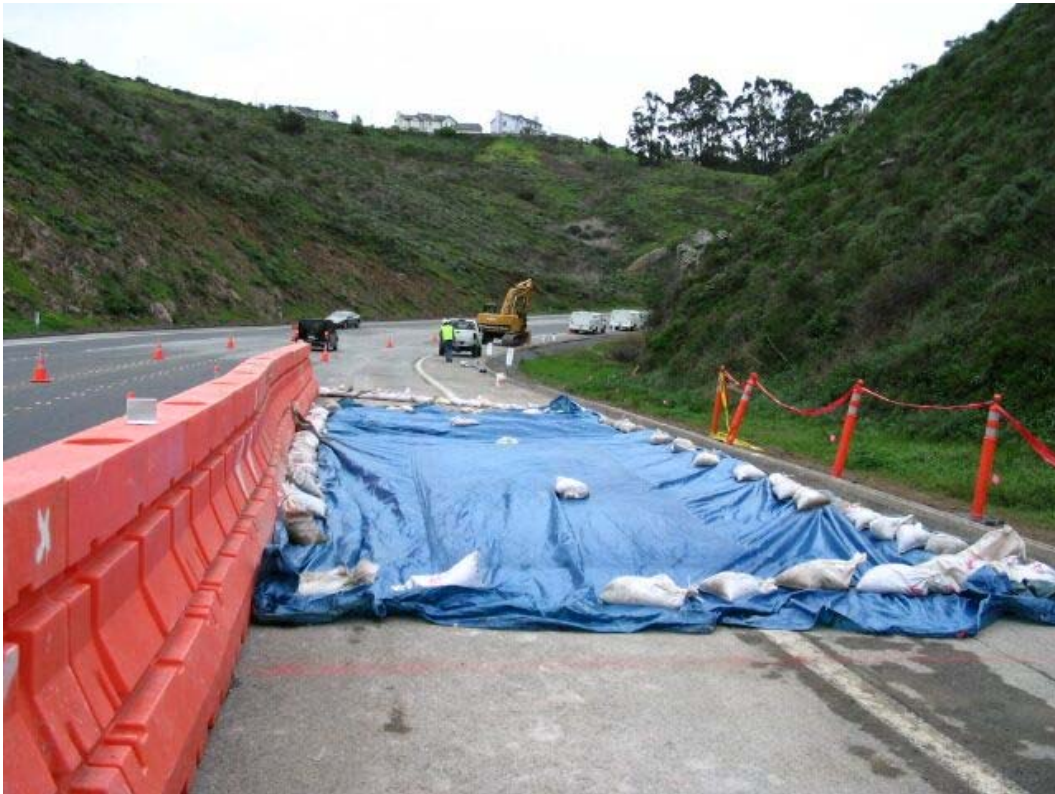
Figure 5 – Manhole #67 covered and sandbagged to prevent stormwater from entering area, Segment 5, February 17, 2005

1. Excavation of Manhole #67 (Station #1255-06) vault pit began February 14 along Guadalupe Canyon Parkway on San Bruno Mountain. Due to inclement weather the pit was covered and secured with sandbags to prevent runoff from entering the pit (see Figure #5). Crews finished excavating the manhole to about 15 feet on Tuesday and the vault was installed on Wednesday. Cement slurry was poured on Thursday and final paving was completed on Friday.
