PROJECT MEMORANDUM PG&E JEFFERSON-MARTIN 230 kV TRANSMISSION PROJECT

To: Billie Blanchard, CPUC
From: Vida Strong, Aspen Project Manager
Date: March 8, 2005
Subject: Weekly Report #7: February 27, 2005 – March 5, 2005
CPUC Environmental Monitor (EM): Jody Fessler

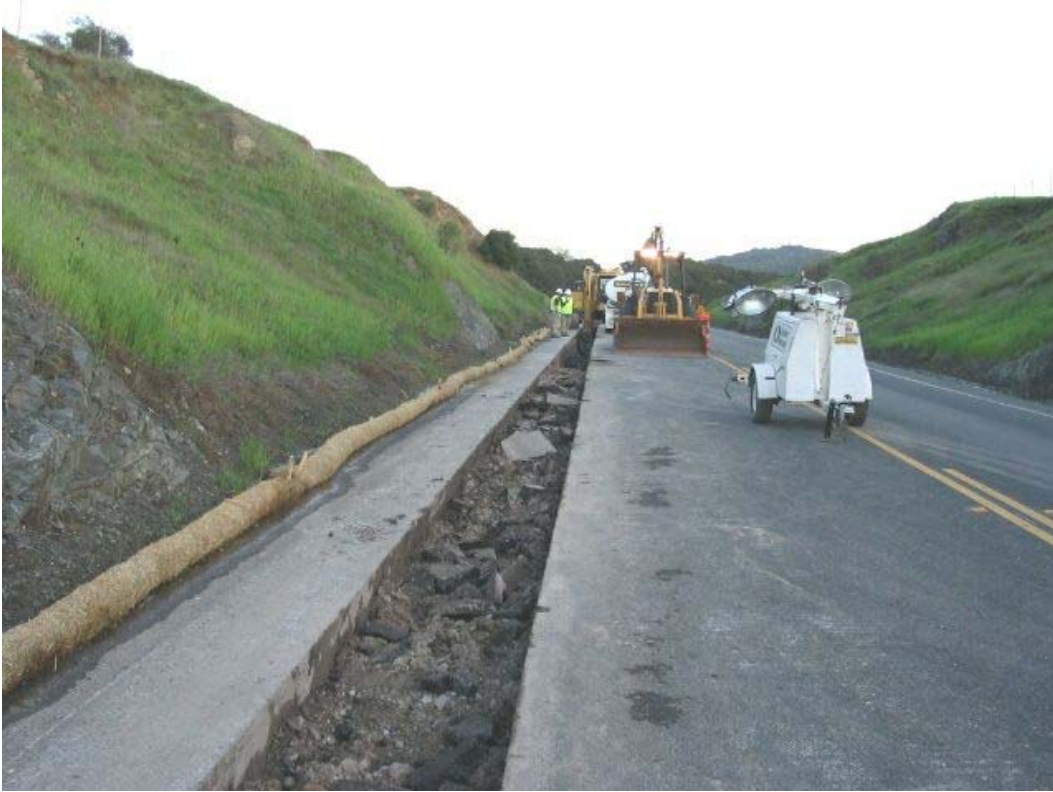
1. On February 28, crews started excavating the trench from approximately Station #72+00 north to Manhole #5 (station #74+00), and between Manhole #5 and Manhole #6 (station #92+00) on Cañada Road (see Figure 1). The soil from the trenching activities was transported to Ox Mountain landfill in Half Moon Bay (Class 3 facility). Serpentine soil and rock was encountered and a geologist was onsite Tuesday and Wednesday to determine serpentine areas. Crews shored the trench as they excavated. On Wednesday night, the hillside at around Station #84+000 started to fail. A geologist was called out to the site as well as San Mateo County. On Thursday morning, the hillside slip was excavated so it would not slide into the trench or road (see Figure 3). The County approved of a temporary fix and is reviewing options proposed by PG&E for a permanent fix. Conduit was installed in the trench as the excavation progressed, and cement slurry was poured around the conduit as it was installed. Crews worked through the night shift installing conduit in the trench. A biological monitor also stayed at the site at night to observe construction, watch for animals, and in case a crew member needed to move their vehicle. On Thursday and Friday, crews conducted asphalt paving of the trench. On Friday, the crew completed the asphalt paving on Cañada Road. All materials and traffic controls were removed from the construction area at the end of the day Friday.

Figure 1 – Trenching along Cañada Road, Segment 1, February 28, 2005

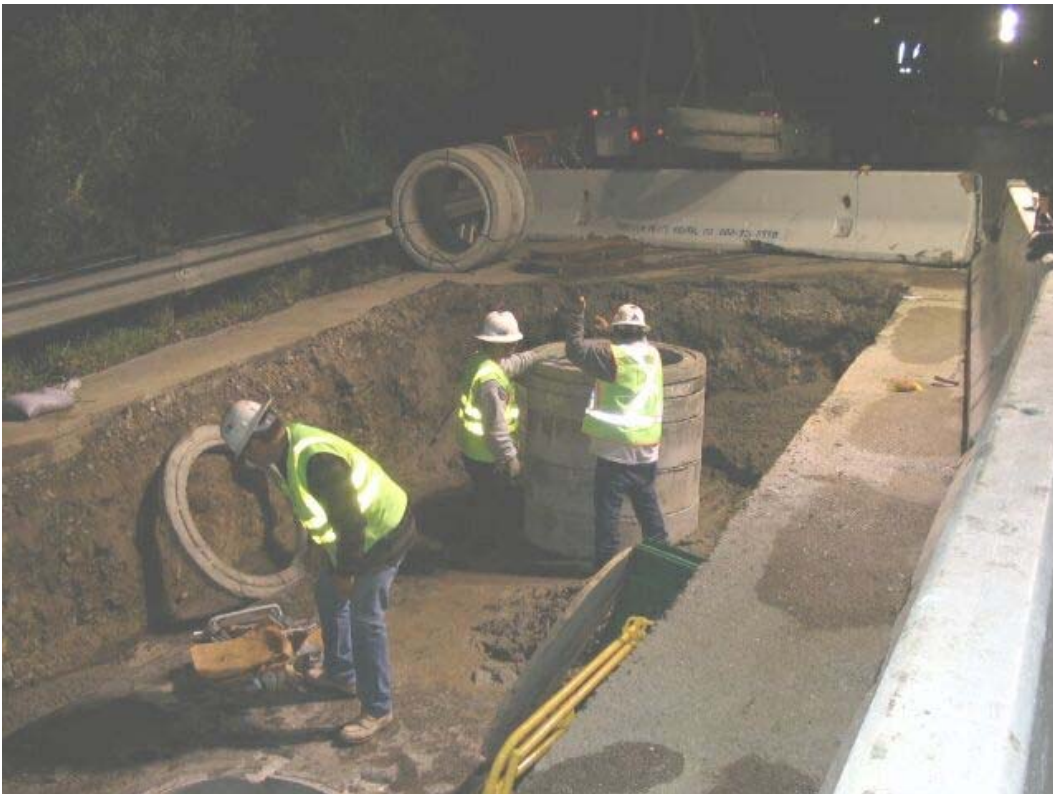
5. Construction in the Caltrans right-of-way (ROW) on Skyline at the Highway 92 West exit off Highway 280 began Sunday night. Work hours at that location are from 9 PM to 6 AM. K-rails were set up around the manhole and traffic controls were set up around the construction zone. Caltrans is allowing the manholes to stay open with K-rails around them as long as two lanes can be open throughout the day. Crews excavated Manhole #20 on Monday night, set the vault on Tuesday night and poured some cement slurry, set manhole rings on Wednesday night and poured more cement slurry, and completed paving Thursday night (see Figure 2).

Figure 2 – Setting manhole rings at Manhole #20 in the Caltrans ROW, Segment 1, March 2, 2005

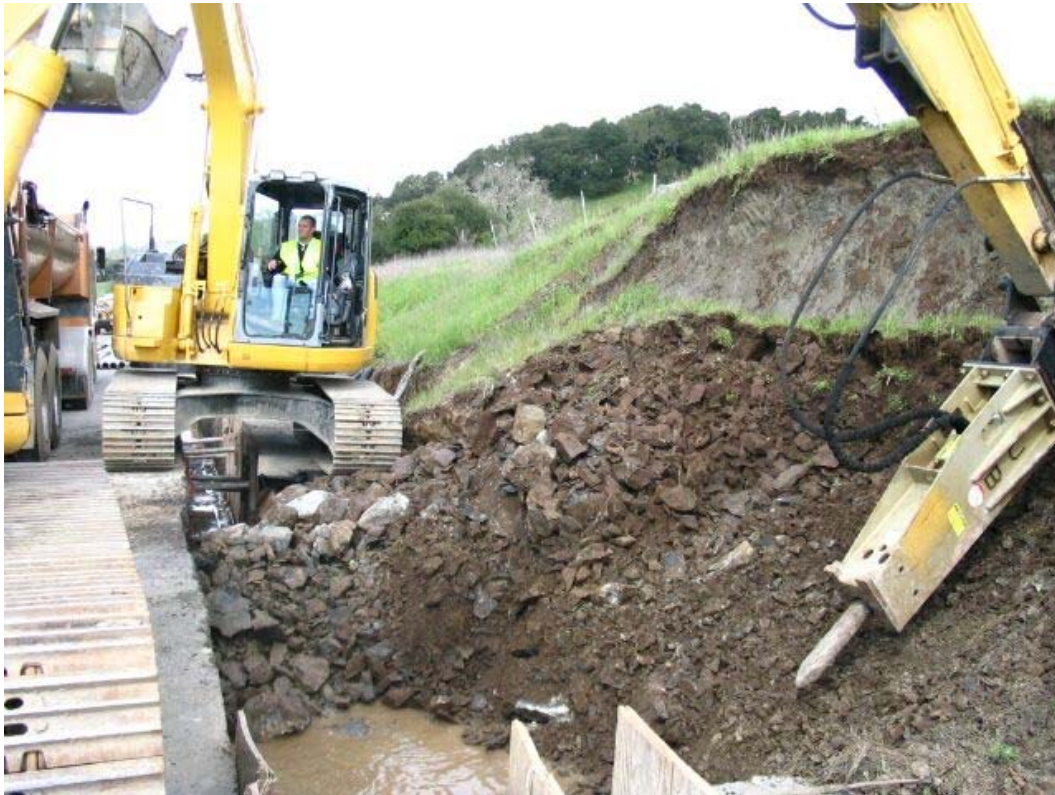
Figure 3 – Hillside failure along trenching at approximately Station #84+00 on Cañada Road, Segment 1, March 3, 2005

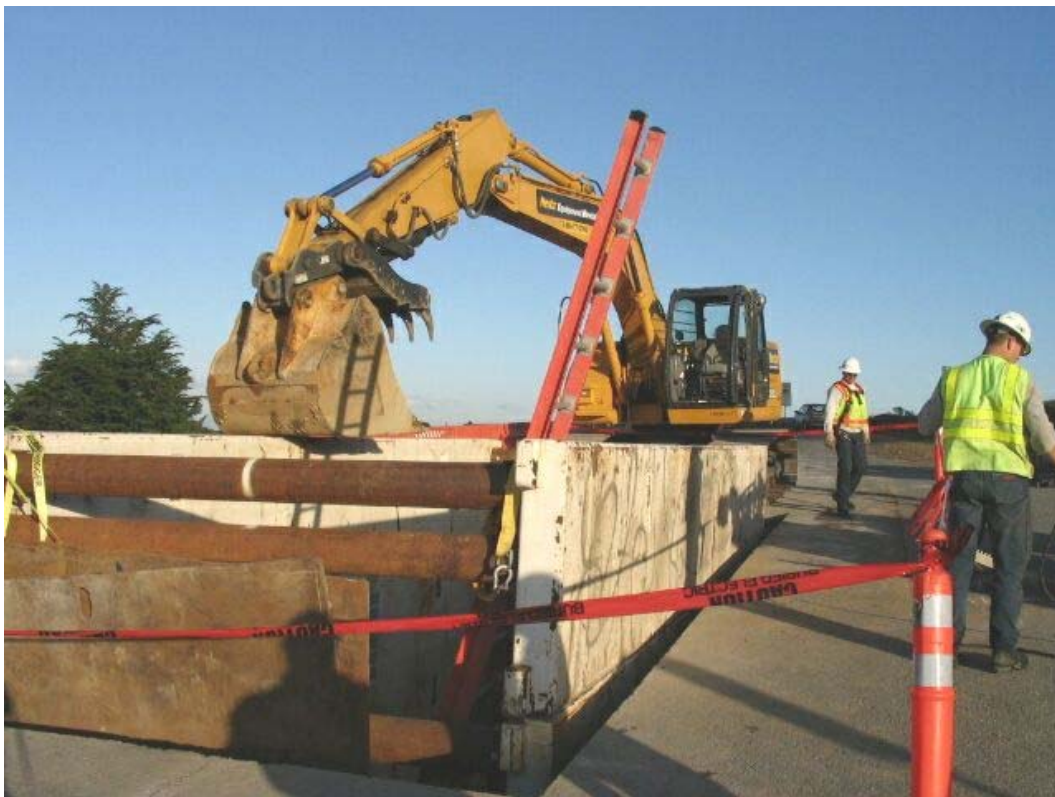
1. Excavation of Manhole #70 (Station #1305+82) vault pit began February 28 along Guadalupe Canyon Parkway on San Bruno Mountain. Crews finished excavating the manhole to about 14 feet and shored the pit on Monday (see Figure 4). The vault was installed on Tuesday and cement slurry was poured on Tuesday, Wednesday, and Thursday. Paving was completed on Saturday.

Figure 4 – Shoring Manhole #70 on Guadalupe Canyon Parkway, Segment 5, February 28, 2005

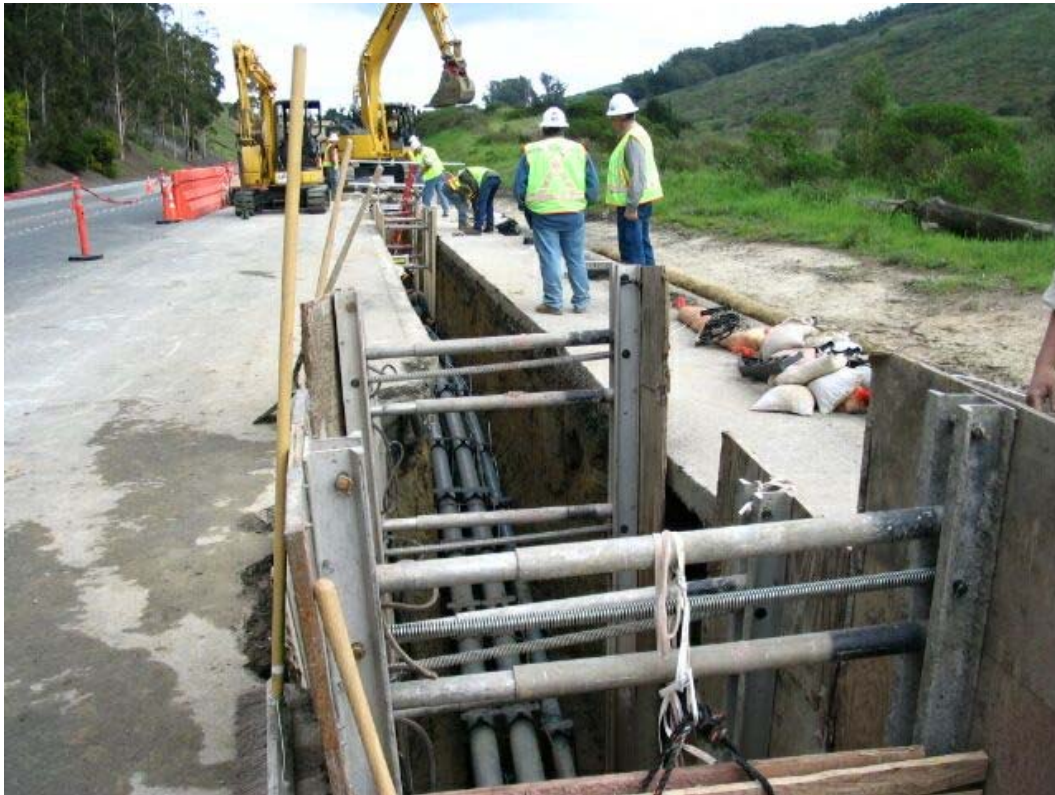
3. Excavation of trench to approximately Station #1275+00 east of Manhole #68 (Station #1271+45) began on Monday for the installation of conduit (see Figure 5). On Wednesday night, the trench was covered with plywood and plastic sheets that were anchored with sandbags to prevent storm water from getting into the trench. Conduit was installed throughout the week, cement slurry poured, and final paving done on Saturday.

Figure 5 – Crews installing conduit in trench east of Manhole #68, Segment 5, March 3, 2005
