PROJECT MEMORANDUM PG&E JEFFERSON-MARTIN 230KV TRANSMISSION PROJECT

To: Billie Blanchard, CPUC
From: Vida Strong, Aspen Project Manager
Date: April 6, 2005
Subject: Weekly Report #11: March 27, 2005 – April 2, 2005
CPUC Environmental Monitors (EM): Jody Fessler and Jenny Slaughter

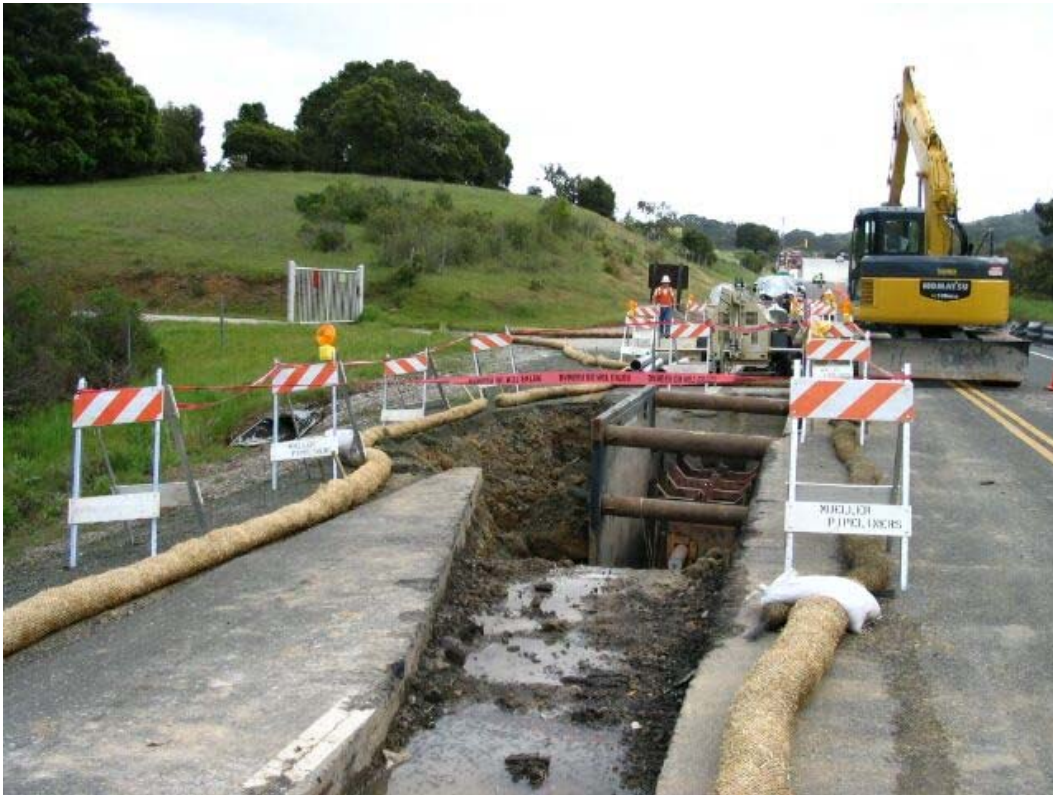
1. On March 28, crews started excavating trench between Manhole #4 and Manhole #5 on Cañada Road (Figure 1 & 2). The soil from the trenching activities was transported to Ox Mountain landfill in Half Moon Bay (Class 3 facility). Crews shored the trench as they excavated. Conduit was installed in the trench as the excavation progressed, and cement slurry was poured around the conduit as it was installed. A lot of water was encountered during excavation, which slowed trenching progress. Approximately 390 linear feet of conduit was installed during the week. Crews were on-site during the night, but little work was done. A biological monitor also stayed at the site at night to observe construction, watch for animals, and in case a crew member needed to move their vehicle. On Friday, crews conducted asphalt paving of the trench and clean-up activities. All materials and traffic controls were removed from the construction area at the end of the day Friday. Biological Exclusion Fencing was also removed from this area at the end of the day Friday after vehicles and equipment had left the site.

Figure 1 – Stub-out areas at Manhole #4 on Cañada Road, Segment 1, March 29, 2005.

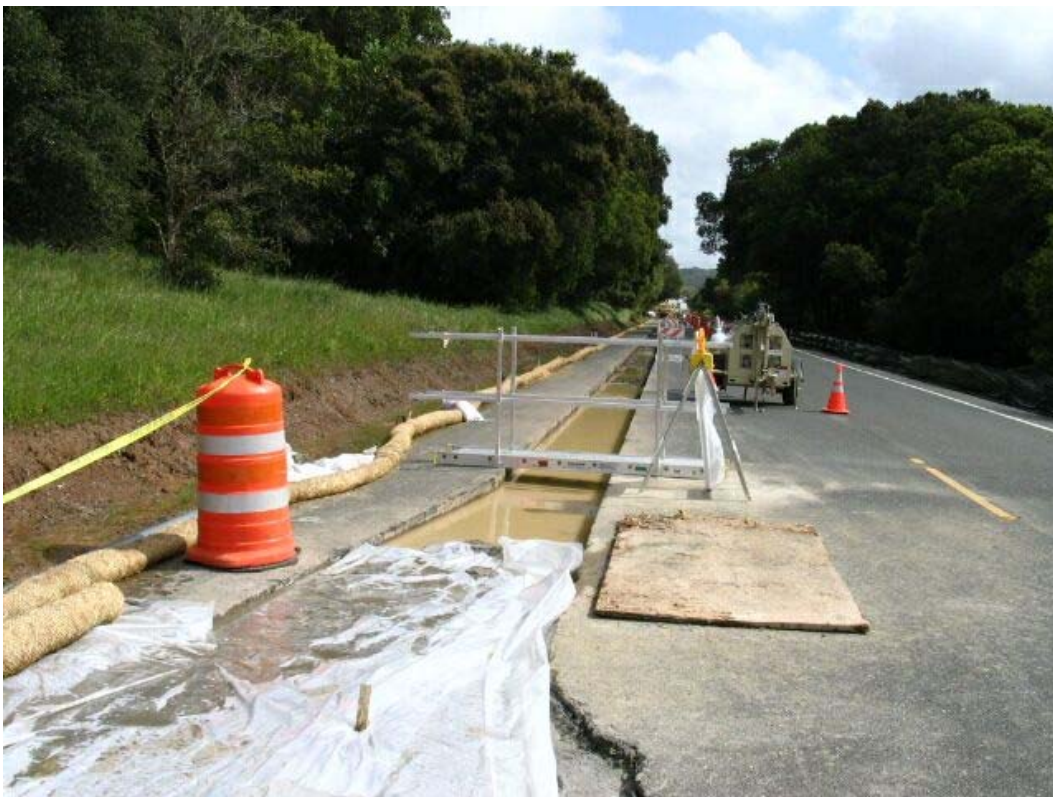
Figure 2 – Water in trench south of Manhole #5 on Cañada Road, Segment 1, March 29, 2005.

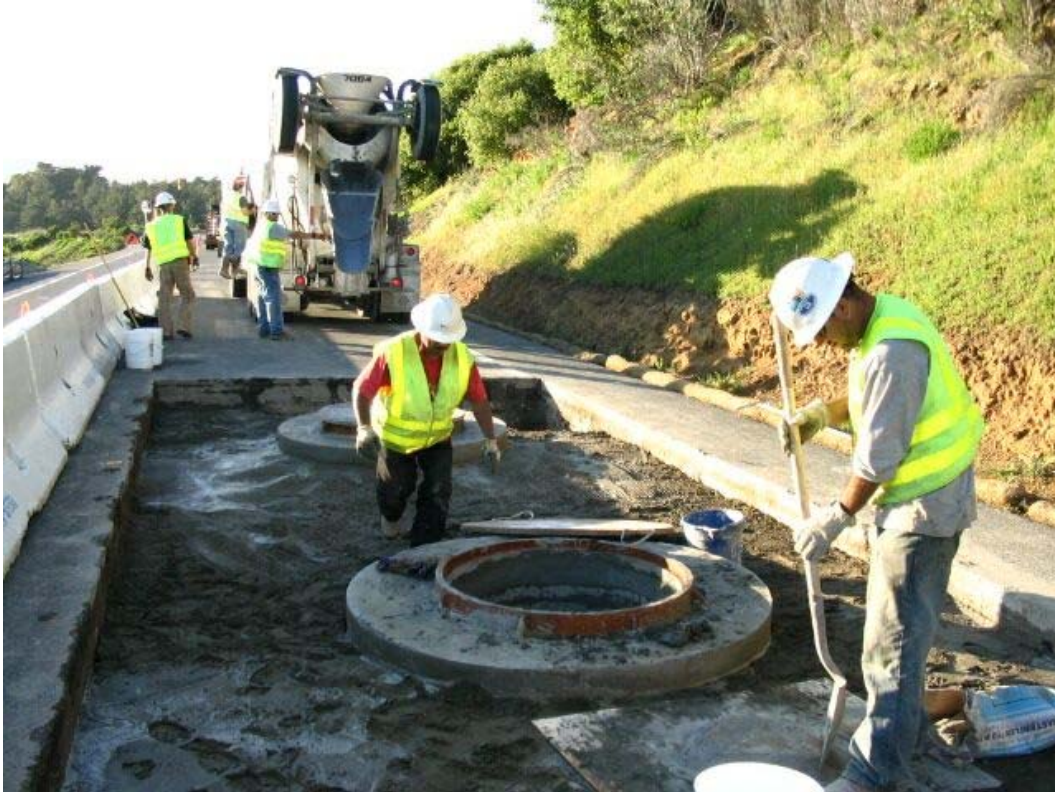
2. On Monday, March 28, excavation of Manhole #11 and Manhole #14 on Cañada Road began (Figure 3). The soil from the manhole activities was transported to Ox Mountain landfill in Half Moon Bay (Class 3 facility). Excavation was completed on Monday and shoring was installed in the pit. The manhole vaults arrived on Tuesday morning and cement slurry was poured around and over the vault. Paving was done on Thursday and traffic controls were removed from the site on Thursday.

Figure 3 – Crews getting ready to pour more cement slurry at Manhole #11 on Cañada Road, Segment 1, March 30, 2005.

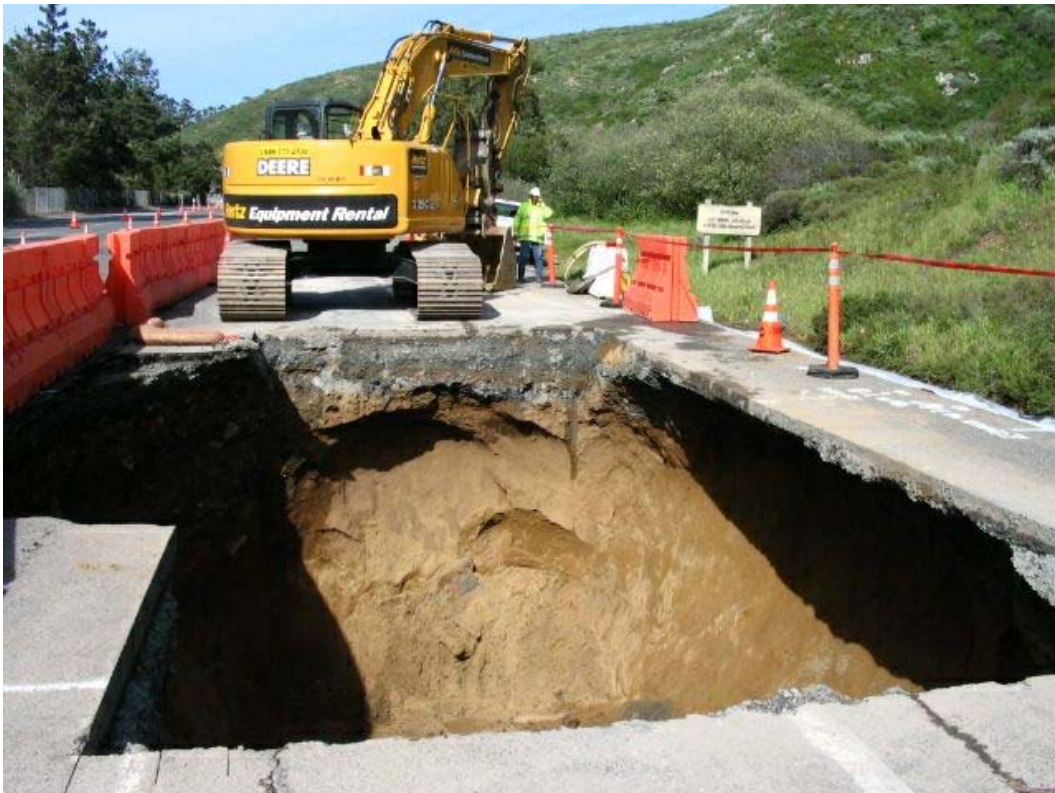
1. On March 28, the excavation of Manhole #66 began on Guadalupe Canyon Parkway (Figure 4). The soil from the manhole activity was transported to Ox Mountain landfill in Half Moon Bay (Class 3 facility). There were some cave-in issues, but vault pit was completed on Monday and shoring was set that afternoon. The vault arrived and was set in the pit by a large crane on Wednesday. Slurry was then poured over the manhole vault, manhole rings were set, and the site was paved over on Saturday.

Figure 4 – Manhole #66 vault pit having cave-in issues on Guadalupe Canyon Parkway, Segment 5, March 28, 2005.

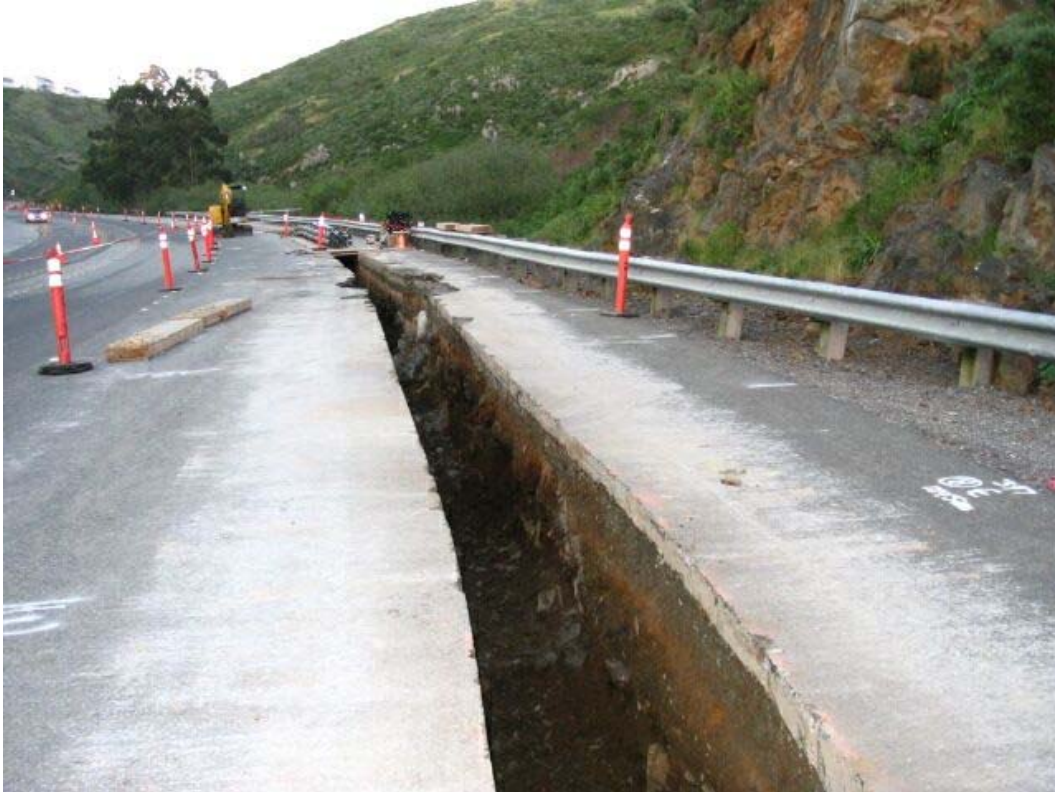
2. Excavation of trench occurred between Manhole #66 to Manhole #67 and east of Manhole #69 for the installation of conduit (Figure 5). The soil from the trenching activities was transported to Ox Mountain landfill in Half Moon Bay (Class 3 facility). Approximately 900 linear feet of conduit was installed throughout the week, cement slurry poured, and final paving done on Saturday.

Figure 5 – Trench excavated east of Manhole #66 on Guadalupe Canyon Parkway, Segment 5, March 30, 2005.
