PROJECT MEMORANDUM PG&E JEFFERSON-MARTIN 230KV TRANSMISSION PROJECT

To: Billie Blanchard, CPUC
From: Vida Strong, Aspen Project Manager
Date: April 12, 2005
Subject: Weekly Report #12: April 3, 2005 – April 9, 2005
CPUC Environmental Monitors (EM): Jody Fessler and Jenny Slaughter

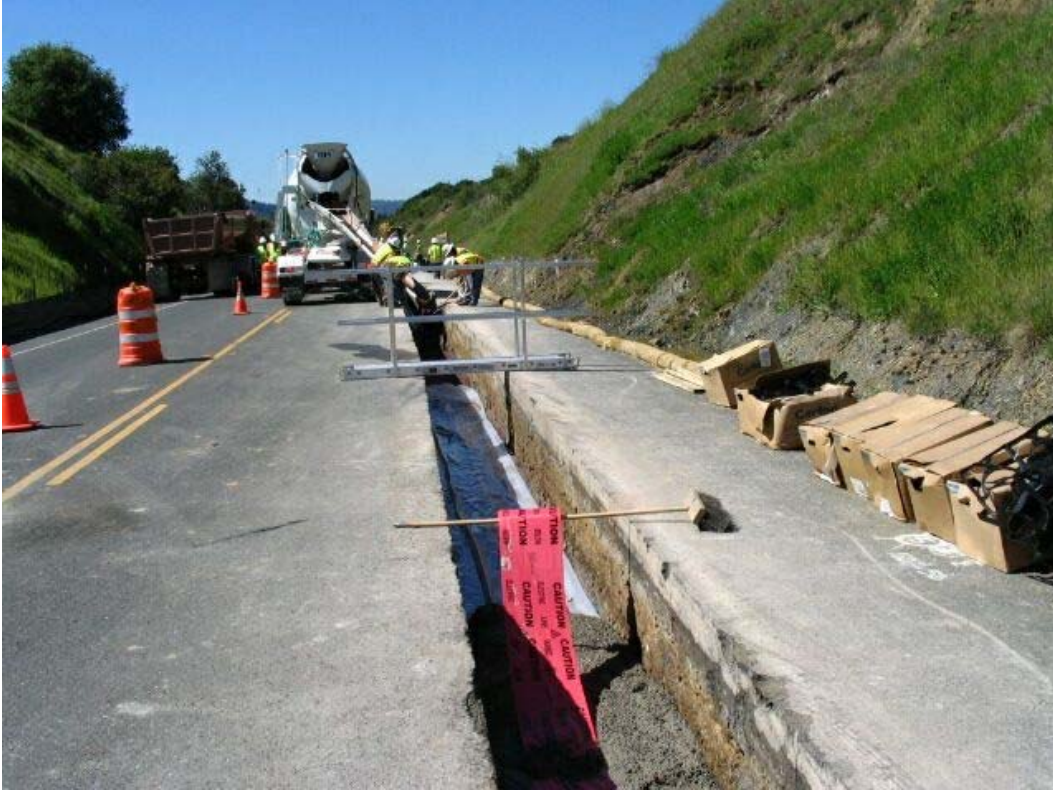
Figure 1 – Crews conducting trenching activities between Manholes #10 and #11 on Cañada Road, Segment 1, April 5, 2005.

1. On April 4, crews started excavating trench between Manhole #10 and Manhole #11 on Cañada Road (Figure 1). The soil from the trenching activities was transported to Ox Mountain landfill in Half Moon Bay (Class 3 facility). Crews shored the trench as they excavated. Conduit was installed in the trench as the excavation progressed, and cement slurry was poured around the conduit as it was installed. A small crew was on-site during the night, but little work was done. A biological monitor also stayed at the site at night to observe construction, watch for animals, and check under vehicles and equipment in case a crew member needed to move their vehicle. On Thursday and Friday, crews conducted asphalt paving of the trench and cleanup activities. All materials and traffic controls were removed from the construction area at the end of the day Friday.

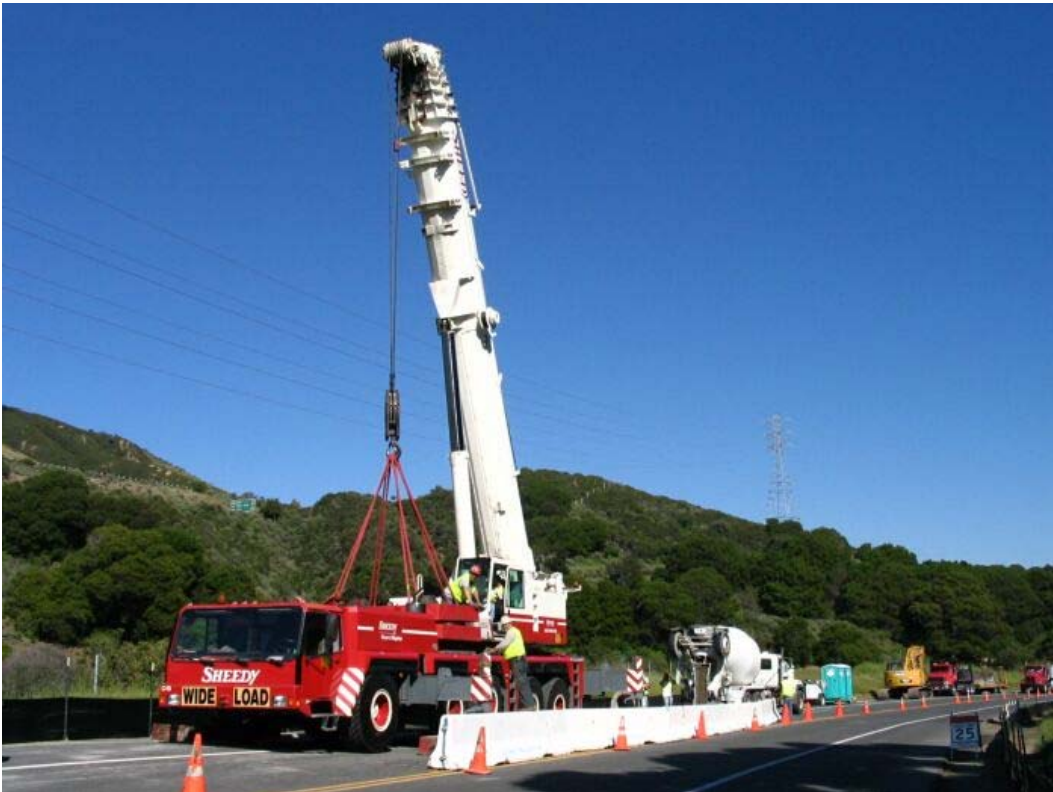
Figure 2 – Crane setting vault at Manhole #13 on Cañada Road, Segment 1, April 5, 2005.

2. On Monday, April 4, excavation of Manhole #13 and Manhole #15 on Cañada Road began. The soil from the manhole activities was transported to Ox Mountain landfill in Half Moon Bay (Class 3 facility). Excavation was completed on Monday and shoring was installed in the pit. The manhole vaults arrived on Tuesday and were set in the pit by a large crane (Figure 2). Cement slurry was poured around and over the vault. Paving was done on Friday and traffic controls were removed from the site in the afternoon.

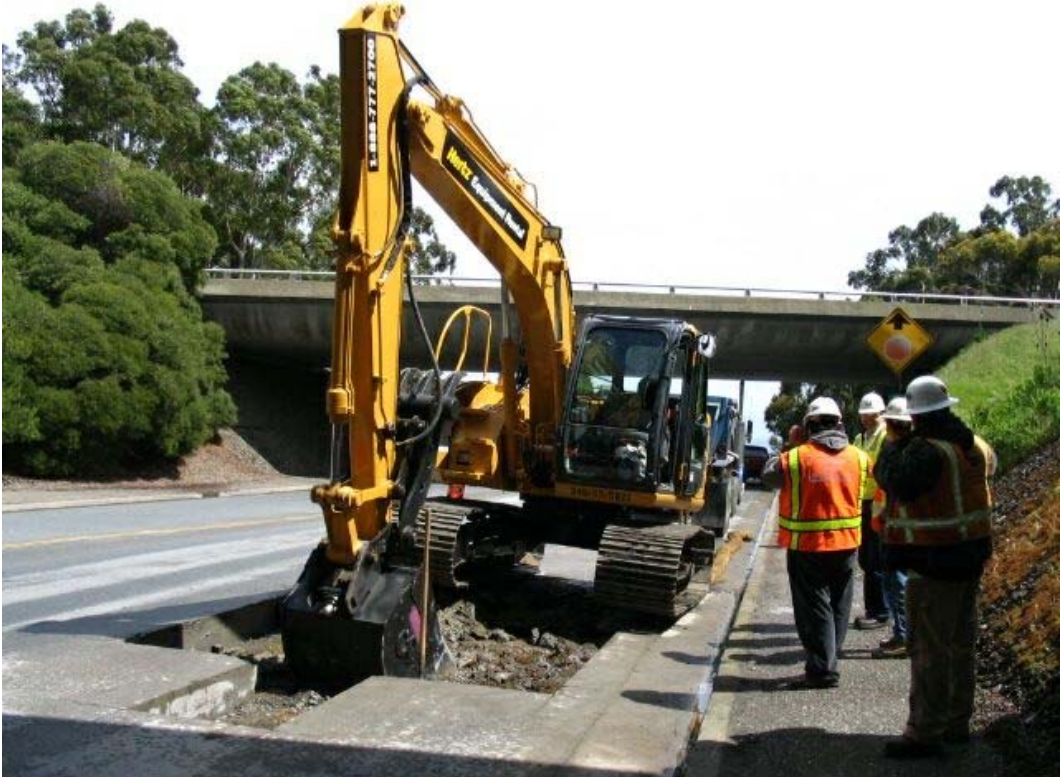
Figure 3 – Crews excavating asphalt for Manhole #37 on Trousdale, Segment 2, April 7, 2005.

The CPUC EM conducted a site visit of the underground segment throughout the week. Construction started on April 7, Thursday, at Manhole #37 with the excavation of the vault pit (Figure 3). Crews did not get very far along before their excavator started leaking hydraulic fluid. A mechanic was sent out to the site to fix the leak and the area contaminated by hydraulic fluid was temporarily cleaned up. Some contaminated asphalt will have to be excavated and disposed of properly. The asphalt for the vault pit was excavated on Thursday and plated. Crews did not work on Friday.

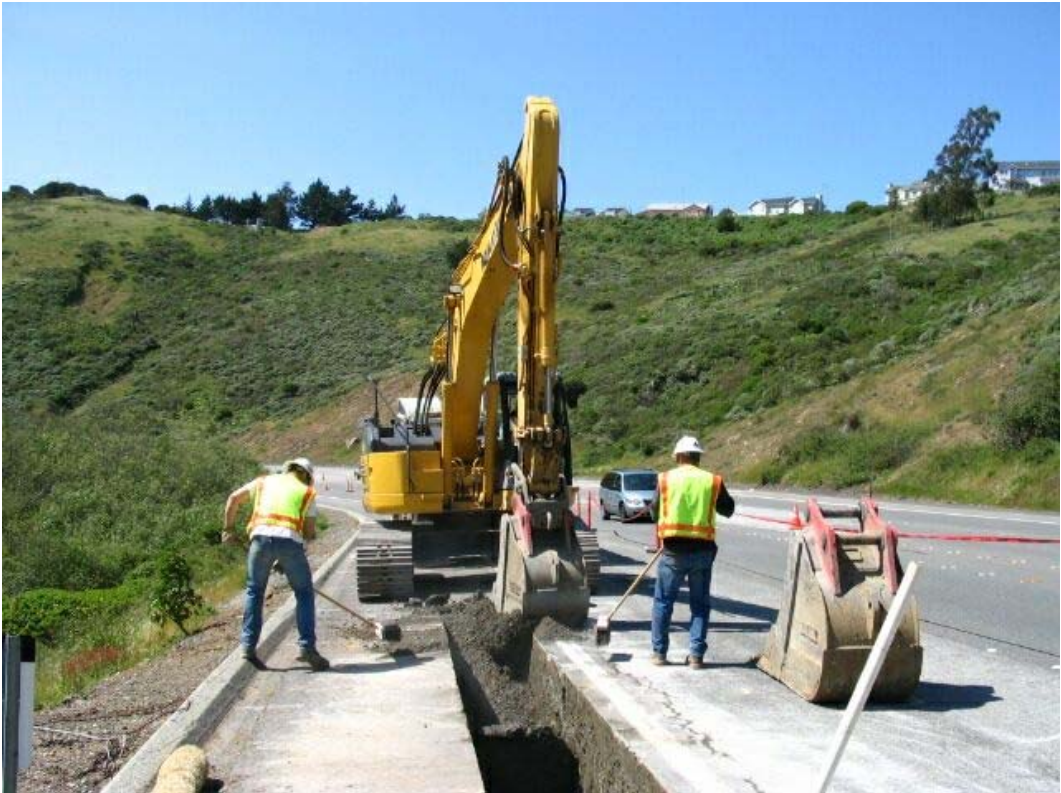
Figure 4 – Crews excavating east of Manhole #67 on Guadalupe Canyon Parkway, Segment 5, April 4, 2005.

2. Excavation of trench occurred between Manhole #67 and Manhole #68 for the installation of conduit (see Figure 4). The soil from the trenching activities was transported to Ox Mountain landfill in Half Moon Bay (Class 3 facility). Approximately 1,300 linear feet of conduit was installed throughout the week, cement slurry poured, and final paving done on Friday.

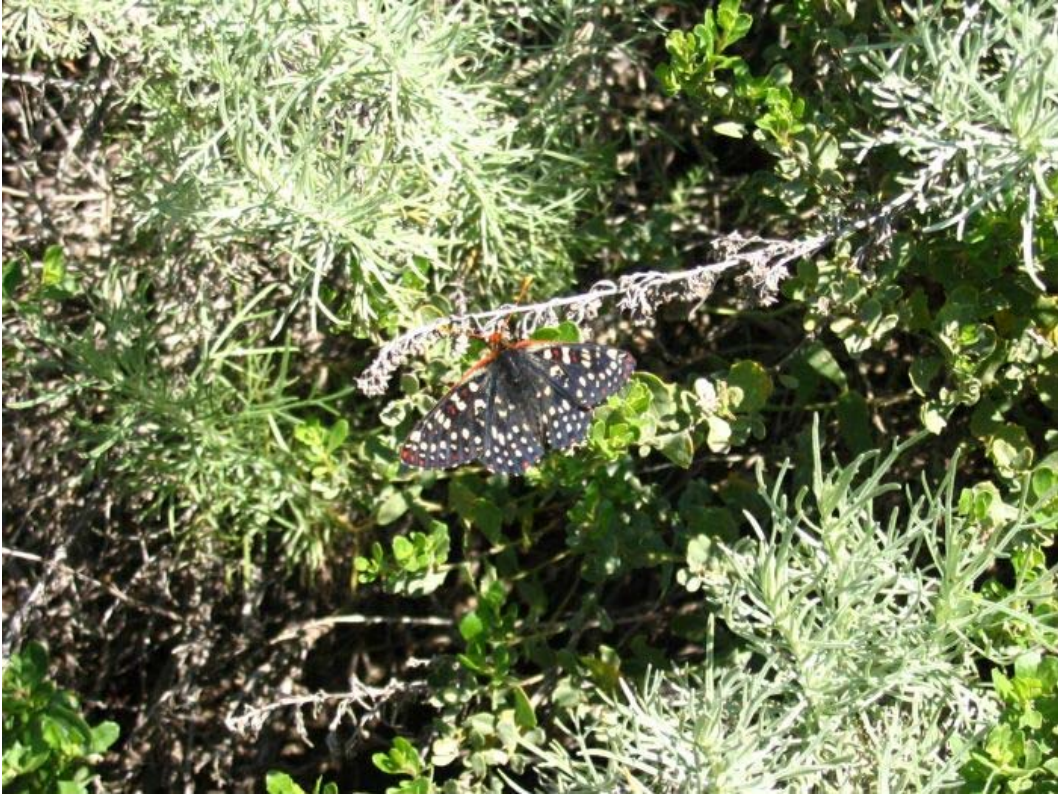
Figure 5 – Possible Bay checkerspot butterfly on the hillside of San Bruno Mountain near Manhole #66 on Guadalupe Canyon Parkway, Segment 5, April 6, 2005.
