PROJECT MEMORANDUM PG&E JEFFERSON-MARTIN 230KV TRANSMISSION PROJECT

To: Billie Blanchard, CPUC
From: Vida Strong, Aspen Project Manager
Date: April 20, 2005
Subject: Weekly Report #13: April 10, 2005 – April 16, 2005
CPUC Environmental Monitors (EM): Jody Fessler and Jenny Slaughter

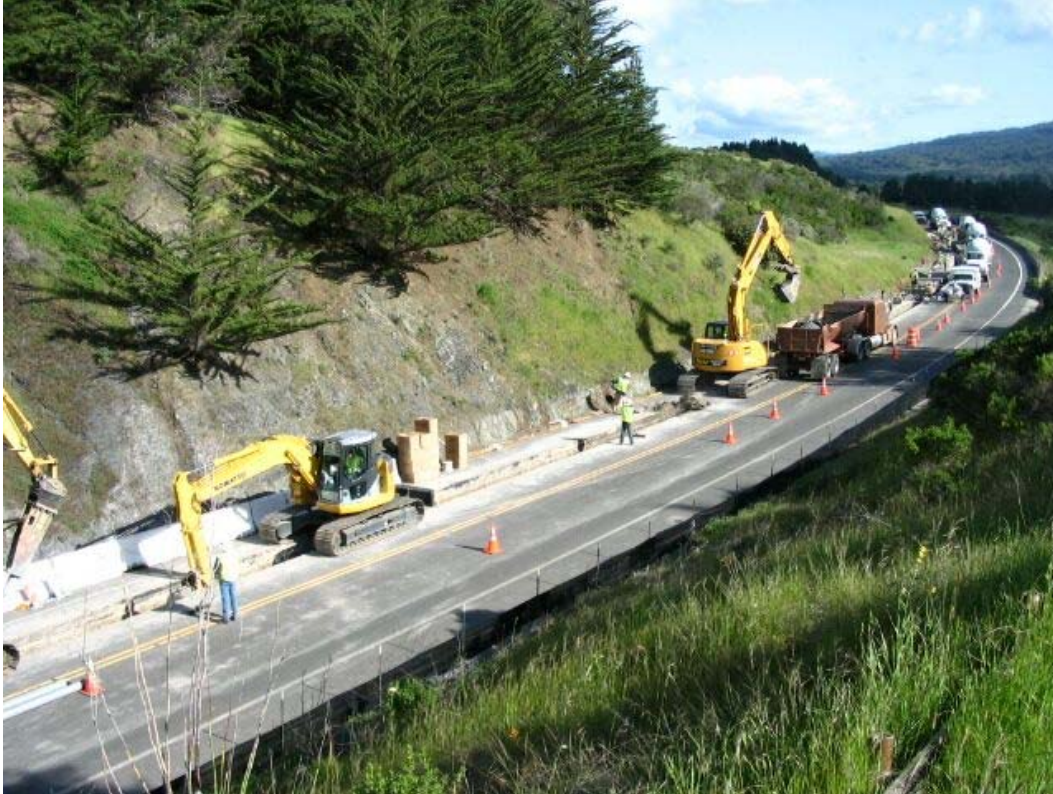
1. On April 11, crews started excavating trench between Manhole #11 and Manhole #12 on Cañada Road (Figure 1). A pilot vehicle was used in this area. The soil from the trenching activities was transported to Ox Mountain landfill in Half Moon Bay (Class 3 facility). Crews shored the trench as they excavated. Conduit was installed in the trench as the excavation progressed, and cement slurry was poured around the conduit as it was installed. Approximately 1,705 linear feet of conduit was installed throughout the week. A small crew was on-site during the night, but little work was done. A biological monitor also stayed at the site at night to observe construction, watch for animals, and check under vehicles and equipment in case a crew member needed to move their vehicle. On Wednesday, Thursday, and Friday, crews conducted asphalt paving of the trench. Clean-up activities were done on Thursday and Friday. All materials and traffic controls were removed from the construction area at the end of the day Friday.

Figure 1 – Crews conducting trenching activities between Manholes #11 and #12 on Cañada Road, Segment 1, April 13, 2005.

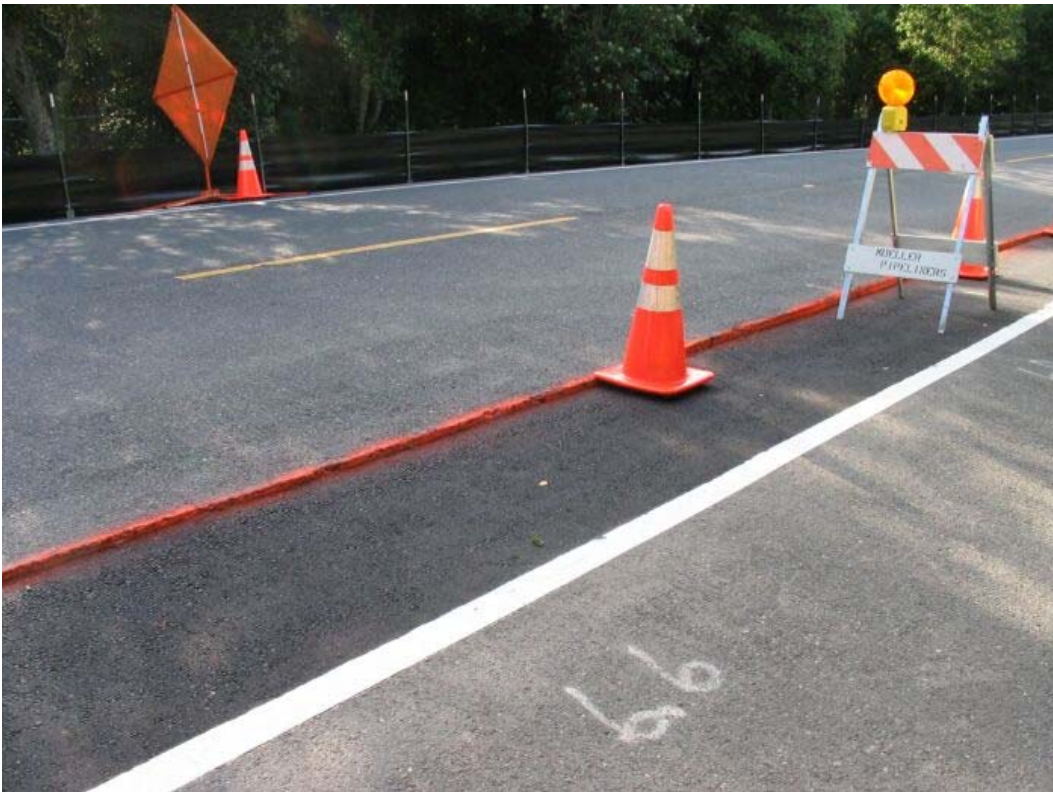
5. On Sunday, April 10, a cyclist had an accident between Manhole #4 and Manhole #5 on Cañada Road at approximately Station #65+00 (Figure 2). The cyclist claims that the accident occurred because of uneven pavement where some of the trench had sunk due to gravel backfill and lots of groundwater. On Monday, April 11, the area between Manhole #4 and Manhole #5 where the trench had sunk was marked with orange paint and coned off. On Wednesday, April 13, crews started excavating out the gravel backfill in the trench and replaced it with flowable thermal backfill. A pilot vehicle was used at that location on Thursday and Friday because the traffic control zone was about 1,000 feet long. Final paving was completed at that location on Friday.

Figure 2 – Area where trench sank between Manholes #4 and #5 on Cañada Road, Segment 1, April 12, 2005.

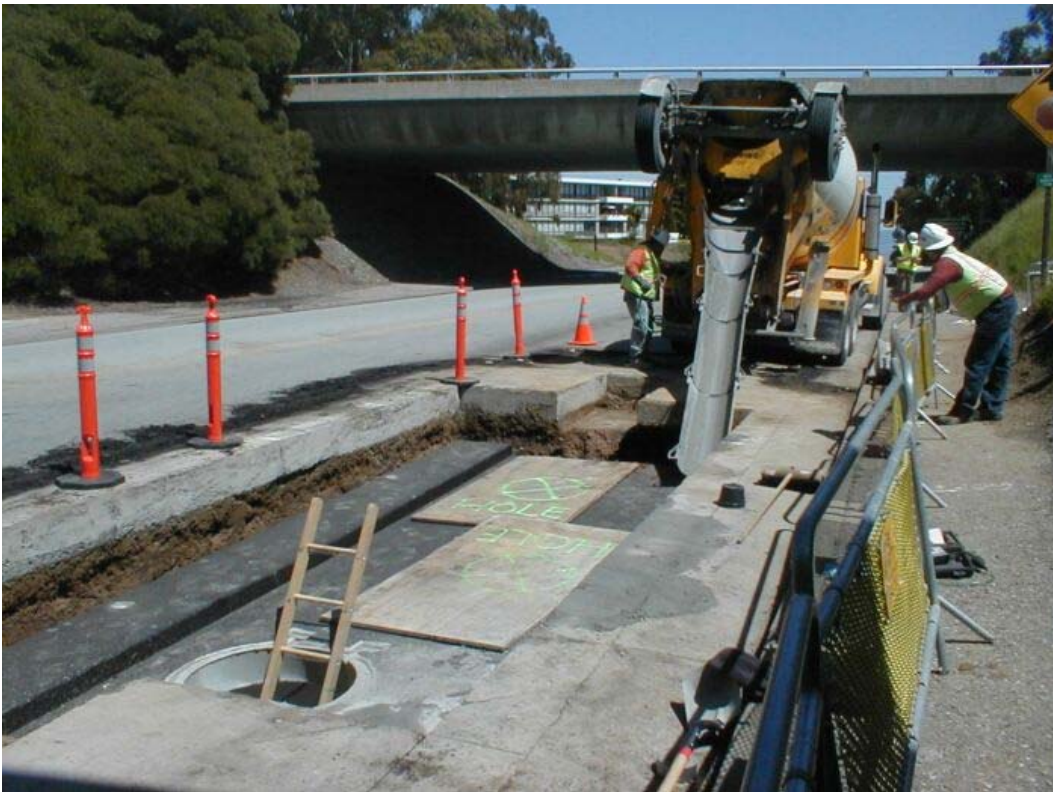
1. On Monday, April 11, construction continued at Manhole #37 in the Caltrans area on Trousdale Drive (Figure 3). The excavator was reported to be leaking more hydraulic fluid and a mechanic was called out to the site again. On Thursday, April 14, the vault was set in the manhole pit. Plates were placed over the manhole pit by 3:00 p.m. every day.

Figure 3 – Crews pouring cement slurry at Manhole #37 on Trousdale, Segment 2, April 14, 2005.

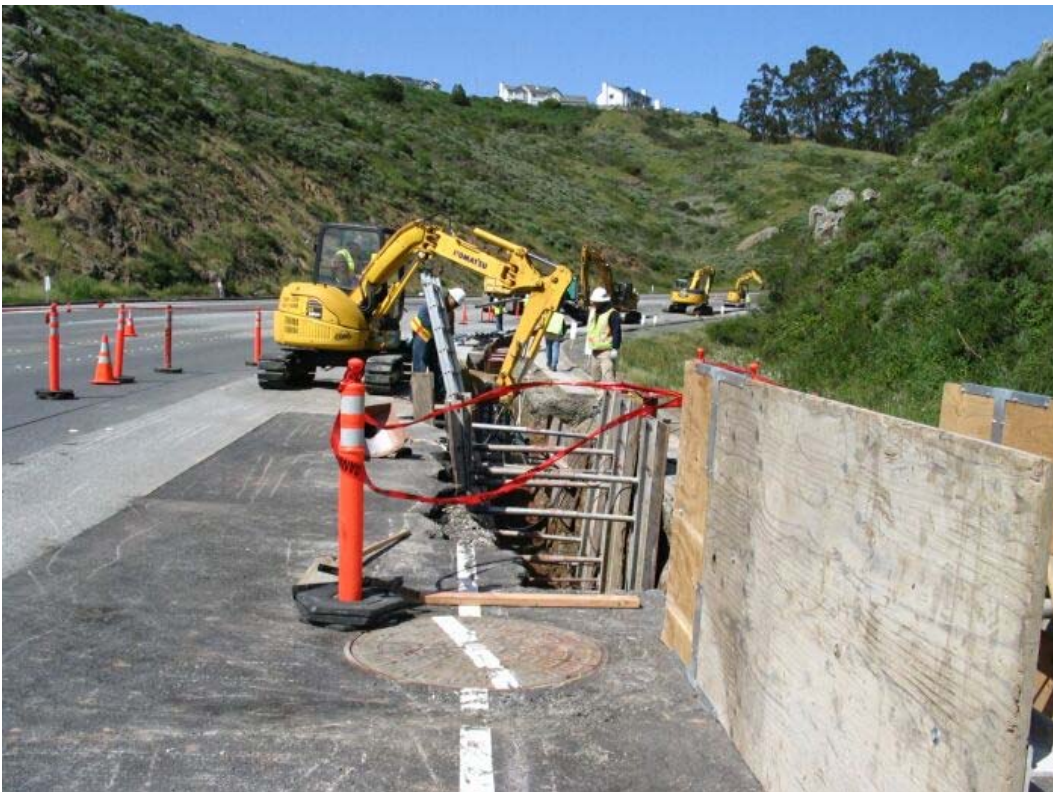
1. On April 11, crews started excavating to tie-in the stub-out on the east side of Manhole #66 to the rest of the conduit already in the trench. Crews also started excavating more trench between Manhole #67 and Manhole #68 (Figure 4). The soil from the trenching activity was transported to Ox Mountain landfill in Half Moon Bay (Class 3 facility). Throughout the week, the trenches were shored, conduit installed, cement slurry poured, and the area paved over on Friday night. No work was done on Saturday.

Figure 4 – Crews excavating east of Manhole #67 on Guadalupe Canyon Parkway, Segment 5, April 12, 2005.
