PROJECT MEMORANDUM

PG&E JEFFERSON-MARTIN 230KV TRANSMISSION PROJECT

Subject: Weekly Report #19: May 22, 2005 – May 28, 2005

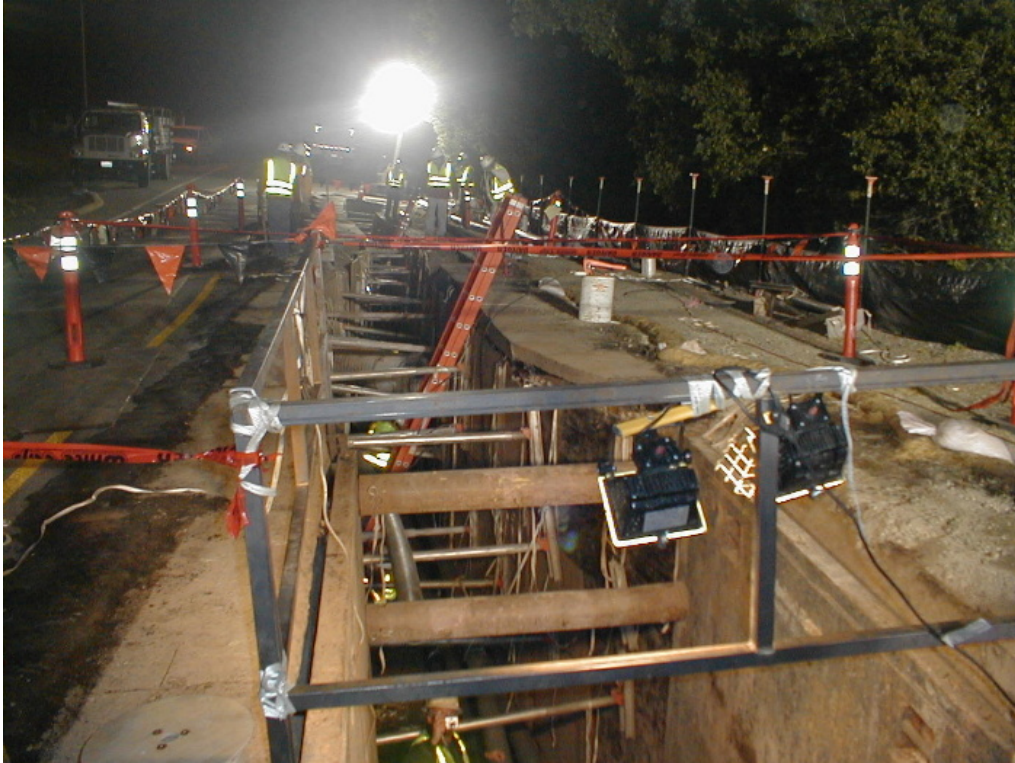
Figure 1 – Trenching activities south of Manhole #20 in Caltrans right-of-way on Skyline Boulevard, Segment 1, May 23, 2005

4. Night trenching work continued in the Caltrans area on Skyline Boulevard this week starting in the night of May 22nd (Figure 1). Skyline Boulevard/Highway 35 was closed to public traffic from the Crystal Springs Dam to the Highway 35/Highway 92 Interchange from 8:00 p.m. to 5:00 a.m., Monday through Friday. From Manhole #20, crews continued to trench south, installed conduit, and poured cement slurry in the trench. Approximately 480 linear feet of conduit was installed in the Caltrans area throughout the week. The soil from the trenching activities was transported to Ox Mountain landfill in Half Moon Bay (Class 3 facility). On Wednesday night, trench plates were placed over the trenched area that was not completed yet in preparation for the long weekend. BEF was installed at this location. One or two PG&E EIs were always on-site to ensure environmental compliance.

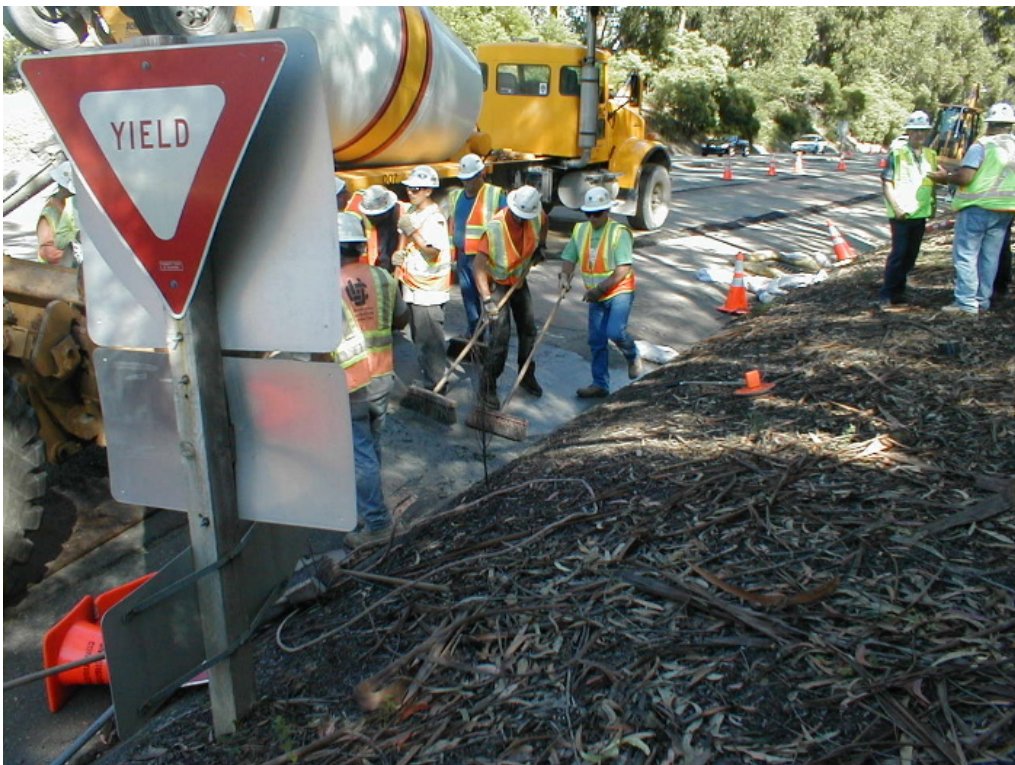
On Wednesday, May 25th, there was a cement slurry spill of about 50 gallons of cement on the west side of the road on the asphalt (Figure 2). The CPUC EM watched as crews cleaned up the spill. Crews were about an hour and a half past their Burlingame Encroachment Permit time limit for getting construction off the road for the day. On Thursday, May 26th, the CPUC EM was informed of another cement slurry spill of a few gallons in the same area as the day before. The CPUC EM observed clean-up activities. Crews were about two and a half hours late getting off the road on Thursday. The CPUC EM witnessed

Figure 2 – Cement slurry spill in trenching area between Manholes #36 and #37 on Skyline Boulevard, Segment 2 Underground, May 25, 2005

several traffic control violations on Thursday which could have caused traffic accidents with the public. On Friday, May 27th, the CPUC EM issued two Project Memorandums for crews going past their Burlingame Encroachment Permit time deadline and traffic control violations.

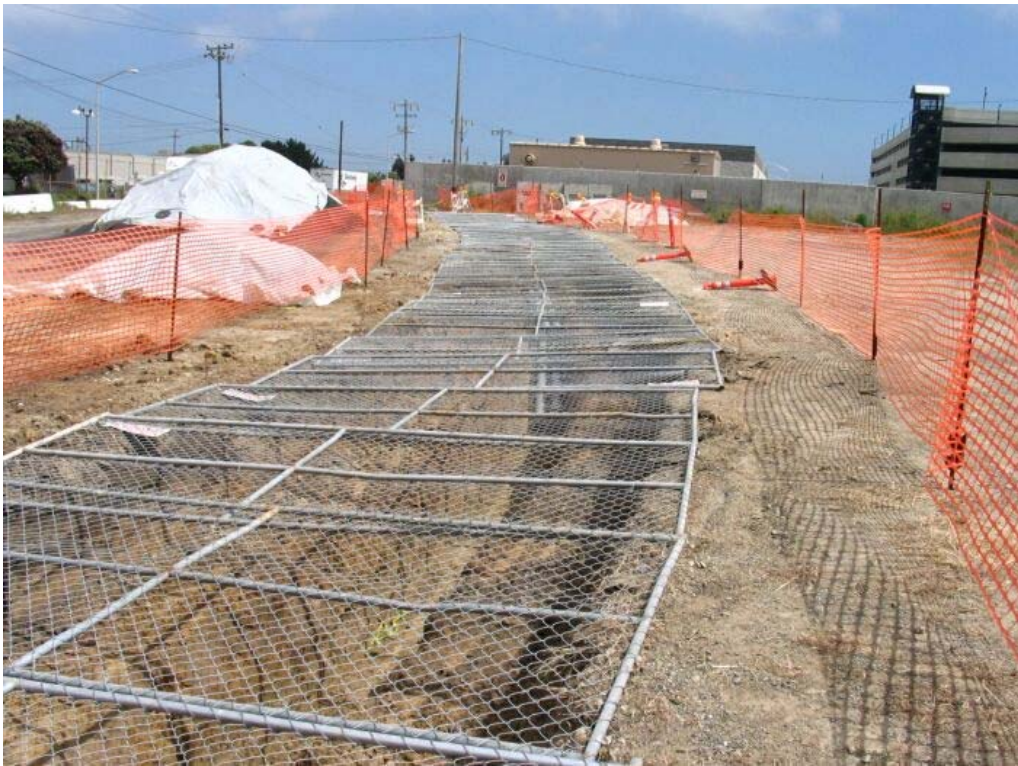
1. On Monday, May 23rd, excavation of stub-outs continued on either side of Manhole #49 in the BART right-of-way. Crews continued to work at this location throughout the week.
2. Trenching activities began north of Manhole #48 this week (Figure 3). Crews shored the trench as they excavated. Conduit was installed in the trench as the excavation progressed, and cement slurry was poured around the conduit as it was installed. The trenches were covered with plywood and/or chain link fence sections and surrounded by snow fencing at the end of each day. Approximately 120 linear feet of conduit was installed throughout the week.
3. Manhole #50 and Manhole #51 were excavated in the beginning of the week, vault pits installed throughout the week, the area backfilled, and the soil re-contoured to grade toward the end of the week.

Figure 3 – Trenching area north of Manhole #48 in the BART right-of-way, Segment 4, May 27, 2005

On Friday, May 27th, the CPUC EM observed some plastic blowing off a pile of backfill material near Manhole #48. The CPUC EM also observed that two chain link fence sections were not fully covering the trench north of Manhole #48. The CPUC EM spoke with a PG&E EI about these issues and they informed her that construction management would take care of them right away. The CPUC EMs observed that all other Segment 4 construction activities were in compliance with mitigation measures adopted in the EIR and other permit requirements.

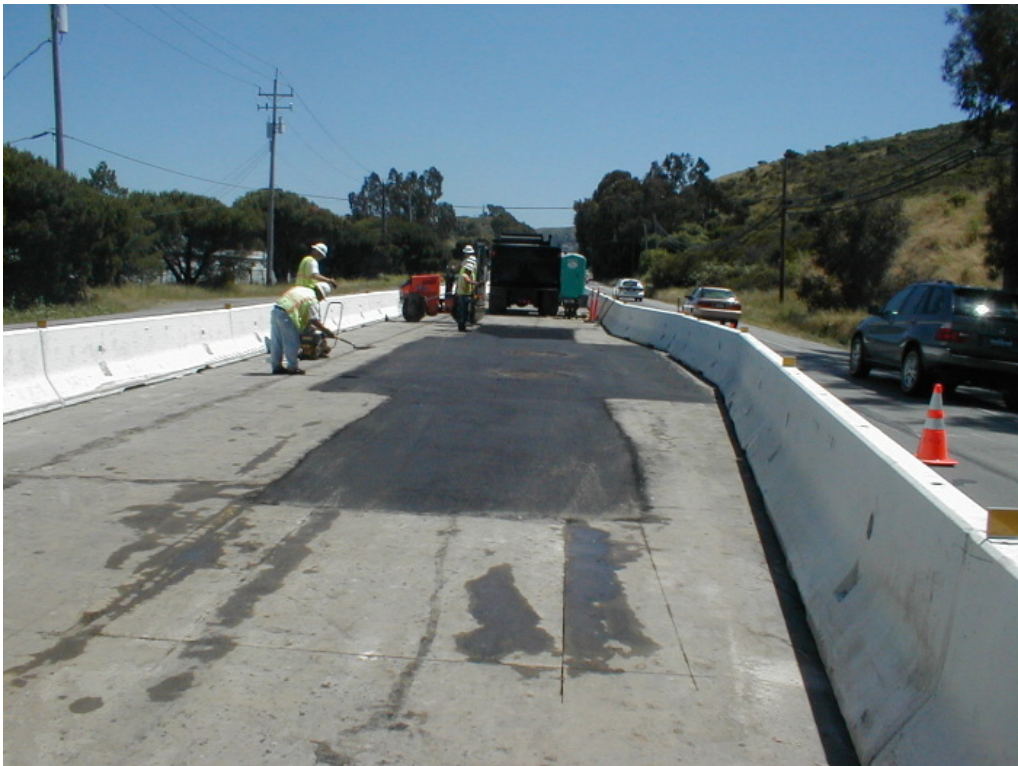
2. On Wednesday, May 25th, Manhole #78 area was paved over and the K-rails and all traffic controls were removed from the area (Figure 4).
3. Conduit still has to be attached to the bridge at the top of San Bruno Mountain on Guadalupe Canyon Parkway. Once the brackets are made, construction crews will complete the bridge work.

Figure 4 – Crews finishing paving at Manhole #78 on Bayshore Boulevard, Segment 5, May 25, 2005
