PROJECT MEMORANDUM PG&E JEFFERSON-MARTIN 230KV TRANSMISSION PROJECT

To: Billie Blanchard, CPUC
From: Vida Strong, Aspen Project Manager
Date: June 14, 2005
Subject: Weekly Report #21: June 5, 2005 – June 11, 2005
CPUC Environmental Monitors (EM): Jody Fessler and Jenny Slaughter

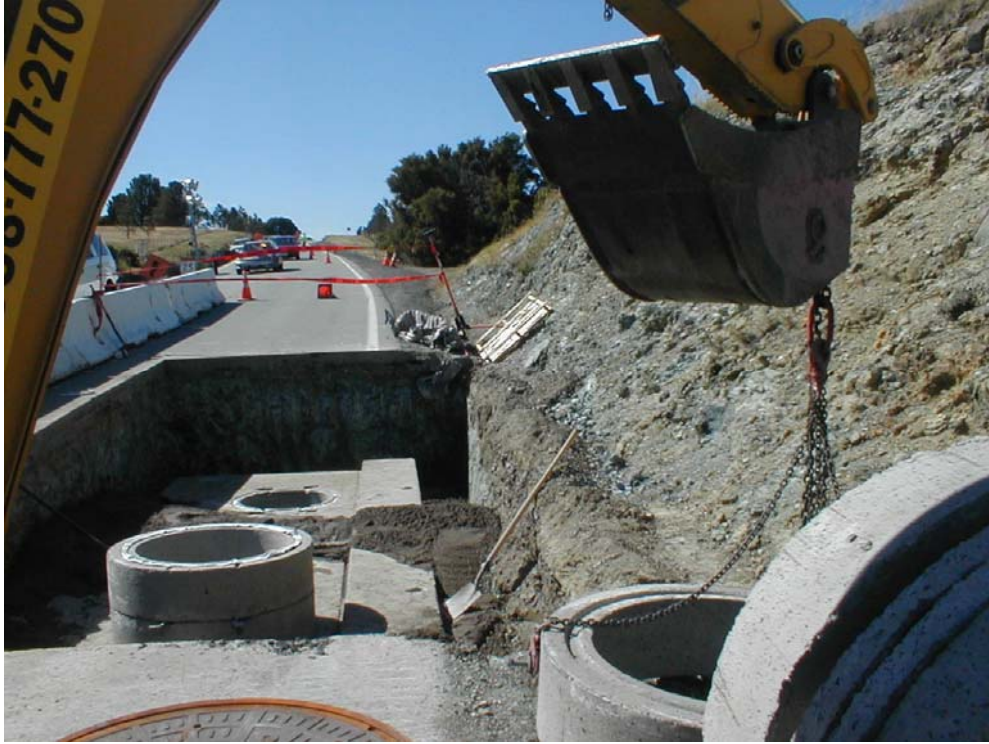
4. Excavation of Manhole #25 and Manhole #26 took place this week during the day in County jurisdiction on Skyline Boulevard. Both Manhole #25 and Manhole #26 pits were excavated and shored on Tuesday and the vaults installed on Wednesday (see Figure 1). Cement slurry poured over and around the vaults on Wednesday and Thursday, and the areas paved over on Friday. K-rails were set up around the manhole areas. Traffic controls were in place from Manhole #25 to Manhole #27 with a pilot car in use. Flaggers were also in place during the day to direct traffic and biological monitors were stationed on the west side of the BEF.

Figure 1 – Ring placement at Manhole #26, Segment 1, June 7, 2005

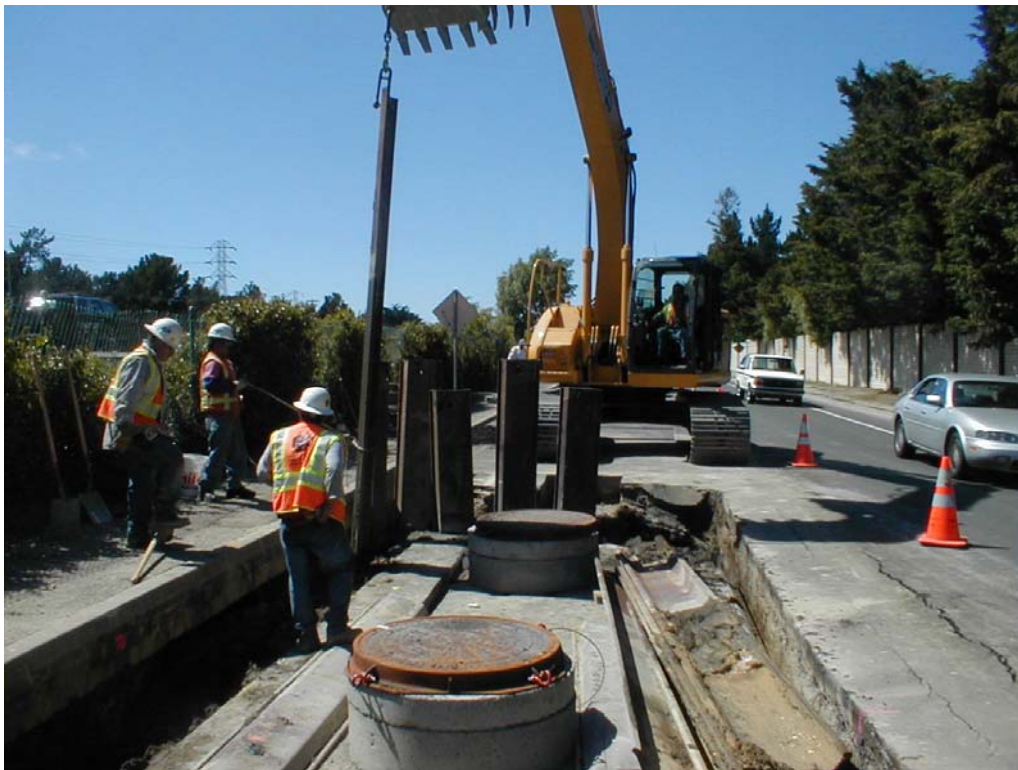
4. At Manhole #30, crews completed excavation of the pit and installed the vault (see Figure 2). Because of cave-in problems at this location, repairs along the sidewalk will be necessary at this location. Steel plates were placed over the pit at the end of each day.

Figure 2 – Crews removing shoring at Manhole #30 on Skyline Boulevard, Segment 2 Underground, June 7, 2005

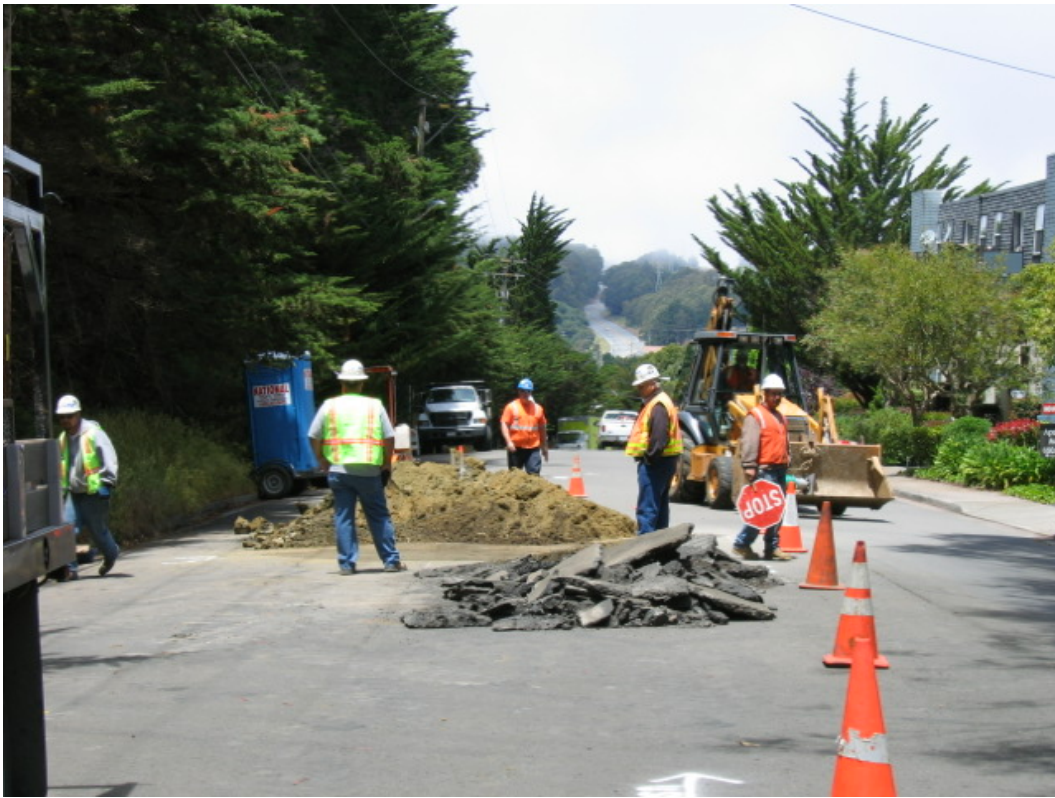
The Segment 3 pre-construction meeting was held Wednesday, June 8th, at the Black & Veatch office in San Mateo. Construction started this week with pot-holing activities beginning on June 9th at Manhole #39 on Glenview Drive (see Figure 3).

Figure 3 – Crews potholing near Manhole #39 Segment 3, June 9, 2005

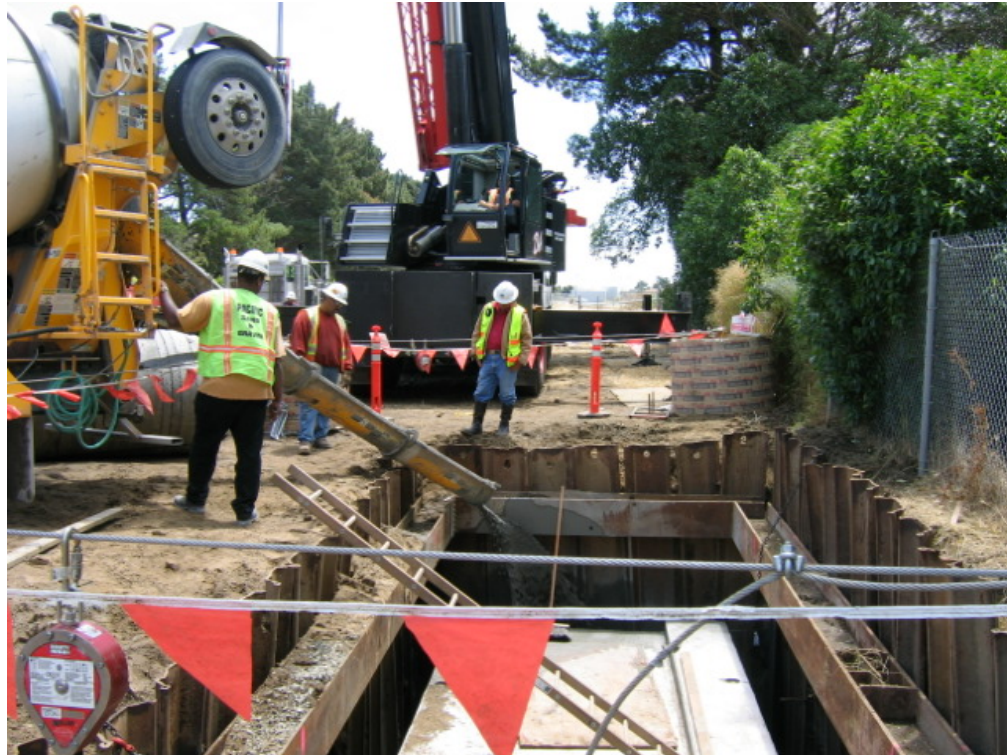
2. On Monday, June 6th, the Manhole #55 pit was excavated and shored. The vault was set on Tuesday and the area backfilled. On Wednesday, June 8th, Manhole #53 pit was excavated and shored. The vault was set on Thursday (see Figure 4). Manhole #53 still has to be backfilled. The pit areas were covered with plywood at the end of each day and the work area surrounded with chain link fencing.

Figure 4 – Shoring and vault placement at Manhole #53, in Segment 4, June 9, 2005.

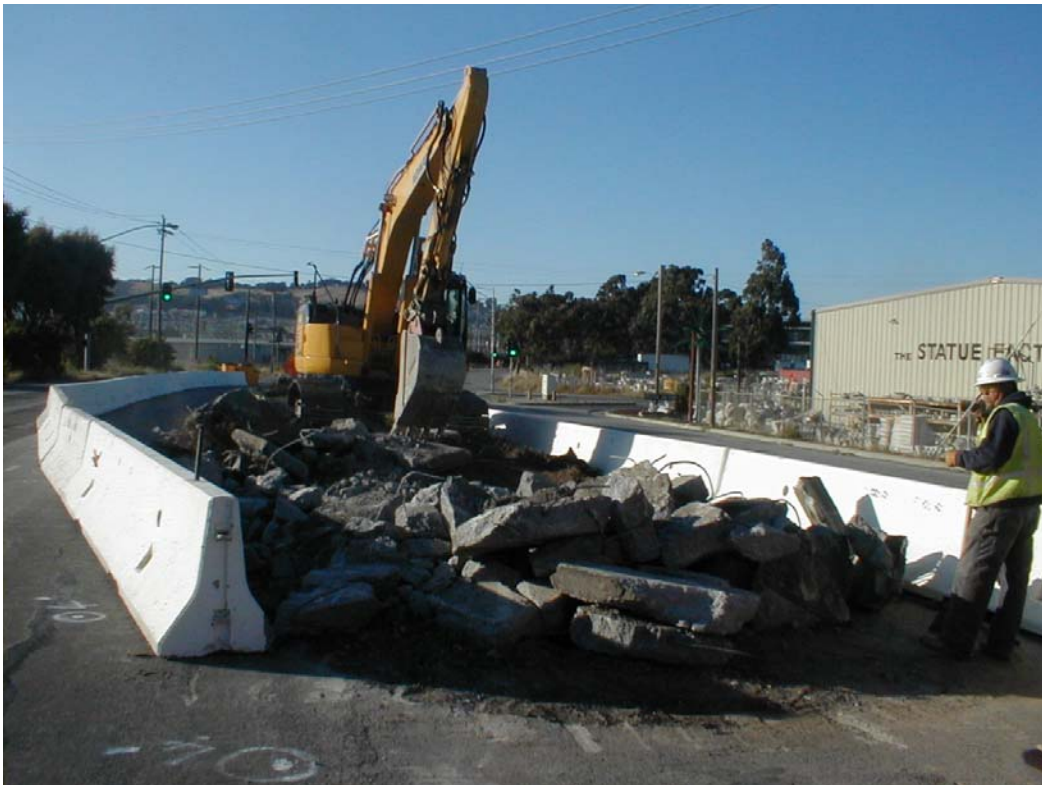
3. The construction zone along Bayshore Boulevard is in the middle of the road with one lane of southbound traffic blocked off (see Figure 5). K-rails run along both sides of the construction zone and the only access to the construction zone is at either the south end or north end of the zone.

Figure 5- Segment 5 along Bayshore Boulevard in the City of Brisbane, June 6, 2005
