PROJECT MEMORANDUM PG&E JEFFERSON-MARTIN 230 kV TRANSMISSION PROJECT

To: Billie Blanchard, CPUC
From: Vida Strong, Aspen Project Manager
Date: June 28, 2005
Subject: Weekly Report #23: June 19, 2005 – June 25, 2005
CPUC Environmental Monitors (EM): Jody Fessler and Jenny Slaughter

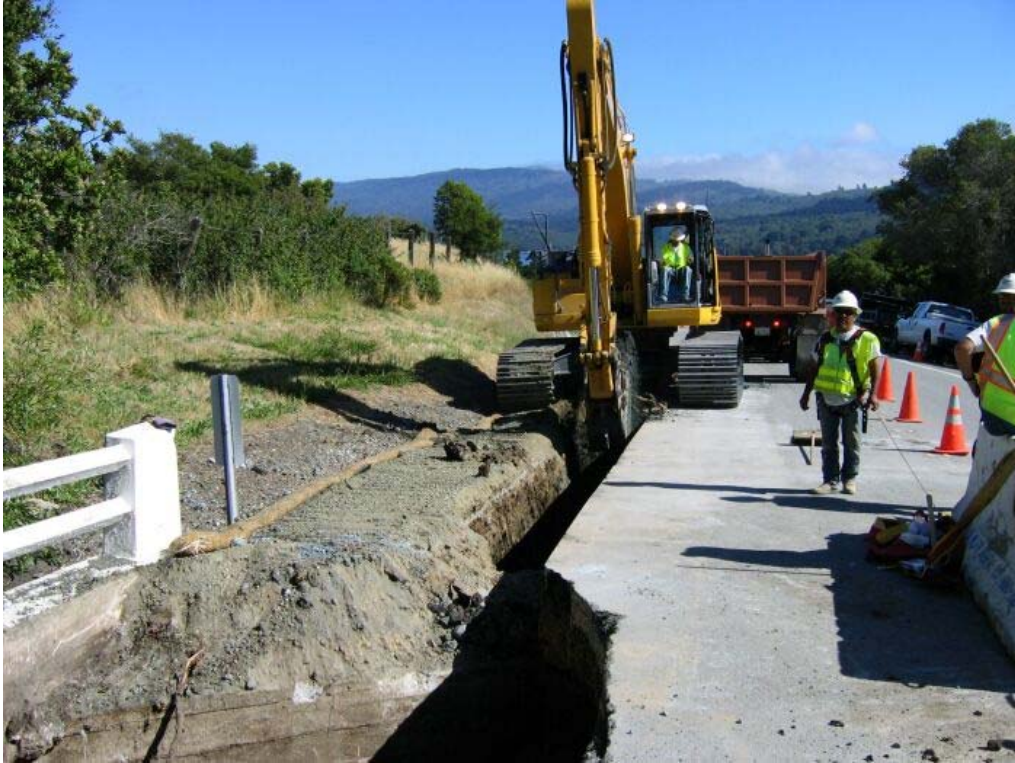
Figure 1 – Trenching activities between Manholes #24 and #25, Segment 1, June 22, 2005

1. On June 20th, crews started excavating trench between Manhole #24 and Manhole #26 on Skyline Boulevard during the day shift (see Figure 1). A pilot vehicle was used in this area with a biological monitor riding along to look for snakes in the road. The soil from the trenching activities was transported to Ox Mountain landfill in Half Moon Bay (Class 3 facility). Crews shored the trench as they excavated. Conduit was installed in the trench as the excavation progressed and cement slurry was poured around the conduit as it was installed. Approximately 2622 linear feet of conduit was installed throughout the week. Biological monitors were placed on the west side of the biological exclusion fencing (BEF) along Skyline Boulevard. There were at least three PG&E EIs in the construction zone at all times. A small crew was on-site during the night to watch the construction area and to do some light work. A PG&E EI also stayed at the site at night to observe construction, watch for animals, and check under vehicles and equipment in case a crew member needed to move their vehicle. Crews conducted asphalt paving of the trench on Friday and Saturday. Clean-up activities were done on Friday and Saturday. All materials and traffic controls were removed from the construction area at the end of the day Saturday.

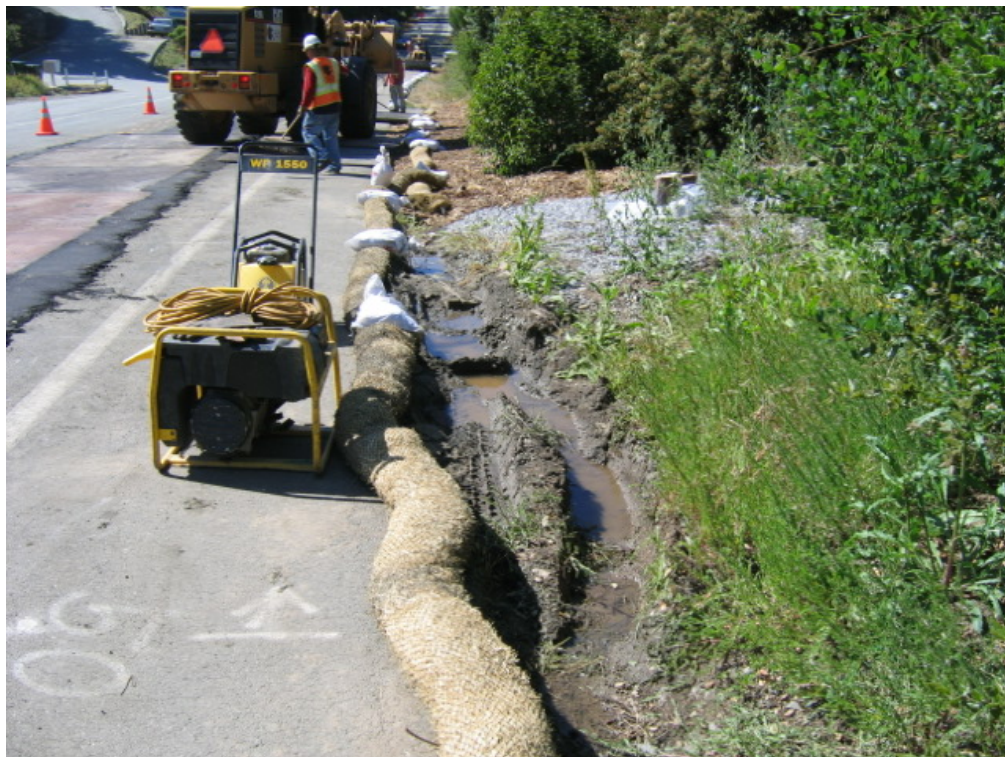
On June 22nd, the CPUC EMs observed the following issues: (1) Three construction vehicles were parked on a side street off Skyline Boulevard and the right-of-way. The CPUC EM spoke with B&V's Assistant Segment Construction Manager and reminded him for the second time that no construction vehicles were to be staged off the right-of-way. (2) A front-loader was observed depositing soil in an end-dump that was parked outside of the construction zone across an active lane of traffic. The CPUC EM spoke with B&V's Assistant Segment Construction Manager about the activity. The Assistant Segment Construction Manager had the end-dump move into the active construction zone. (3) In the trenching area, the CPUC EM observed a construction worker set a can of gasoline on a straw wattle along the road adjacent to a wet drainage (see Figure 2). The CPUC EMs observed that all other Segment 2 underground construction activities were in compliance with mitigation measures adopted in the EIR and other permit requirements. Erosion controls were in place around the construction areas.

Figure 2 – Location of gas can staged near roadside drainage in trenching area on Skyline Boulevard near Manhole #35, Segment 2 Underground, June 22, 2005

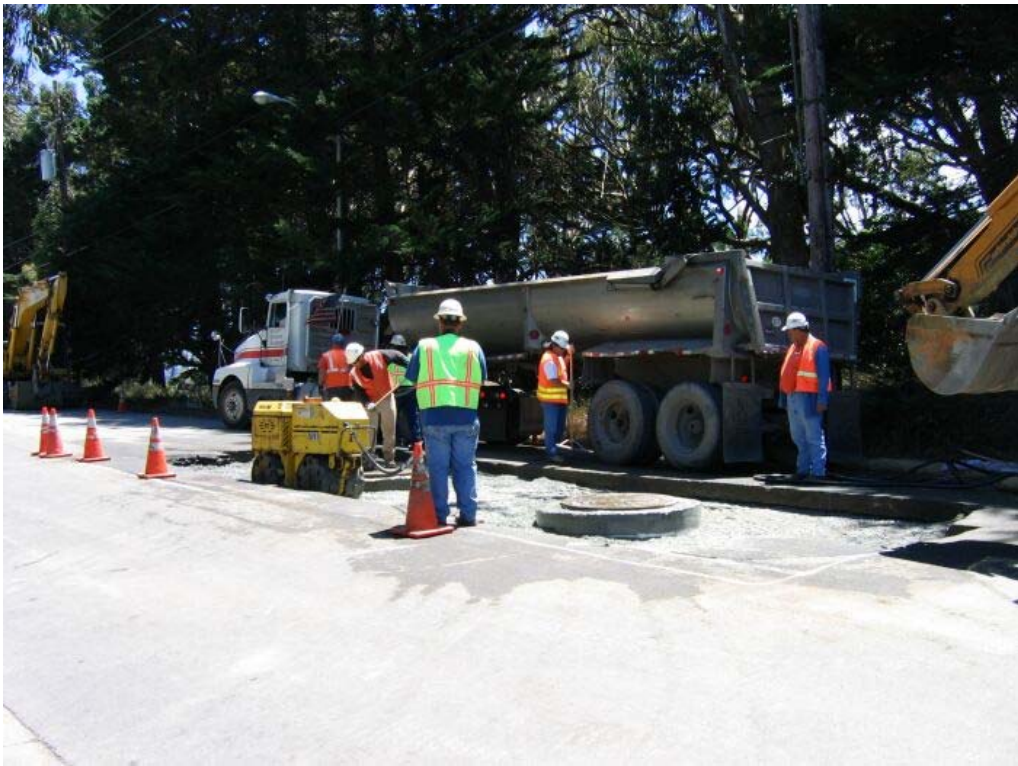
Figure 3 – Crews compacting base rock over backfilled Manhole #39 vault, Segment 3, June 21, 2005

1. Work continued this week at Manhole #39 on Glenview Drive see (see Figure 3). Crews finished backfilling the vault and compacted base rock on Tuesday. The area was paved over on Wednesday. On Thursday, a street sweeper was seen at that location cleaning the street.
2. Pot-holing activities were conducted along Huntington Street at the north end and south end of the street within the segment. The activities included the use of a small back-hoe to excavate some small trenches in the road for locating utilities.
3. Traffic controls were set up around the work area. Signs and cones were set up around the work area and a flagger was in place at the construction site to help direct traffic.
4. Crews continue to use their staging yard under Highway 380 just east of Huntington.

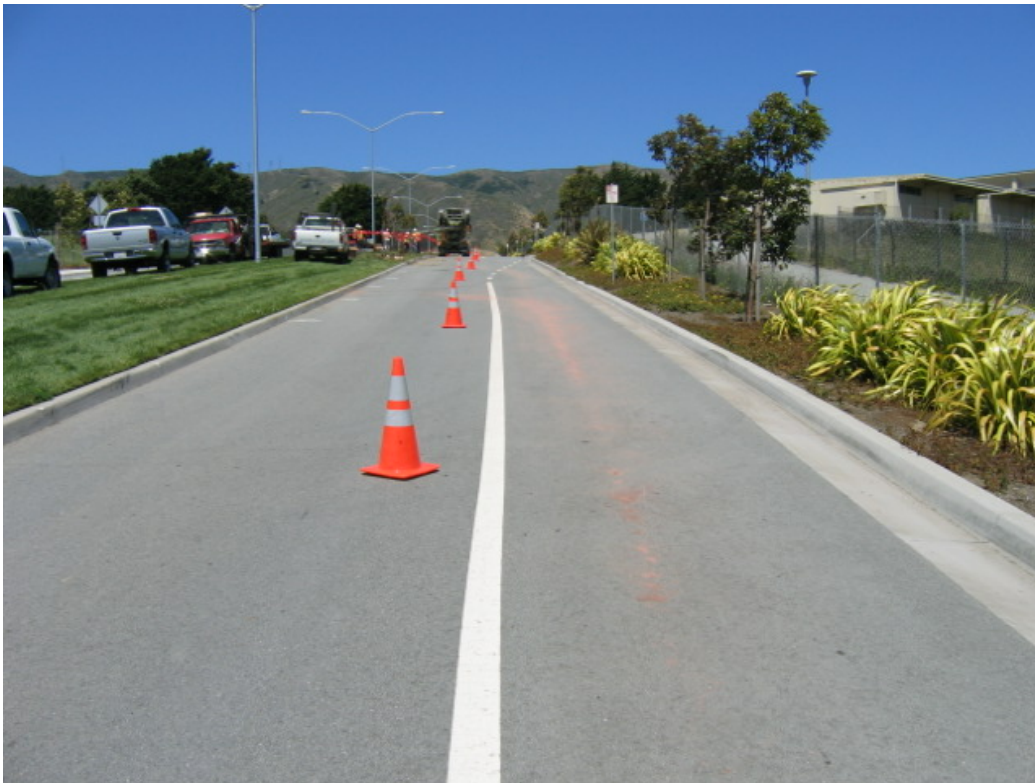
On June 22nd, a cement truck leaked red slurry onto Lawndale Drive for a distance of about 200-feet (see Figure 4). The slurry was removed from the street using shovels and brooms, but the street sweeper was still needed to finish cleaning the spill and was dispatched to the site.

Figure 4 – Red cement slurry spill along Lawndale Drive in the Town of Colma, Segment 4, June 23, 2005.

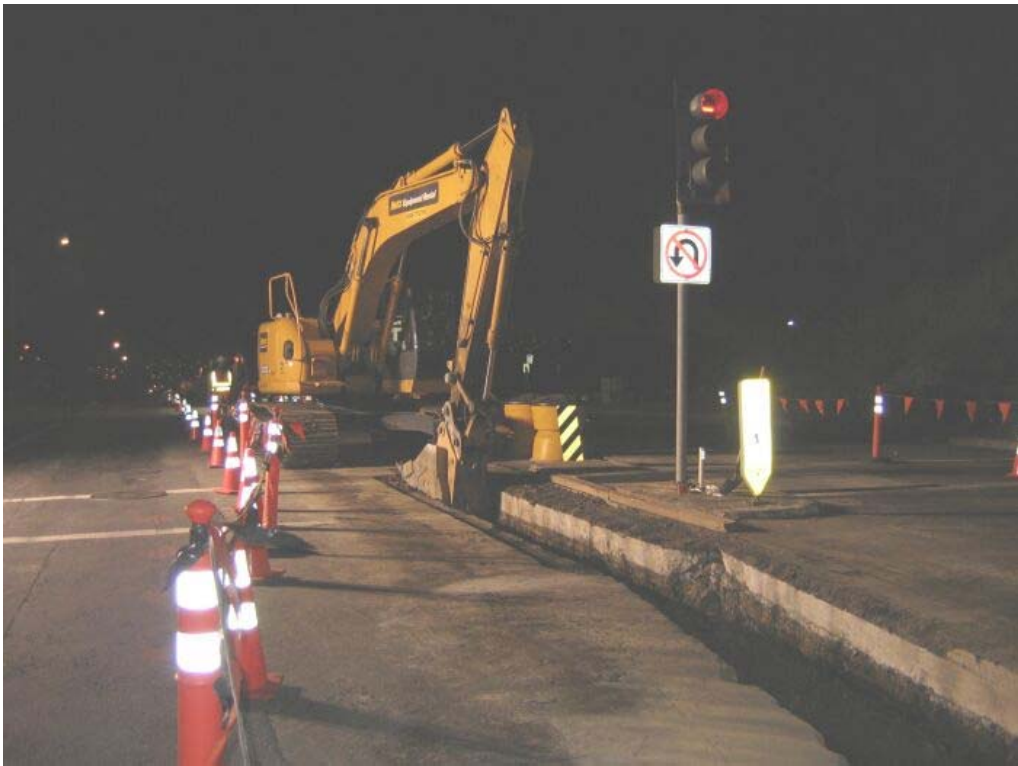
Figure 5 – Night work at the intersection of Bayshore Boulevard and Guadalupe Canyon Parkway in the City of Brisbane, Segment 5, June 22, 2005

2. During the night shift, crews worked at the intersection of Bayshore Boulevard and Guadalupe Canyon Parkway (see Figure 5). Trench was excavated, conduit installed and cement slurry poured over and around the conduit. Work at this intersection is only allowed at night by the City of Brisbane Encroachment Permit.
