**ISPEN** Environmental Group

PROJECT MEMORANDUM
SDG&E - MIGUEL-MISSION 230 KV #2 PROJECT
To: Jensen Uchida, CPUC
From: Vida Strong, Aspen Project Manager
Date: January 4, 2004
Subject: Weekly Report #22: December 26, 2004 – January 1, 2005
CPUC ENVIRONMENTAL MONITOR (EM): Christopher Meyer

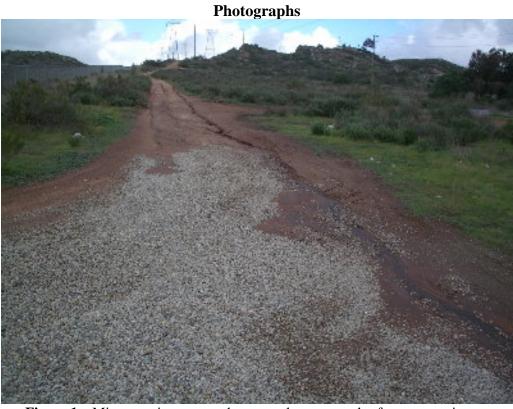
Access to many portions of the right-of-way was not possible due to the recent rains. Minor erosion continued on several access roads due to difficulties placing water bars or other BMPs (see Figure 1).

Figure 1 – Minor erosion occurred at several access roads after recent rains. No environmental impacts were noted.

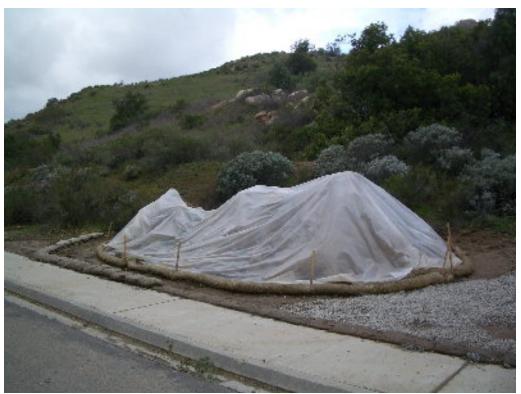
No environmental impacts were noted with the minor erosion observed during the site visit. The spoils piles observed were covered to prevent erosion (see Figure 2). Both sandbags and rock have been used to minimize sediment tracking and transport onto public rights-of-way (see Figure 3).

**Figure 2** – Spoil piles were covered to prevent erosion during the recent rains. The straw waddles installed are not sufficient to contain the material in the pile.

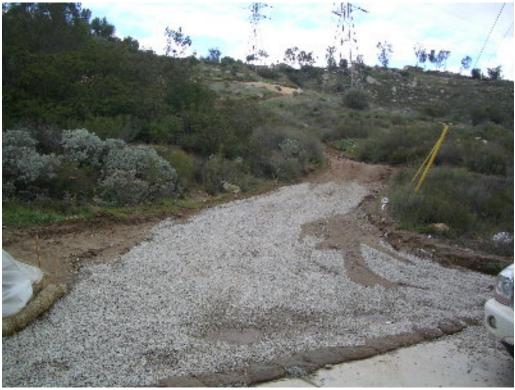
Figure 3 – Sandbags and rock were used to prevent sediment transport onto public roads.
