PROJECT MEMORANDUM

SDG&E – MIGUEL-MISSION 230 kV #2 PROJECT

Subject: Weekly Reports #34: March 20, 2004 – March 26, 2005

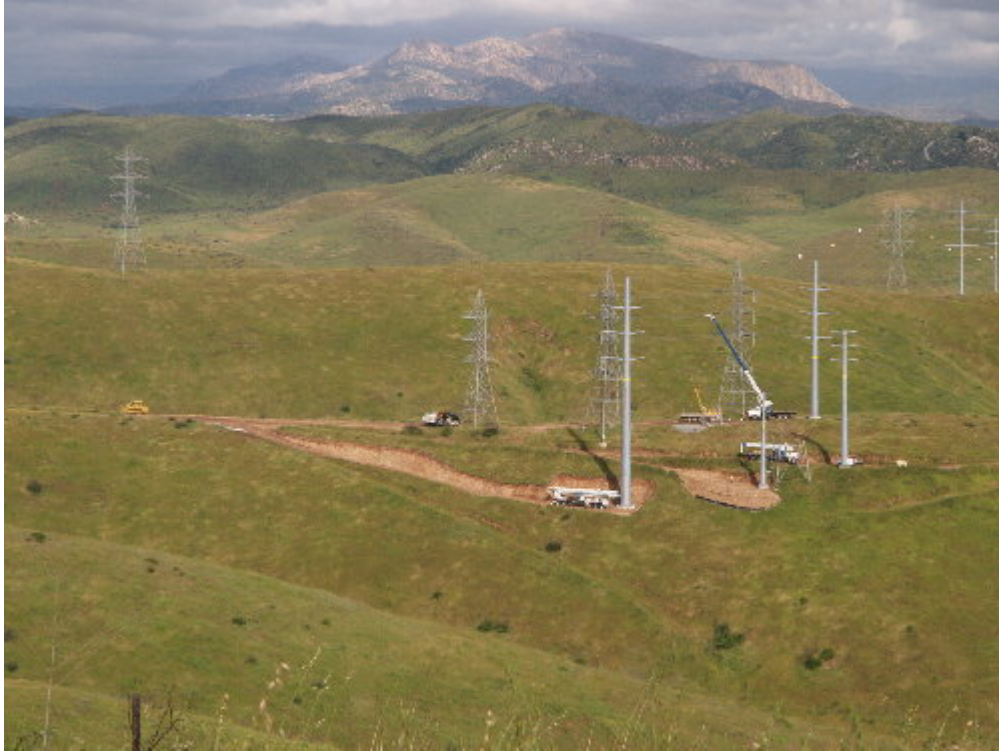
1. The SDG&E transmission line crew at Fanita Junction continued moving cable from the lattice tower to the steel pole (see Figure 1). All equipment and work activities were within the area previously disturbed by the 138 kV and 230 kV construction crews. The access road to the site was dry, but with several large ponded sections, during the site visit.

Figure 1 – An SDG&E transmission line crew worked at Fanita Junction moving lines.

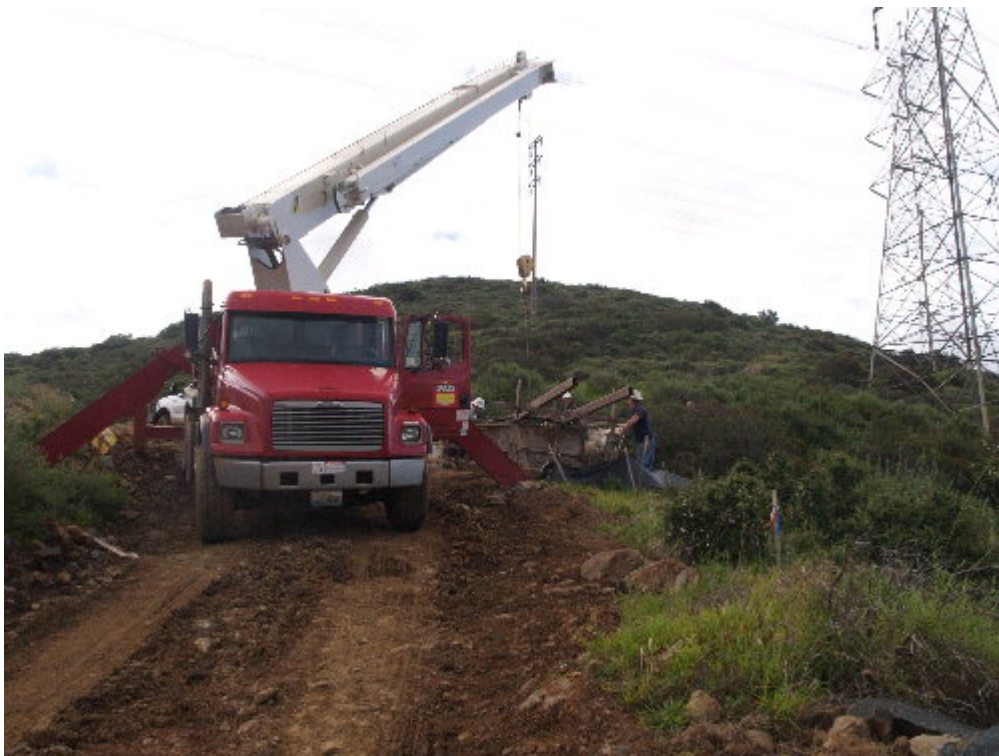
3. A PAR crew worked to set the rebar cage and anchor bolts at Pole Site 172 during the site visit (see Figure 2). The crew will prepare Pole Sites 172 and 181 for concrete so that 172, 181 and 191 can be poured at the same time. The extensive road work and rock placed on the access road to the sites has made travel possible for light vehicles after rains; however larger vehicles could still damage the road and prevent access.

Figure 2 – PAR worked at Pole Site 172 to set the rebar cage and anchor bolts in preparation for pouring concrete.

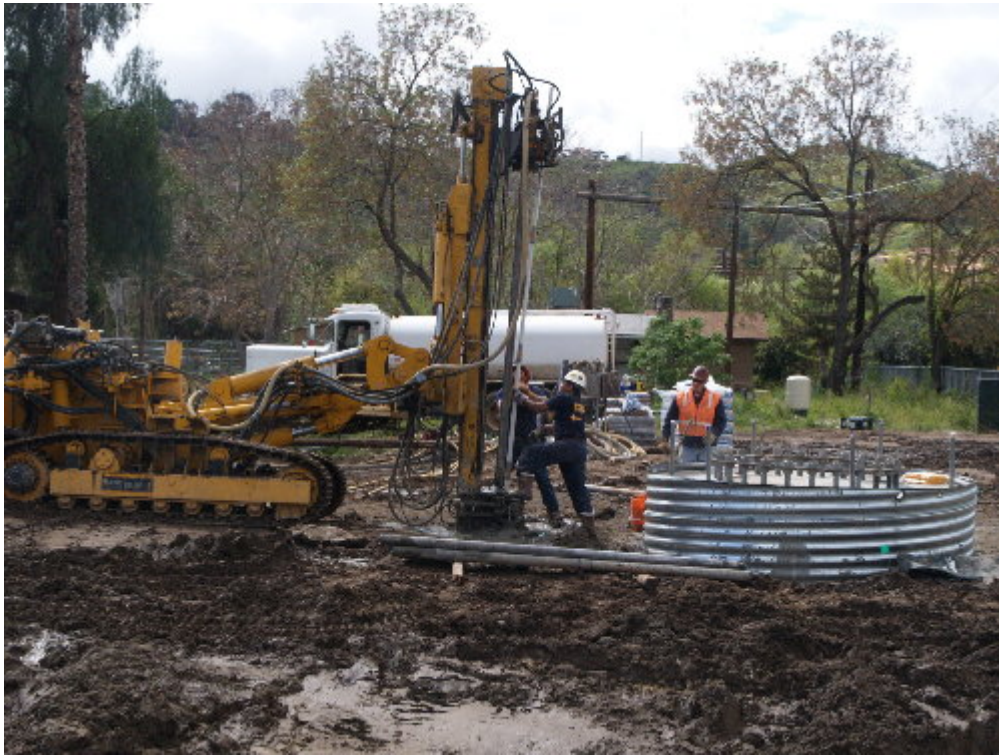
4. The drilling operation and foundation pouring was completed for the wet hole at Pole Site 1210 on March 22. The entire operation was designed to be completed in one day to prevent loss of the hole due to the high water table. The drilling machine completed the hole using a polymer to hold the sidewalls during drilling and during preparation for the concrete pour. The water with the polymer was collected by water trucks and is treated with bleach to deactivate the binding properties of the polymer and revert the mix back to water. The concrete pouring operation continued after 7:00 p.m. under Variance Request #8. The first two attempts at the site were not successful, one due to a failed test on the foundation and the second due to a collapsed hole prior to pouring any concrete. Crews worked at the site to drill holes for the pressure grouting during the site visit (see Figure 3). The wet spoils at the site were covered with plastic to prevent sediment travel in the event of predicted rains.

Figure 3 – The drilling and foundation pouring at Pole Site 1210 was completed on March 22 and crew prepared to pressure grout around the casing.

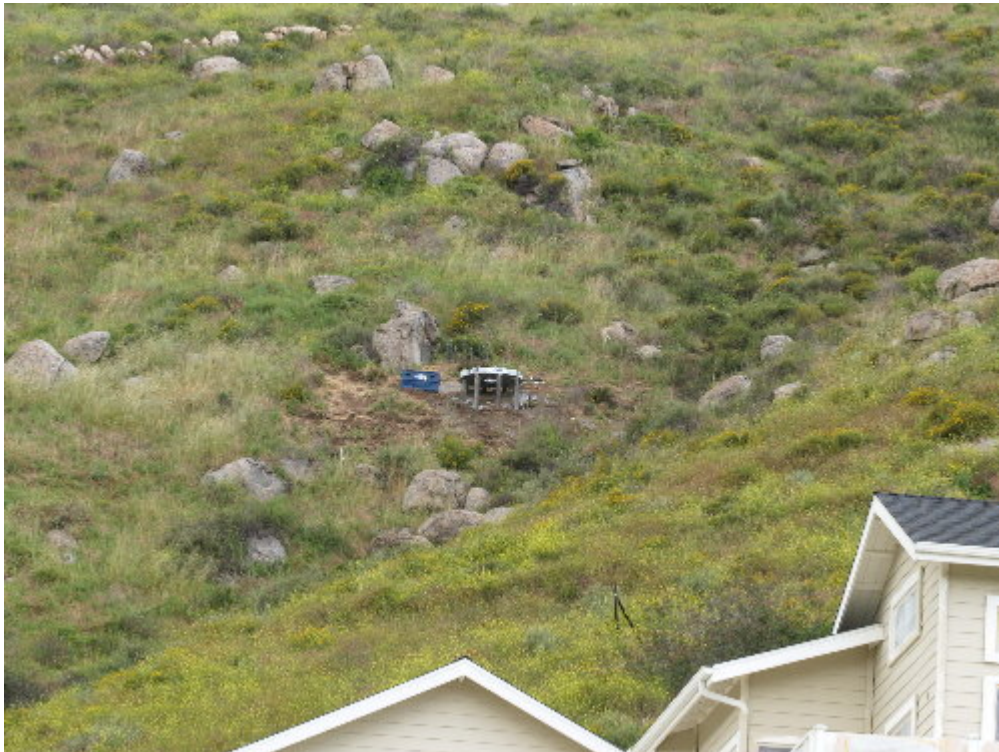
5. The micro-pile at Pole Site 493 was completed during the subject week (see Figure 4). The micro-pile foundations at site 493 and 522 will be ready for poles following testing of the foundations.

Figure 4 – The micro-pile crew work has been completed on the steep side-slope at Pole Site 493.

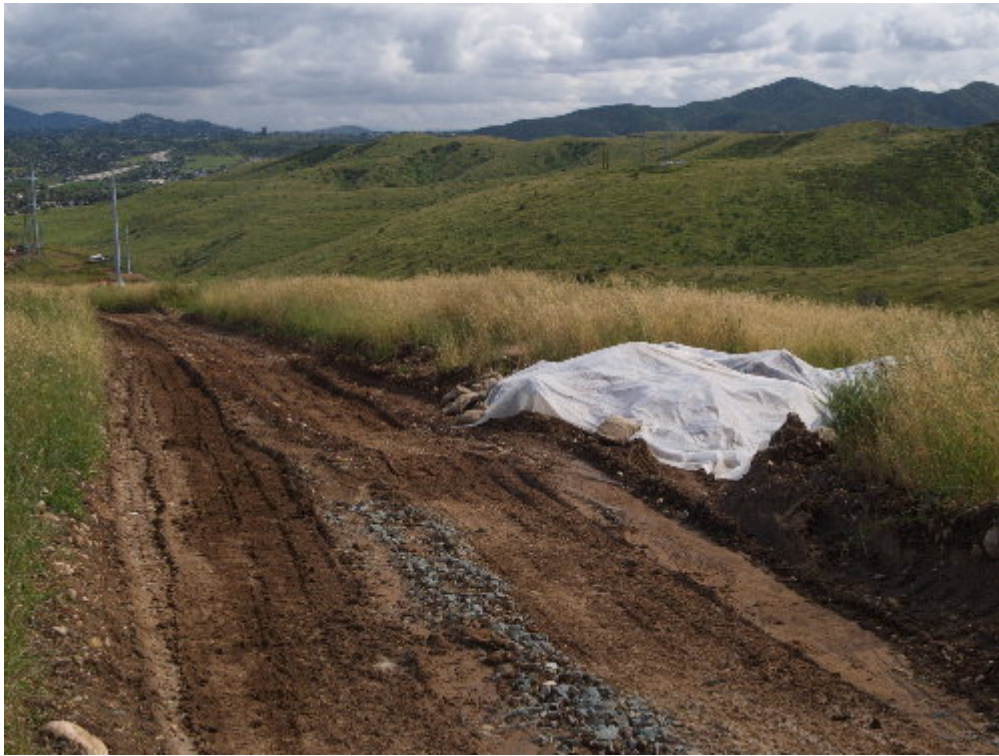
2. The road to Fanita Junction needed repair before work could continue. The access road was covered with mud and grading would just force the mud off the approved access road. The CPUC EM previously reminded SDG&E that the mud from the access road could not be pushed outside the footprint of the existing access road. However, as previously reported, some mud has been pushed from the road during recent grading activities and will have to be addressed prior to any rains. This mud is still on site, but has been covered with plastic to prevent sediment transport (see Figure 5).

Figure 5 – The wet material pushed off the right-of-way at Fanita Junction has been covered and will be removed shortly.

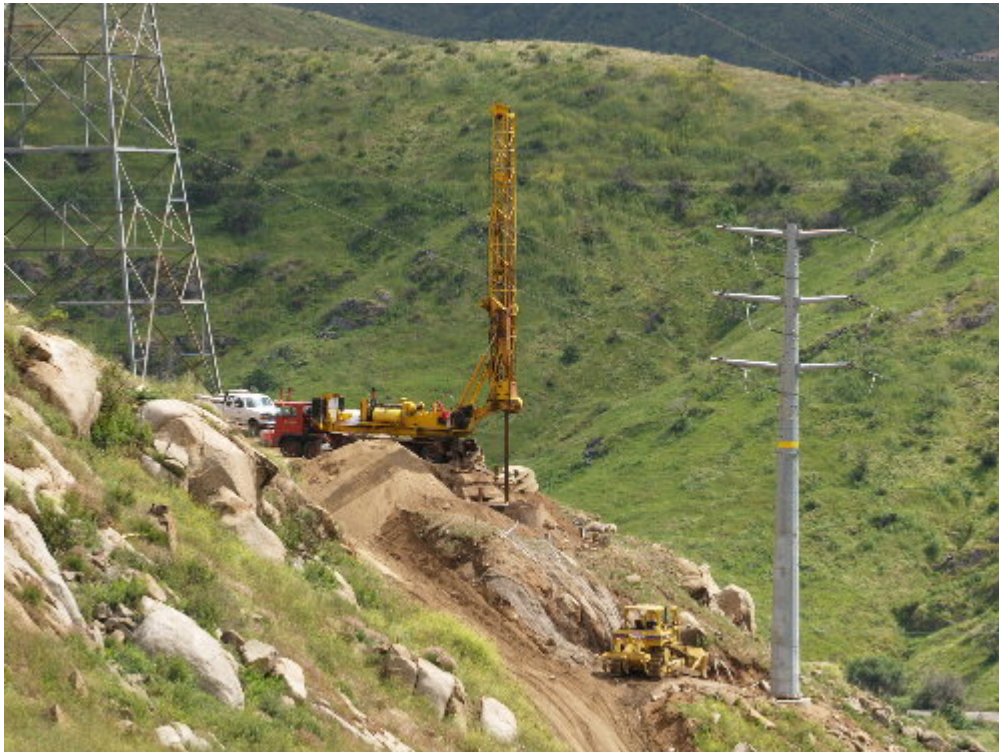
1. A crew from Tri-State Drilling worked on the foundation above El Monte Road at Pole Site Z201914 during the site visit (see Figure 6).
2. A Wilson crew working to clean up at Pole Site Z201915 took an excavator off the access road and impacted ruderal vegetation on the slope (see Figure 7). The steep access road does not provide easy maneuvering or passing.

Figure 6 – Tri-State Drilling worked at Pole Site Z201915 to excavate the 230 kV foundation.

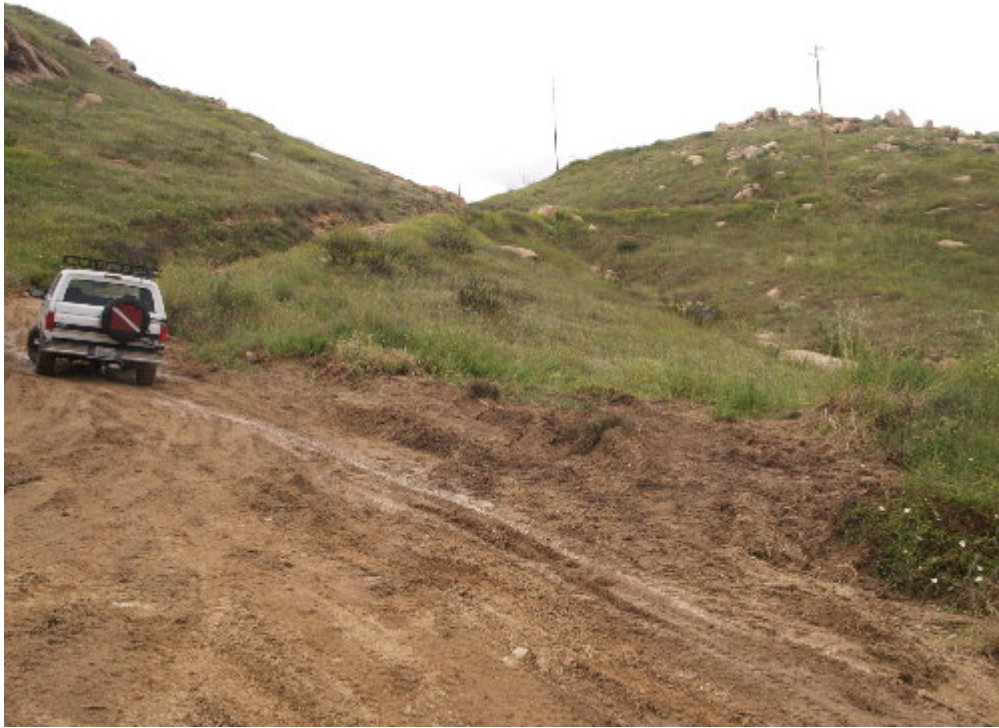
Figure 7 – An excavator traveled off the approved access road to Pole Site Z201914 and the area needs to be stabilized prior to any rains.

1. The impacts from the off right-of-way travel with the excavator on the access road to Pole Site Z201915 were minimal and the vegetation lost was ruderal. The nature of the slope may require some minor restoration and stabilization efforts, but reseeding should not be necessary.
2. Best Management Practices (BMPs) have been installed around the pad locations and crews have repaired the pads and the access roads that were not passable after the early season storms.
3. An Essex EI has been working closely with the Wilson crews to perform any necessary training and arrange for any required biological surveys.
