**PROJECT MEMORANDUM
SCE RIVERWAY SUBSTATION PROJECT**

To: Jensen Uchida, CPUC
From: Vida Strong, Aspen Project Manager
Date: April 22, 2008
Subject: Construction Status Report #4: March 9, 2008 –April 5, 2008

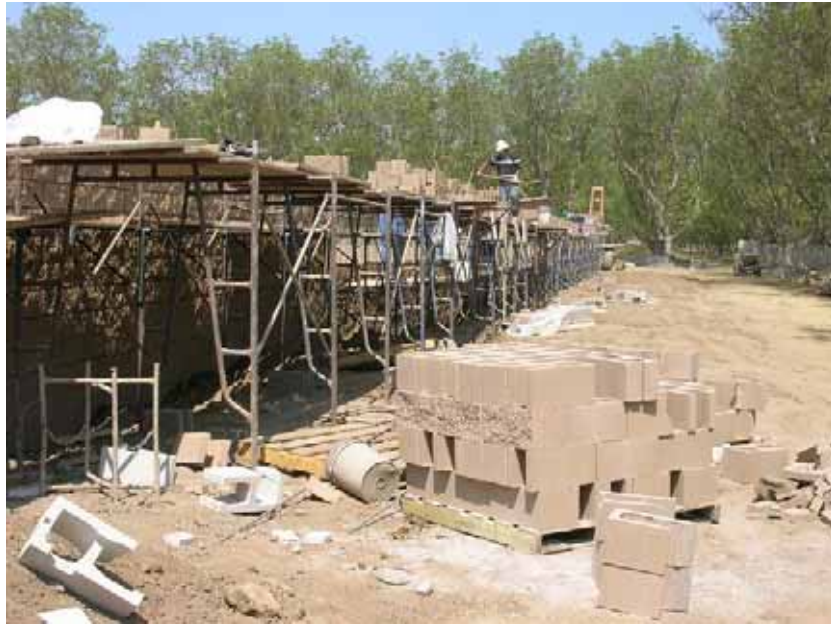
Figure 1: The substation perimeter wall construction was underway. The wall has been designed to match nearby new housing tract perimeter wall appearance. The photograph is of the east side of the wall, and faces northward.

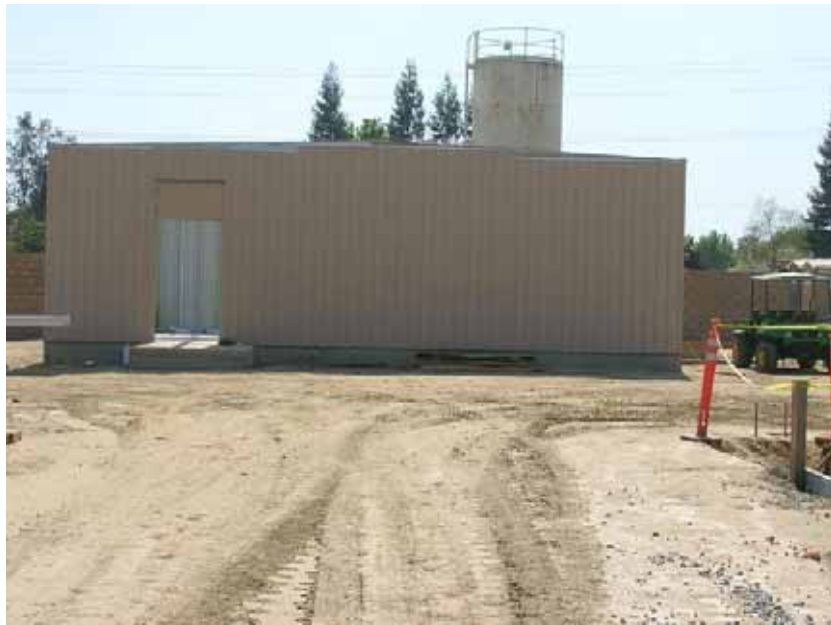
Figure 2: The Mechanical Electrical Equipment Room (MEER), which will be the only permanent building on site, was in place, and will be equipped during the electrical construction phase of the Project. The photograph faces southward.

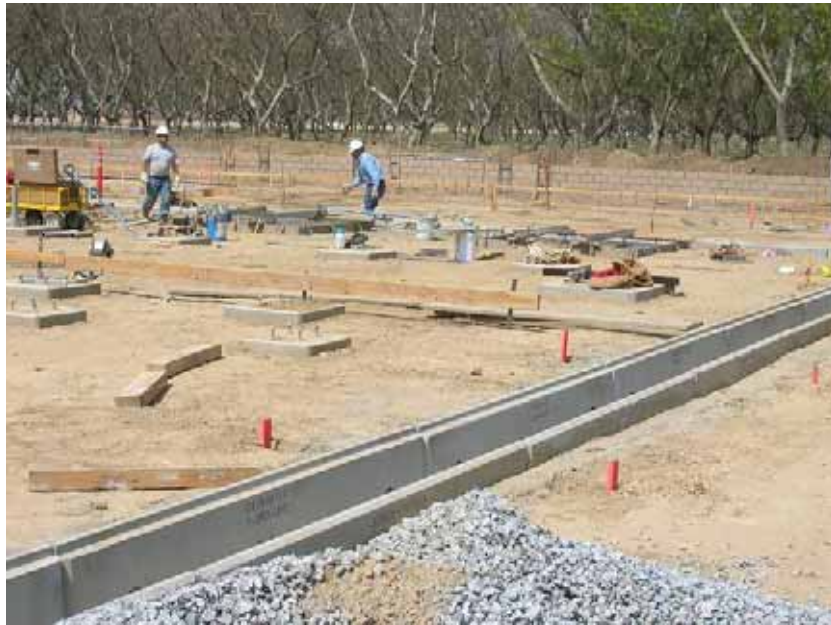
Figure 3: The construction of the underground power grid construction was underway. The photograph faces northwestward.

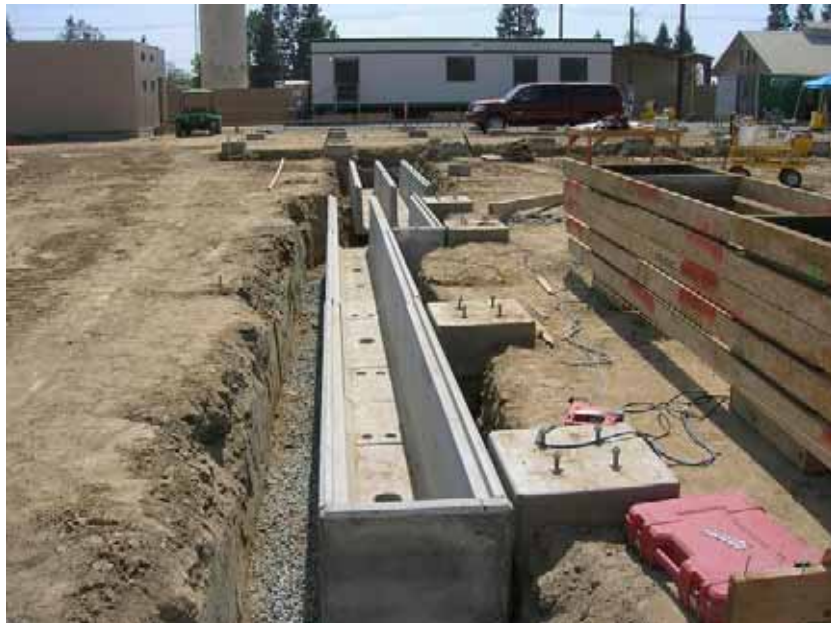
There were several trenches two feet and greater deep. These trenches were provided with wood ramps at the close of each work day in order to prevent trapping of wildlife (see Figure 4).

Figure 4: There were several trenches two feet and greater deep. These trenches were provided with wood ramps at the close of each work day in order to prevent trapping of wildlife. The temporary SCE construction trailer can be seen in the middle background. The MEER room is on the left. The building in the distant right corner is off site. The photograph faces southward.
