**PROJECT MEMORANDUM  
SCE RIVERWAY SUBSTATION PROJECT**

**To:** Jensen Uchida, CPUC  
**From:** Vida Strong, Aspen Project Manager  
**Date:** May 1, 2008  
**Subject:** Construction Status Report # 5: April 6, 2008–April 26, 2008

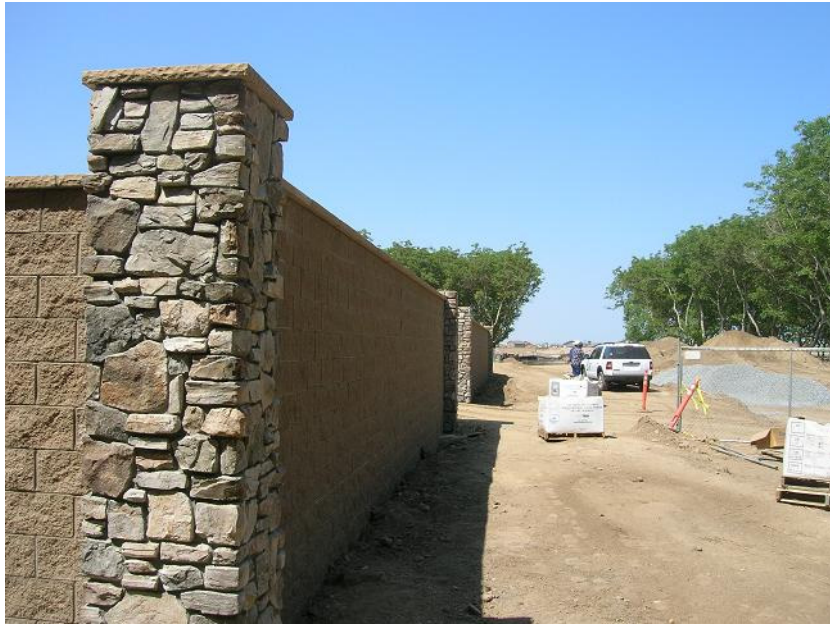
**Figure 1:** The perimeter wall was mostly completed. The design of the wall, including pillars and capstones, is intentionally similar to nearby housing tracts. The photograph faces westward along the route of the future permanent entrance road.

MCS Construction, Inc. began civil construction activities on March 7<sup>th</sup>, 2008. By April 21<sup>st</sup>, perimeter wall construction was mostly completed (see Figure 1). Work on the power grid, concrete footings, placement of concrete pads, and installation of conduit continued (see Figures 2 and 3). The Mechanical Electrical Equipment Room (MEER), which will be the only building on site, was in place. MCS is scheduled to complete the civil work within two or three more weeks.

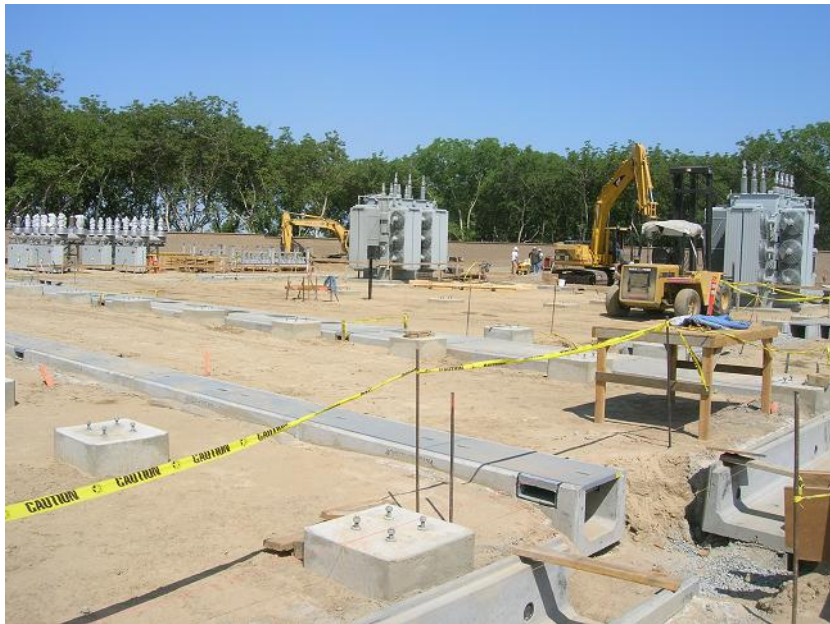
**Figure 2:** Civil work continued, including installation of concrete pads, concrete footings, and conduit. The photograph faces northwestward.

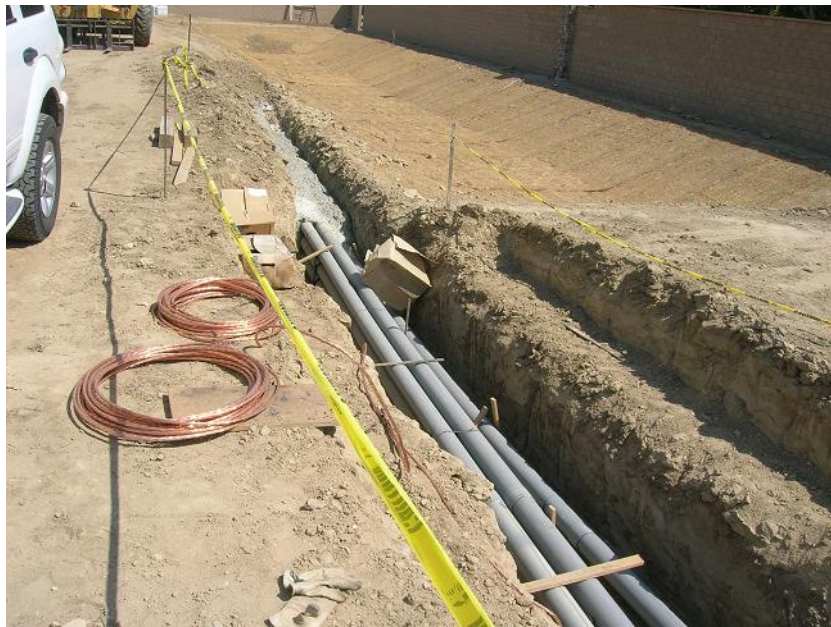
**Figure 3:** Conduit construction included trenching, placement of conduit, and grouting over the placed conduit.

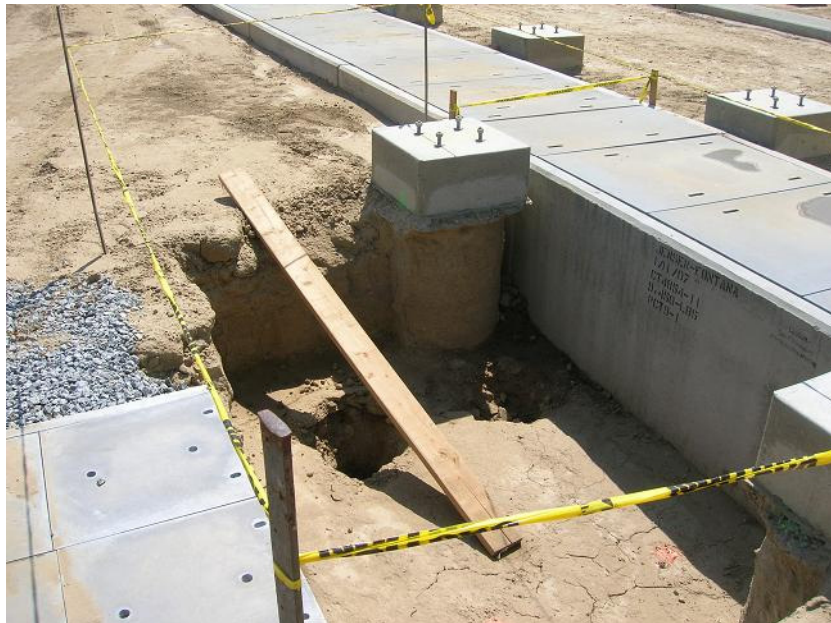
There were several trenches two feet and greater deep. These trenches continued to be provided with wood ramps at the close of each work day in order to prevent trapping of wildlife (see Figure 4).

**Figure 4:** Wildlife ramps continued to be placed in all trenches two or more feet deep.
