**PROJECT MEMORANDUM  
SCE SONGS PROJECT**

**To:** Jensen Uchida, Project Manager, CPUC  
**From:** Vida Strong, Aspen Project Manager  
**Date:** January 21, 2009  
**Subject:** Monitoring Report #1, January 7-10, 2009

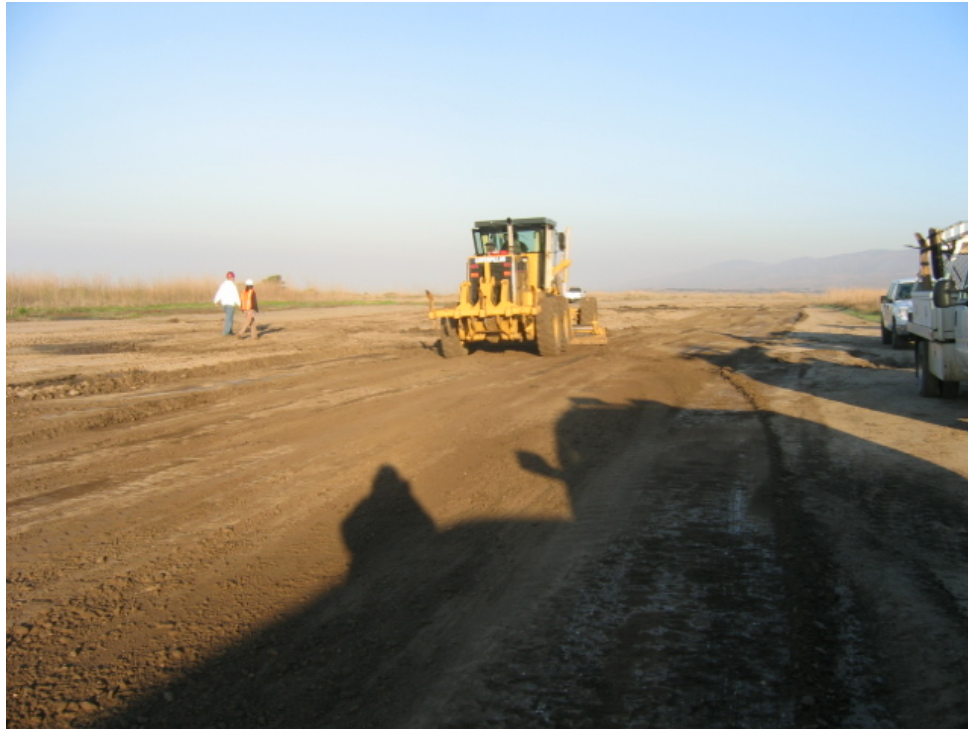
1. Road improvement and vegetation clearing took place along the transport route within Marine Corps Base Camp Pendleton (MCBCP) in anticipation of the RSG transport. SCE has contracted a local grading contractor to complete the route preparation. Some minor route improvements occurred in December; however, after rains in the area, much of the road work had to be retouched in early January (see Figures 1 and 2).

**Figure 1:** Transport route preparation within MCBCP. Minor grading was required to accommodate the RSGs along the transport route.

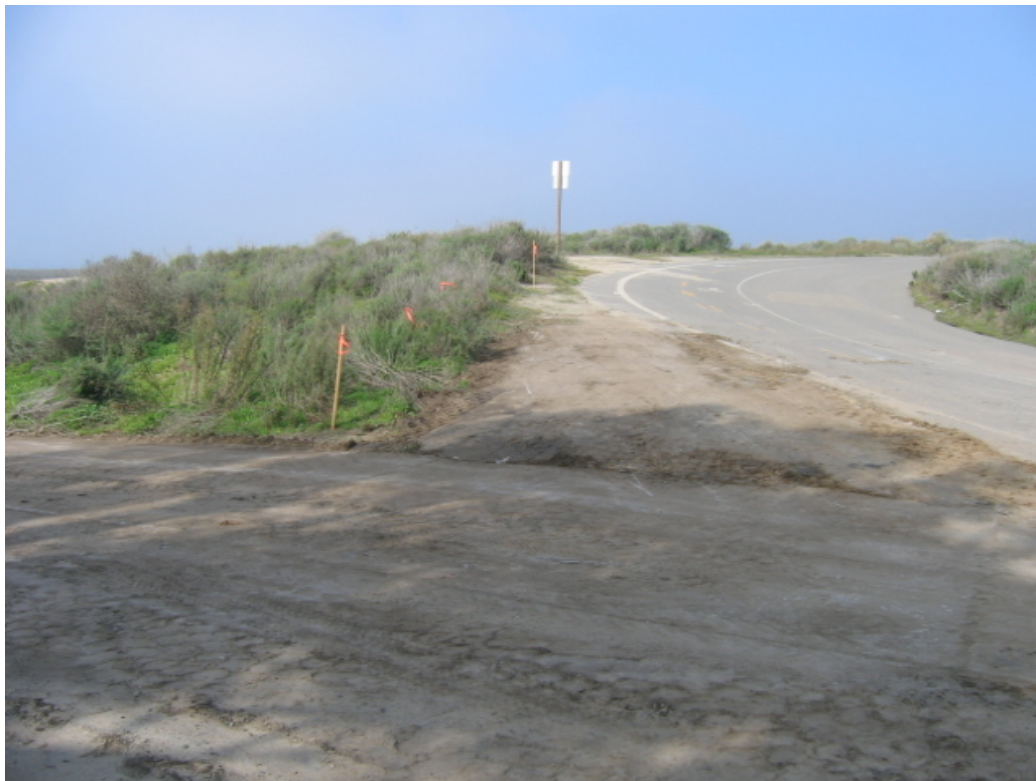
**Figure 2:** Minor vegetation removal occurred at the Y-Turn within MCBCP.

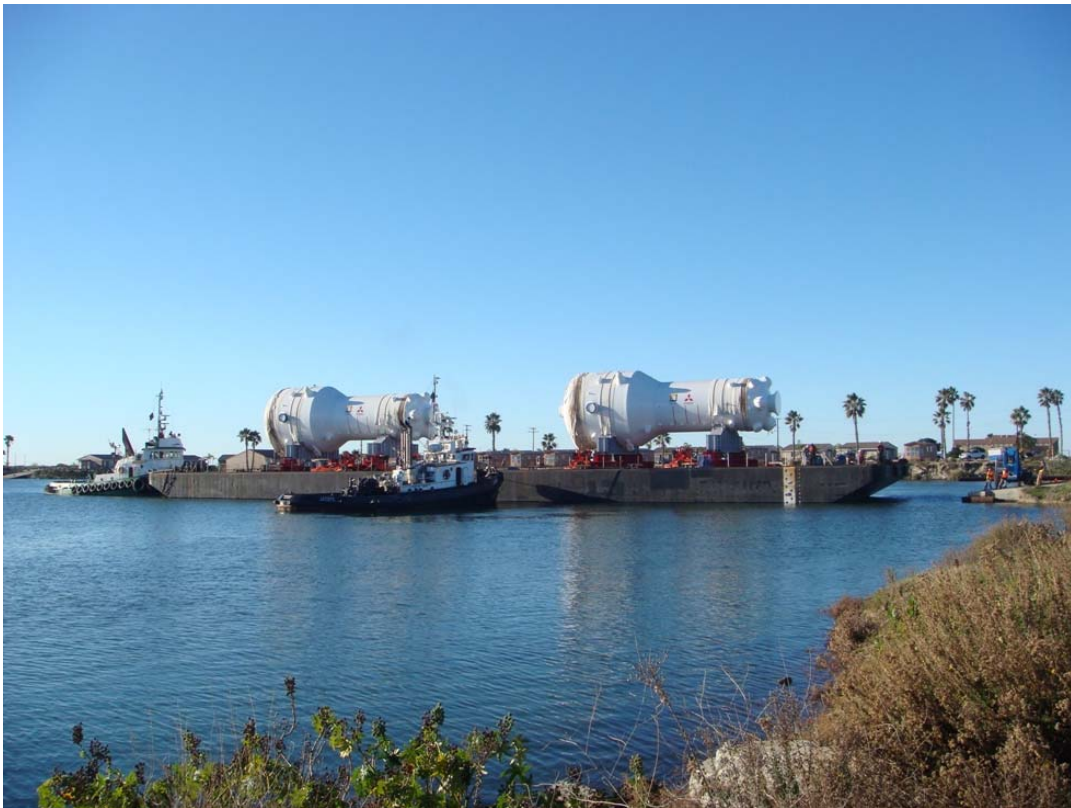
3. Two RSG's arrived from Japan in late December and were transferred to a barge for transport to the Del Mar Boat Basin on MCBCP. The barge was ready for transport to the Del Mar Boat Basin the afternoon of Friday, January 9<sup>th</sup>. A Marine Mammal training was conducted by Marine Biological Consultants (MBC) at the Port of Los Angeles prior to departure. At the training, the crews of the two tug boats used to bring the barge to the boat basin were trained on the protocol for marine mammal avoidance during transport. Also in attendance at the training were SCE project management personnel and the CPUC EM. The barge left the Port of Los Angeles at approximately 8:00 pm and was escorted to the Del Mar Boat Basin by the U.S. Coast Guard (see Figure 3).

**Figure 3:** RSG barge arrival at the Del Mar Boat Basin at MCBCP. The RSG offloading was conducted over four days.

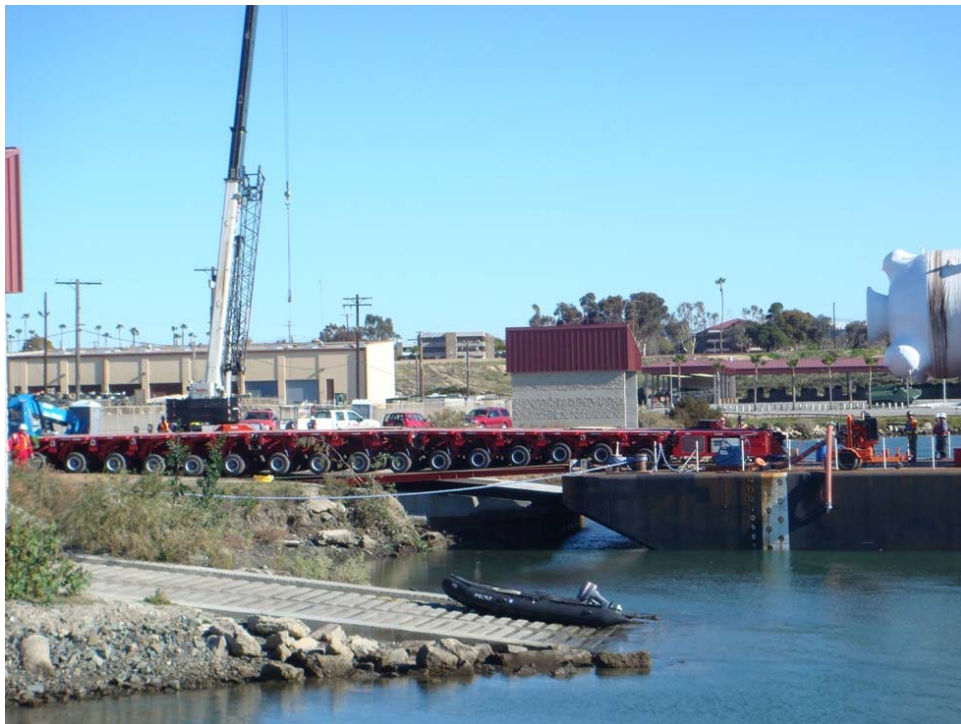
4. On Saturday, January 10<sup>th</sup>, the RSG's arrived at the Del Mar Boat Basin and the barge was put into position at the bulkhead during a rising tide. Once the barge was in position, the Goldhofer was driven onto the barge and into position under the first RSG (see Figure 4). Once the Goldhofer was in place, the barge was moved away from the bulkhead and staged in a deeper area of the harbor overnight for the low tide. The two RSG's were unloaded during high tides using the Goldhofer on Sunday and Tuesday. The two tug boats were used to place the barge into position at the bulkhead.

5. The first RSG was offloaded on Sunday during a high tide. During offloading, one half axle of the Goldhofer experienced a failure resulting in tire rupture and steering turntable damage. The Goldhofer was still able to transport the first RSG into position in the laydown yard and was unloaded onto cribbing. The axle was repaired and the second RSG was offloaded on Tuesday without incident.

**Figure 4:** Loading of the Goldhofer onto the barge. The Goldhofer is a series of trailers joined together. During offloading of the first RSG, the Goldhofer experienced axle damage, causing a delay in offloading the second RSG while repairs were made.
