**PROJECT MEMORANDUM
PG&E SEVENTH STANDARD SUBSTATION PROJECT**

To: Monisha Gangopadhyay, CEQA Project Manager, CPUC
From: Vida Strong, Aspen Project Manager
Date: October 12, 2010
Subject: Report #14: September 19, 2010 – October 9, 2010

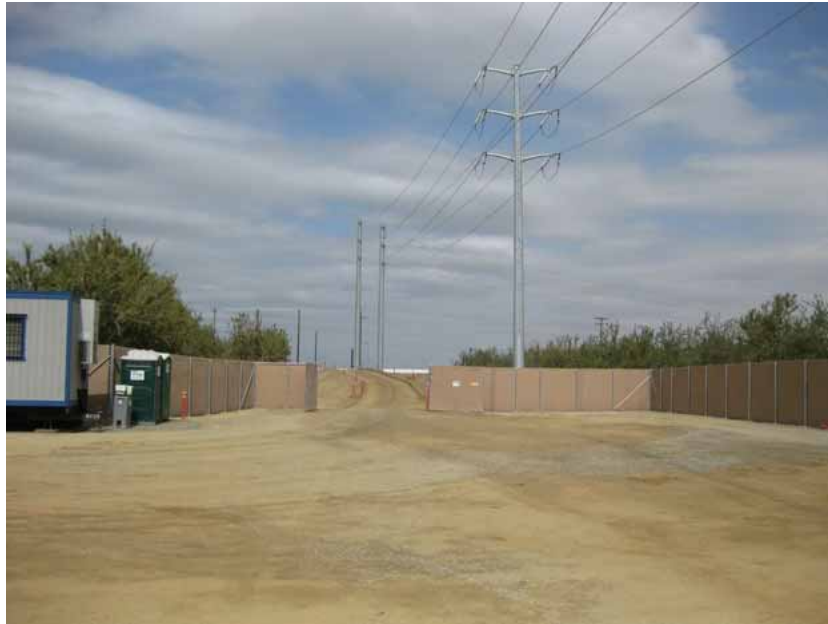
Figure 1: Final connections with outside lines, including the installation of the final two tubular steel poles (in the distance), were completed by PG&E crews during the subject period. Also, the fencing was constructed across the entrance to the substation. The photograph was taken in the eastern portion of the substation site, and faces northward toward the access road.

Final connections with outside lines, including the installation of the final two tubular steel poles (see Figures 1 and 2), were completed by PG&E crews during the subject period. TTR will return once the City of Bakersfield Seventh Standard Road work is completed to bring the site to grade, and apply gravel and pavement.

Work on the perimeter chain link fencing and the access gate in the concrete wall was completed during the subject period (see Figures 1 and 3). The eight-foot high chain link fencing has been installed on both sides of the access road and along the south, north and east boundaries of the substation. A concrete paneled wall was placed along the perimeter of the west edge of the substation site in anticipation of future home development in that area. An access gate was placed in the middle of the wall.

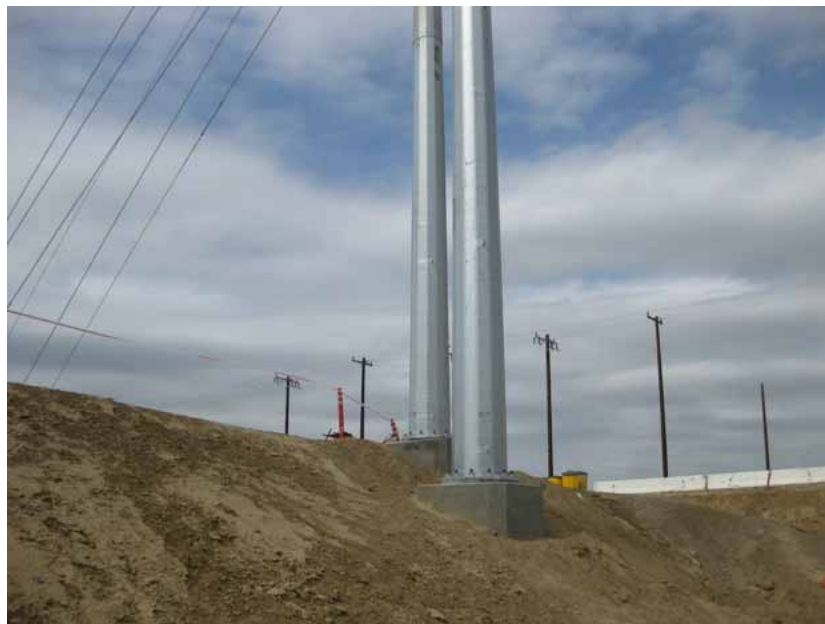
Figure 2: The final two tubular steel towers were installed and conductor was strung. They are adjacent to highway construction on Seventh Standard Road.

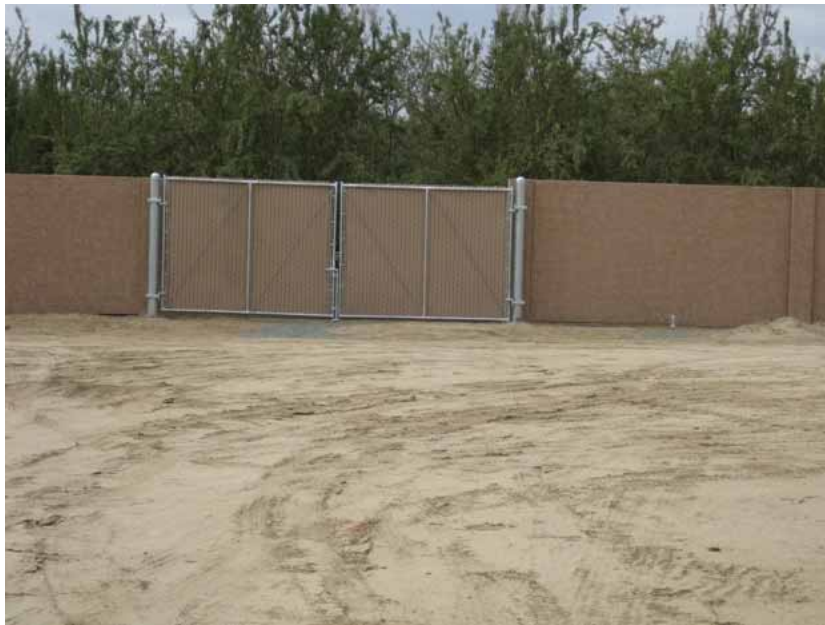
Figure 3: The access gate in the concrete wall along the perimeter of the west edge of the substation site was installed during the subject period. The photograph faces westward.

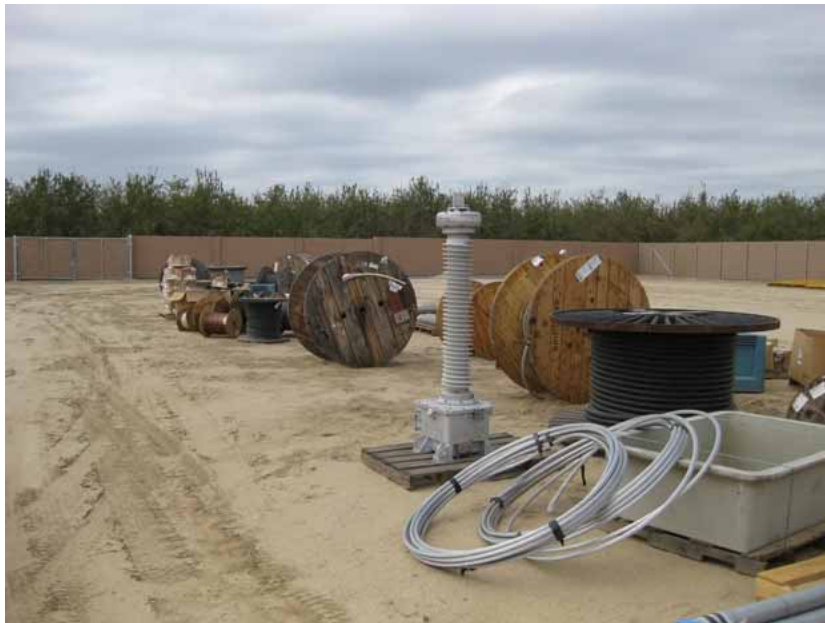
Figure 4: Materials being stored in the western portion of the site will be removed shortly. This area will be temporarily fenced off to vehicular travel to reduce dust problems. The photograph faces northwestward.

ment parking, and for materials storage. Much of the remaining stored material will be removed shortly (see Figure 4). During the subject period, the PG&E line crews working on the installation of the final two tubular steel poles and on the stringing of conductor into the substation used this area for staging (see Figure 5). This section may be used for future substation expansion.

The civil contractor (TTR) provided watering for dust control as needed during the subject period. Shortly, the western portion of the site will be cleared of stored material (see Figure 4). It then will be temporarily fenced off to exclude vehicular traffic until final grading occurs. This exclusion of traffic will preserve the dirt surface crust, thus reducing the need for dust control.

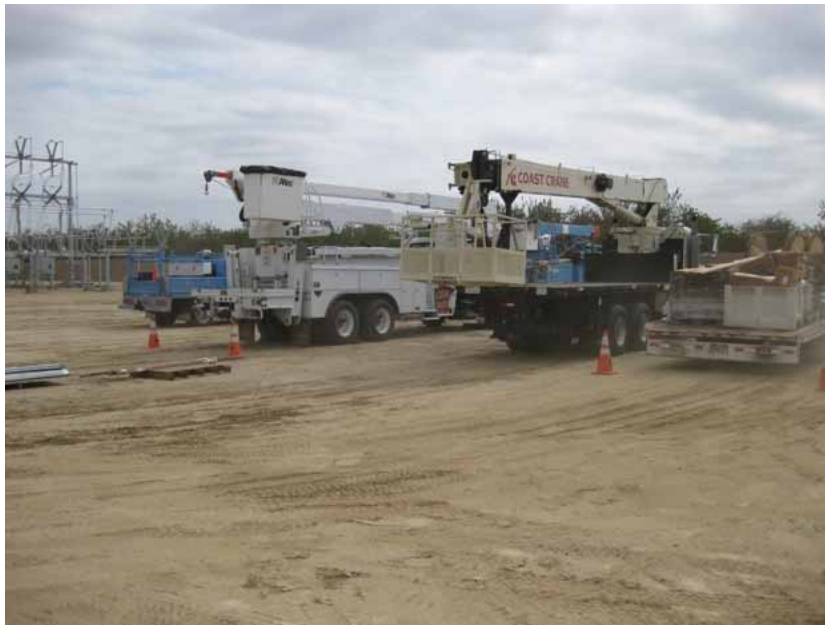
Figure 5: During the subject period, the PG&E line crews working on the installation of the final two tubular steel poles and on the stringing of conductor into the substation used the western portion of the substation site for staging. The photograph faces southeastward.
