**Siskiyou Telephone Company's  
Happy Camp to Somes Bar  
Fiber Connectivity Project**  
(Commission Resolution T-17539)

**FINAL  
MONITORING REPORT**

Prepared for  
**California Public Utilities Commission**

**January 2020**

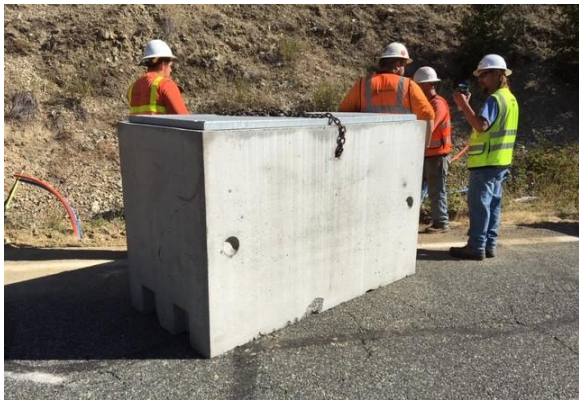
Figure 2. Crew installing tie-in box at MP 24.08 (July 10, 2019)

- **Tie-In Utility Boxes.** Forty concrete hand hole utility boxes were installed as access points for subscriber drop, splice points, and grounding locations (see Figure 2). Boxes were placed at 2,500-foot minimum spacing to provide rural utilities service grounding. Additional boxes were also placed as needed along the route to provide access points for each residential subscriber, or fiber optic line splices.

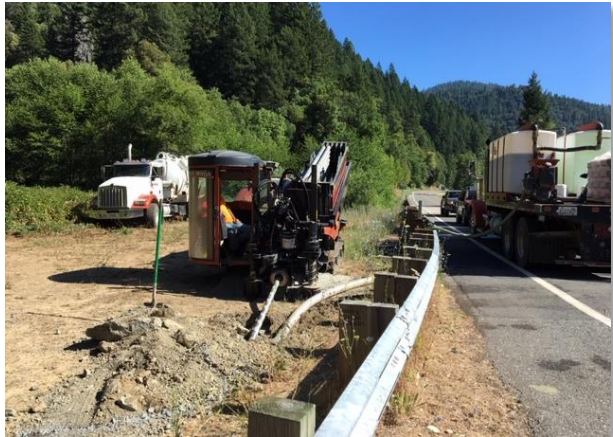
Figure 3. Crew boring south of Swillup Creek at MP 23.25 (July 24, 2019)

The majority of the fiber optic conduit placement was completed using HDDs. Bore holes were drilled with the HDD drill bits, the drill bit would surface, and the conduit was then attached to the drill bit so it could be pulled back through the bore hole. In some areas, boring was not feasible, and trenches were dug to allow for conduit placement (Figure 4).

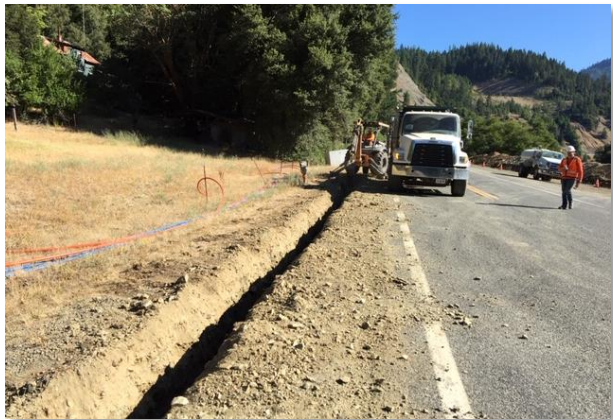
Figure 4. Crew trenching in conduit at MP 28.5 (July 24, 2019)

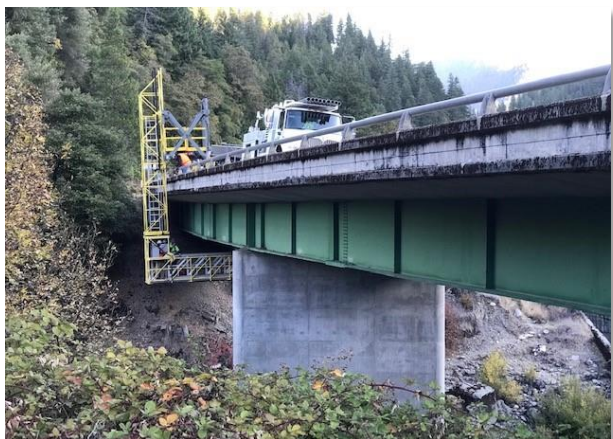
Figure 5. Bridge handling operations at Clear Creek Bridge (October 9, 2019)

Highway 96 crosses two bridges within the Project area: Clear Creek Bridge and Klamath River Bridge. Conduit was hung underneath these bridges using a bridge-hanging truck (Figure 5) to provide worker access to the underside of the bridge. All bridge hanging was completed the week of October 6th.

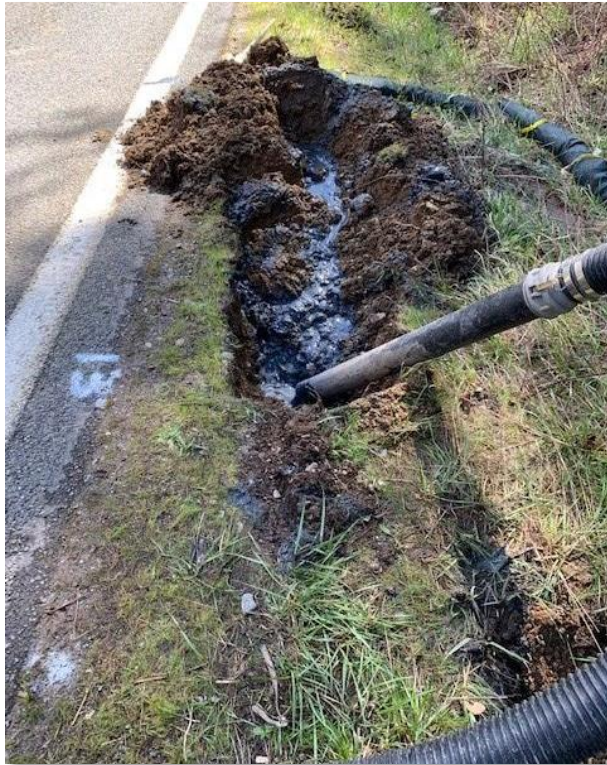
Approximate Location	Date of Frac-Out	Status
MP 31.79	March 26, 2019	HDD activities under roadway approximately 15 ft. from a wetland caused a frac-out into the wetland with some flowing water. Drilling ceased and immediate cleanup occurred. Drill slurry extended approximately 40 ft. downstream before it was contained. Cleanup was completed in two hours.
MP 31.51	March 28, 2019	Drill slurry observed coming out of a culvert outfall. HDD activities ceased, a pit was excavated, and the slurry was vacuumed up. Slurry dissipated at the outfall and clear water was observed.
MP 31.00	June 25, 2019	Drill slurry observed in unnamed drainage. HDD activities ceased and immediate cleanup occurred.
Kennedy Creek	September 30, 2019	Cloudy water observed in pool within the channel of Kennedy Creek. HDD activities ceased upon identification and a worker was lowered down the hill embankment to assess the conditions. The location of the frac-out could not be identified. No visible plumes were observed at or near the confluence of Kennedy Creek and the Klamath River.

Figure 6. Frac-out at MP 31.51 into a culvert outfall (March 28, 2019)

The construction crews responded quickly to frac-outs of bentonite slurry to avoid impacting resources. Frac-outs were monitored by the Siskiyou Telephone’s Environmental Inspector (EI). A frac-out on March 28th, into a culvert outfall (Figure 6), spurred the EI to instruct HDD operators to drill deeper than 15 feet to prevent future frac-outs. Frac-outs were contained with sandbags and a vac-truck. Cleanup consisted of using a backhoe (Figure 7) to dig a pit at the site of the frac-out and a vac-truck to vacuum up the bentonite fluid (Figure 8).

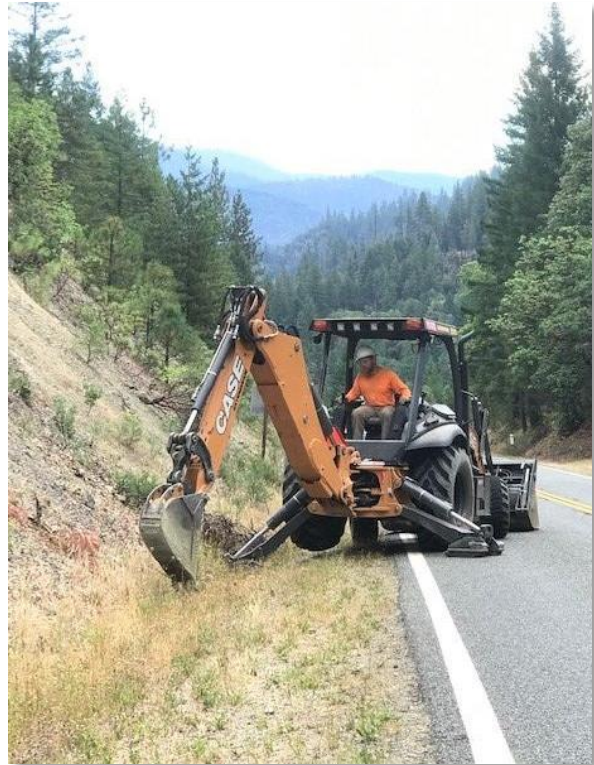
Figure 7. Crew excavating a pit to clean up a frac-out at MP 29.8 (August 28, 2019)

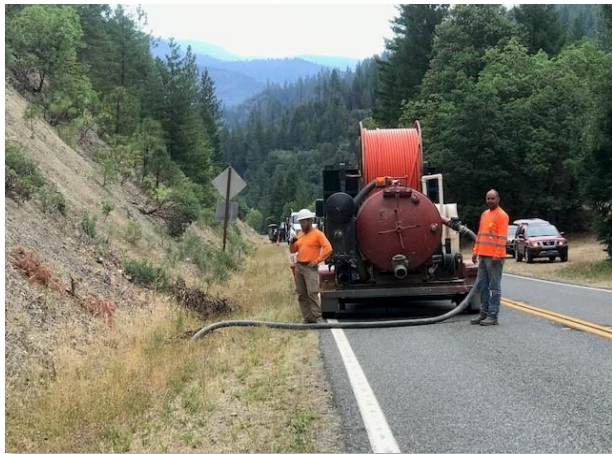
Figure 8. Vac truck placed in position to clean up frac-out at MP 29.8 (August 28, 2019)

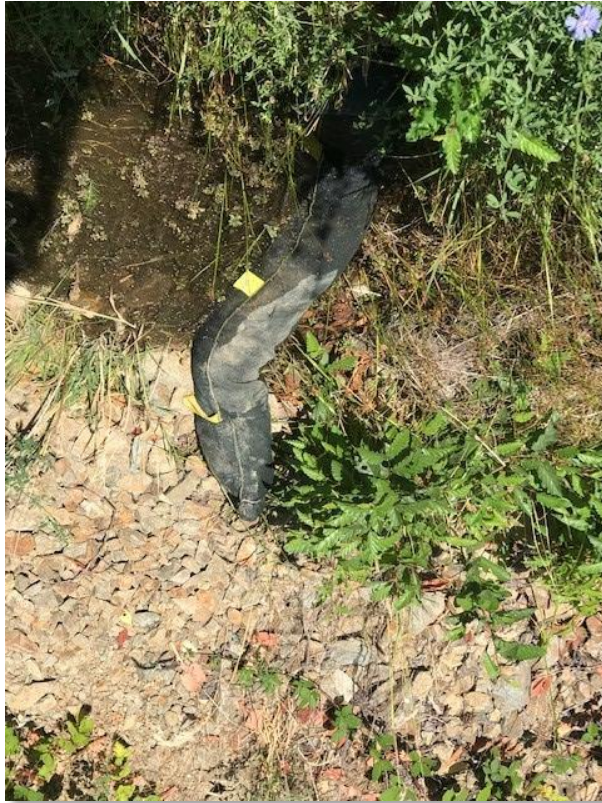
Figure 9. Fiber roll in place for sediment control in drainage at MP 28.75 (July 24, 2019)

**Adherence to SWPPP (APM HAZ-2/APM HYDRO-1/APM HYDRO-2).** BMP installation occurred throughout Project construction (Figure 9) prior to work at any site, and BMPs were maintained for the duration of construction. Absorbent pads were placed underneath staged equipment (Figure 10). Any contaminated soils from leaks/spills/frac-outs were removed from the Project site.

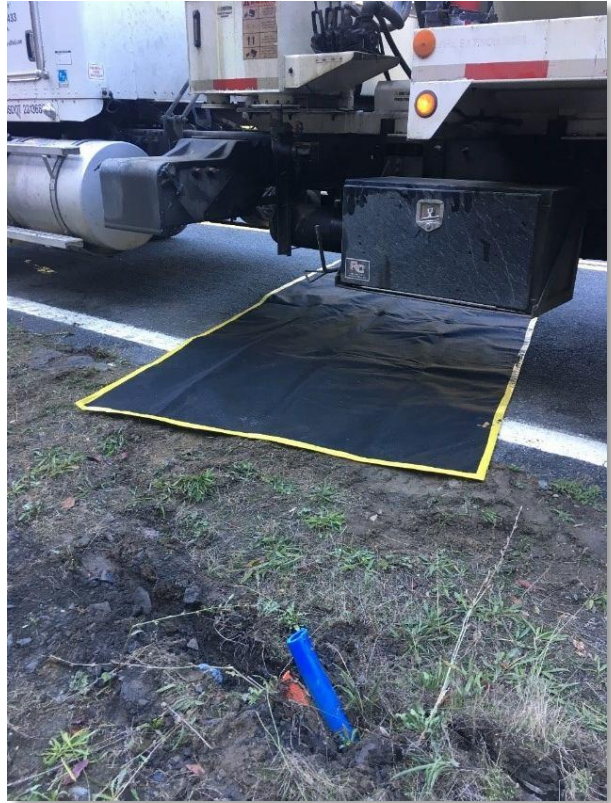
Figure 10. Absorbent placed under equipment to contain spills (September 25, 2019)

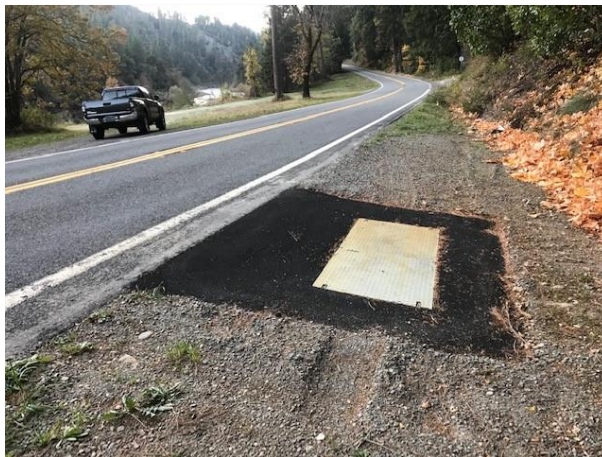
The CPUC EM conducted a final inspection of the Happy Camp to Somes Bar Project sites on October 31, 2019. The CPUC EM observed that the sites were neat and clean with minimal disturbance (Figures 11 and 12). At that time, remaining work included tie-in connections to residential users, fiber optic cable blow-in, and paving underground tie-in boxes in Phases 2 and 3.

Figure 11. Clean drill and tie-in location in Phase 1 (October 31, 2019)

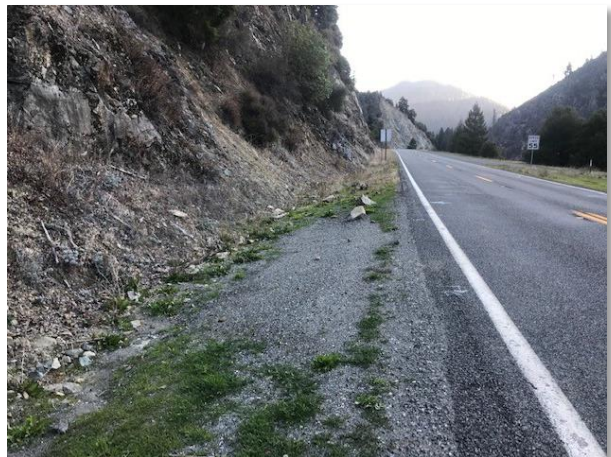
Figure 12. Clean drill and tie-in location with minimal disturbance in Phase 1 (October 31, 2019)
