## PROJECT MEMORANDUM

### SISKIYOU TELEPHONE CO. HAPPY CAMP TO SOMES BAR FIBER CONNECTIVITY PROJECT

**To:** Connie Chen, Project Manager, CPUC  
**From:** Vida Strong, Aspen Project Manager  
**Date:** April 15, 2019  
**Subject:** Monitoring Report #1 – March 11, 2019 to April 7, 2019

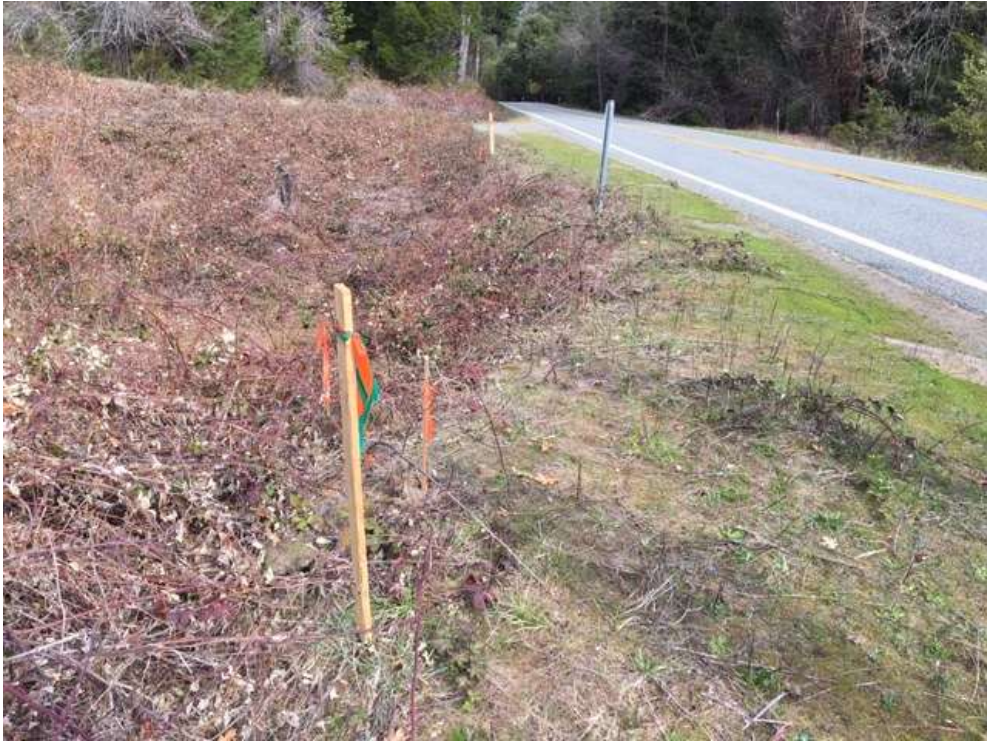
The CPUC Environmental Monitor (EM) conducted a site visit on March 19th and reviewed all of the wetland and environmentally sensitive area staking/flagging along Phase I of the Project (see Figure 1). The CPUC EM monitored a crew that was drilling from MP 32.24 south to MP 32.21, and another crew that was pulling conduit south from MP 32.21 to MP 32.18 (see Figures 2 and 3). Each drill crew had the required spill containment materials and a vac-truck (see Figure 3). Traffic controls and a pilot vehicle were set up at each drill site along Highway 96. Historic nests were observed at MP 31.7, MP 29.9, MP 29.16, and MP 28.1. No birds were observed on the nests; however, an osprey (*Pandion haliaetus*) was near the nest at MP 28.1. Other special-status birds observed included two bald eagles (*Haliaeetus leucocephalus*) and a golden eagle (*Aquila chrysaetos*).

Figure 1 – Wetland staking/flagging installed along Hwy 96 – view north, March 19, 2019.

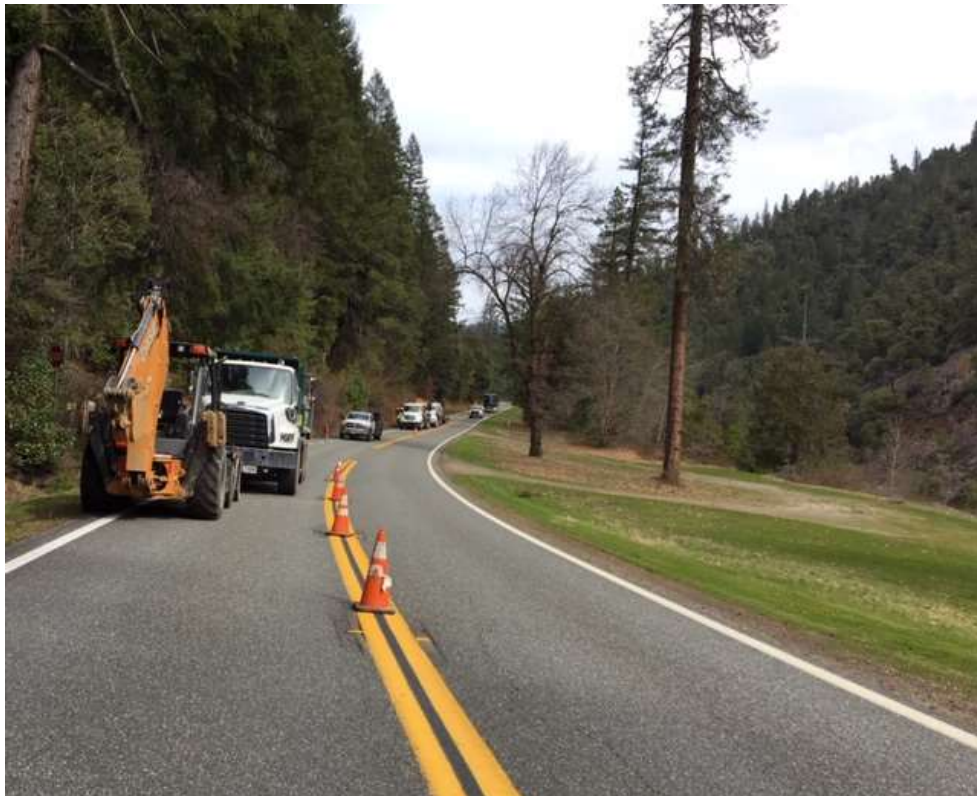
Figure 2 – HDD operations set-up on Hwy 96 – view north, March 19, 2019.

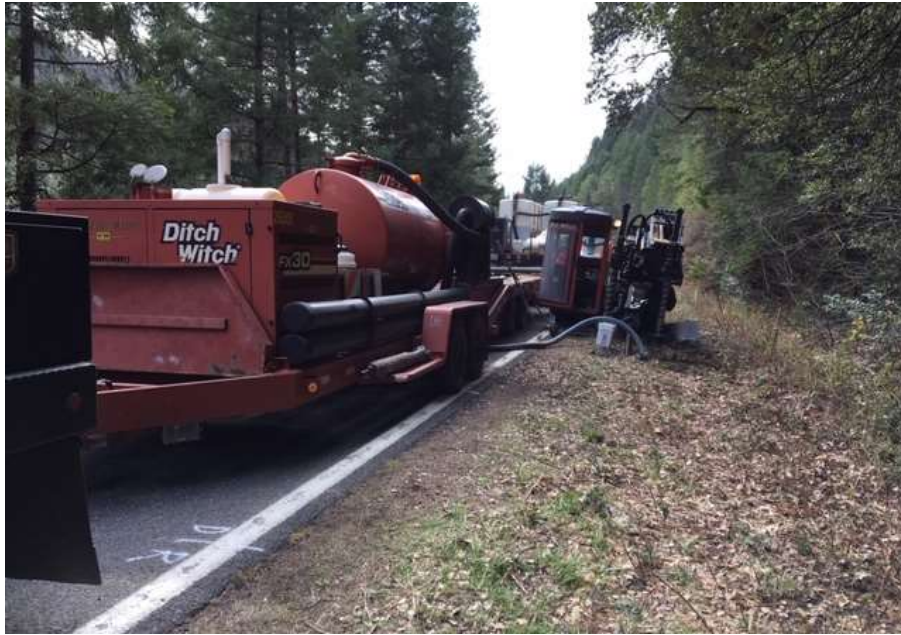
Figure 3 – HDD pulling cable – view south, March 19, 2019.

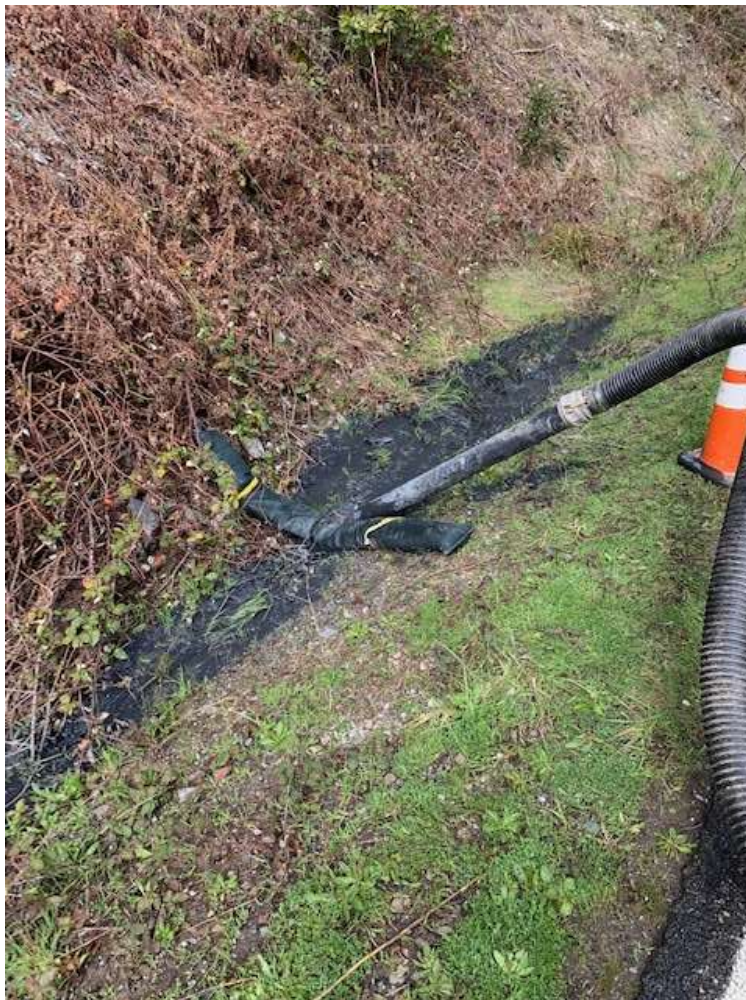
On March 26th, the CPUC EM was informed that there was a frac-out at MP 31.79 that spilled some drilling slurry into a portion of a wetland (see Figure 4). The drill was going under and along the roadway approximately 15 feet from the wetland where the frac-out occurred. The wetland feature had some flowing water from the recent rain and the drill slurry extended approximately 40 feet downstream before it was contained using sandbags and a vac-truck. The frac-out occurred at approximately 11:15 am and was cleaned up by 1:00 pm. The Siskiyou Telephone EI stayed on site to ensure the clean-up started as quickly as possible and monitored the progress.

Figure 4 – Frac-out at MP 31.79 – view northwest, March 26, 2019. Photo courtesy of Siskiyou Telephone.

2. On March 26th and 28th, frac-outs occurred during HDD operations and were contained and cleaned-up according to the Siskiyou Frac-out Plan and Spill Prevention and Response Program. The CPUC EM inspected the frac-out area that occurred on March 28th and noted that the area had been cleaned-up and recontoured. Siskiyou Telephone informed CDFW of the frac-out on March 29th.

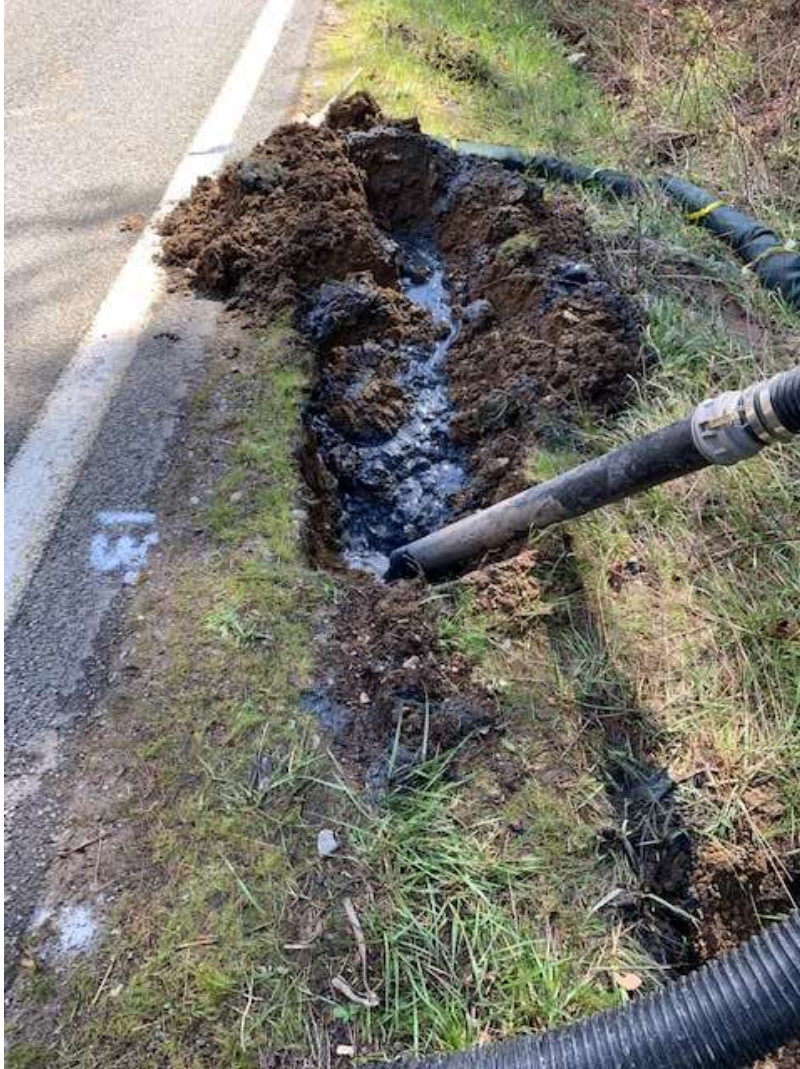
On March 28th, the CPUC EM was informed that there was a frac-out at MP 31.51 and bentonite slurry was observed coming out of a culvert outfall into some blackberry bushes. Drilling stopped, a pit was excavated, and the slurry vacuumed up (see Figure 5). Slurry dissipated at the outfall and clear water was observed. No wetlands or sensitive habitat was impacted. The Siskiyou Telephone EI monitored the clean-up and various points downstream to the river and saw slurry only within 30 feet of the outfall. From there to the river was approximately 100 feet and was clear. HDD operators were instructed to drill deeper than 15 feet from now on to prevent any more frac-outs.

Figure 5 – Frac-out at MP 31.51 – view south, March 28, 2019.  
Photo courtesy of Siskiyou Telephone.

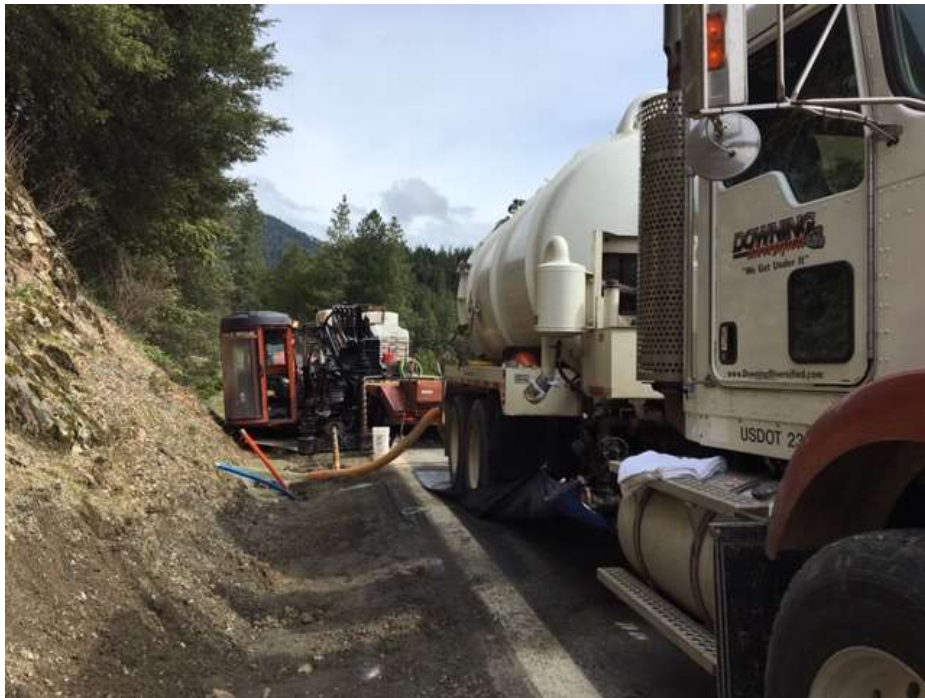
The CPUC Environmental Monitor (EM) conducted a site visit on April 3rd and met with Siskiyou Telephone’s EI in the field. The CPUC EM monitored a crew that was drilling from MP 28.5 south (see Figure 6), and another crew that was drilling at MP 27.93 north. Each drill crew had the required spill containment materials and a vac-truck. The CPUC EM inspected the area where a frac-out occurred the previous week at MP 31.51 and noted that the area had been cleaned-up and recontoured (see Figure 7). Traffic controls and a pilot vehicle were set up at each drill site along Highway 96. The historic nest was observed at MP 29.9 and was not active. No special-status species were observed during the site visit, except possibly an osprey.

Figure 6 – Drilling south at MP 28.5 – view north, April 3, 2019.

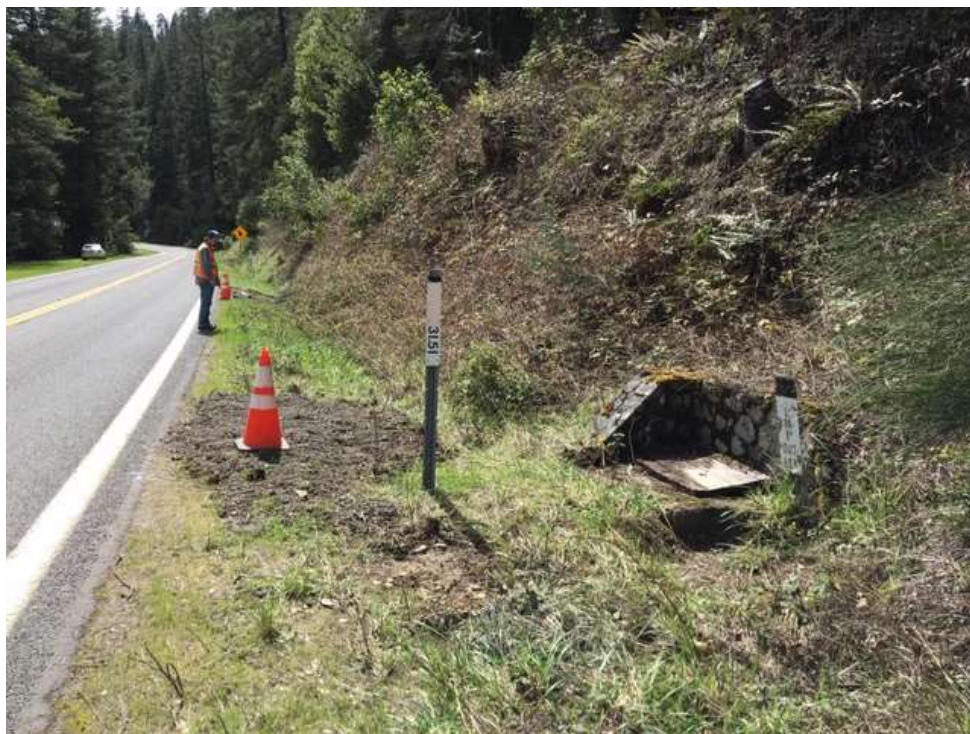
Figure 7 – Area where frac-out occurred at MP 31.51 on March 28th – view south, April 3, 2019.
