**SISKIYOU TELEPHONE CO. HAPPY CAMP TO SOMES BAR FIBER CONNECTIVITY PROJECT**

**To:** Connie Chen, Project Manager, CPUC  
**From:** Vida Strong, Aspen Project Manager  
**Date:** November 8, 2019  
**Subject:** Monitoring Report #11 – October 13, 2019 to November 6, 2019

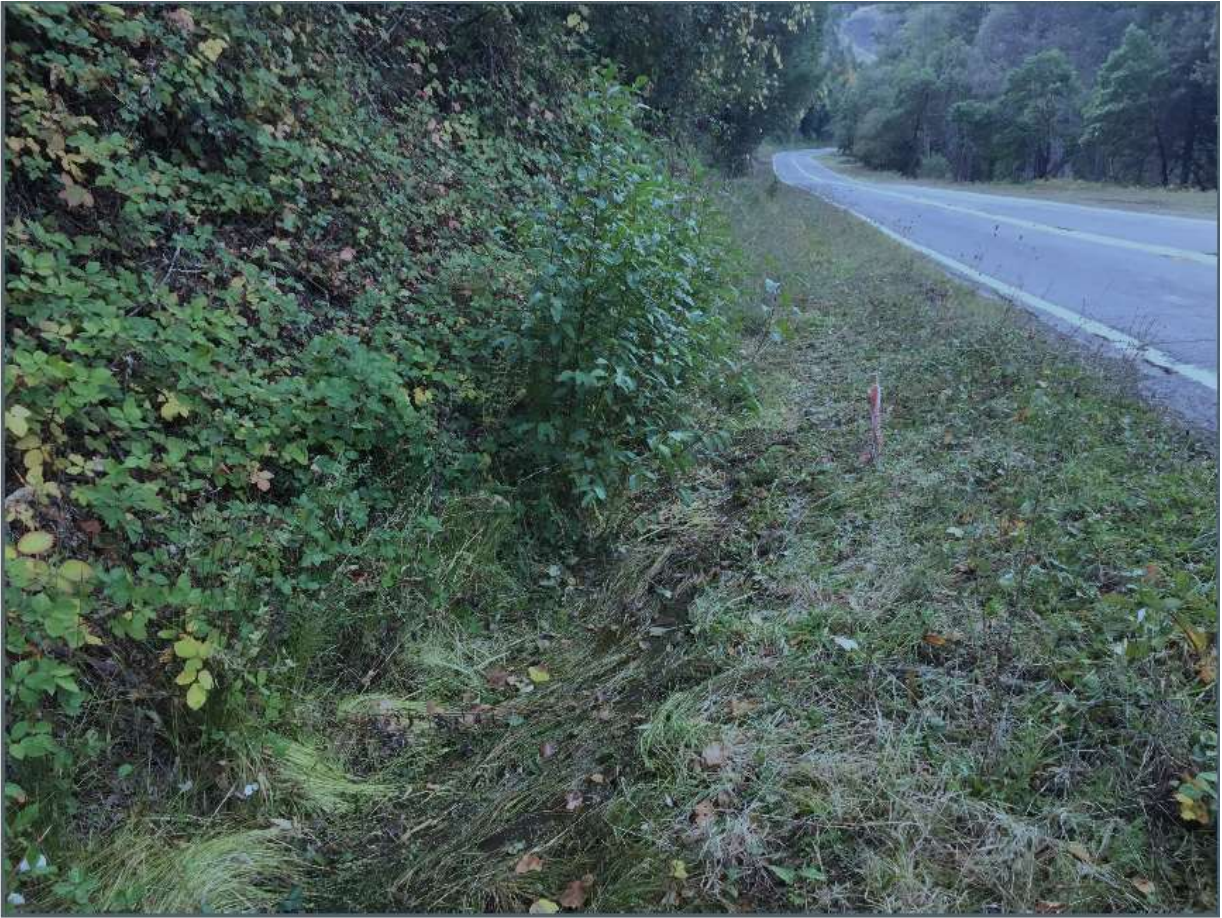
There were several encroachments into sensitive habitat areas in Phase 3 during the week of October 13. Two frac-outs occurred in sensitive habitats that were immediately isolated and cleaned up upon identification. The first frac-out occurred overnight on October 15th at MP 14.05. It is presumed that underground pressure forced bore mud out since no drilling was occurring at the time of the discharge. The sensitive habitat had water present but no flow or connection to the Klamath River. Crews isolated the frac-out, used a vacuum to remove bore mud, and flushed and cleaned the area with water. Figure 1 shows the site after cleanup. The second frac-out occurred on October 17th in sensitive habitat located near MP 13.90. Immediately upon identification, it was isolated, vacuumed, and flushed with water to clean the area. Figure 2 shows the site after cleanup. The CPUC EM was notified of these frac-outs on October 22nd in the Monitoring Report.

Figure 1 – Cleaned up location within sensitive habitat where frac-out of bore mud occurred overnight near MP 14.05, October 24, 2019.

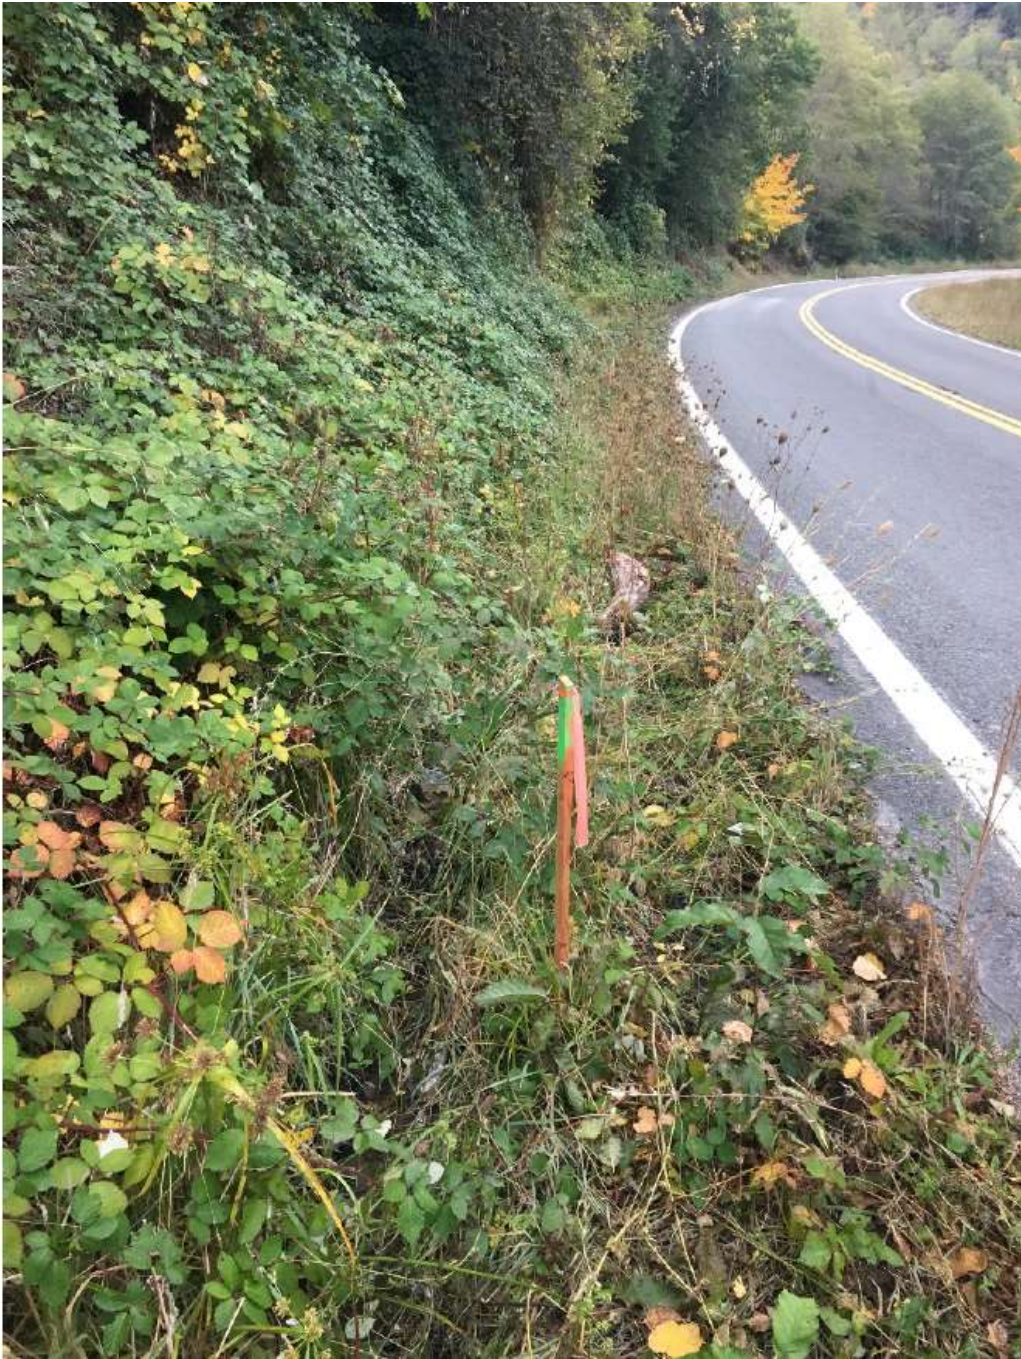
On October 15th, the biologist identified a stake that had been moved into sensitive habitat located near MP 13.90 by drilling crews. The only impact to the sensitive habitat was on the periphery and by foot-traffic. The end-of-day cleanup on October 15th resulted in soil being pushed into two sensitive habitat areas at MP 14.00 and MP 13.80. One sensitive habitat area had standing water but no flow or connection to the Klamath River. At the second sensitive habitat area there was no water present. One tie-in location was on the edge of sensitive habitat in Phase 3. Due to previous drill pad disturbance, the tie-in crew mobilized from Phase 2 to Phase 3 to finalize the tie-in near the sensitive habitat area and clean up any disturbance along the edge. No other frac-out or other drill issues occurred.

Figure 2 – Cleaned up location within sensitive habitat where nominal frac-out of bore mud occurred at MP 13.90, October 24, 2019.

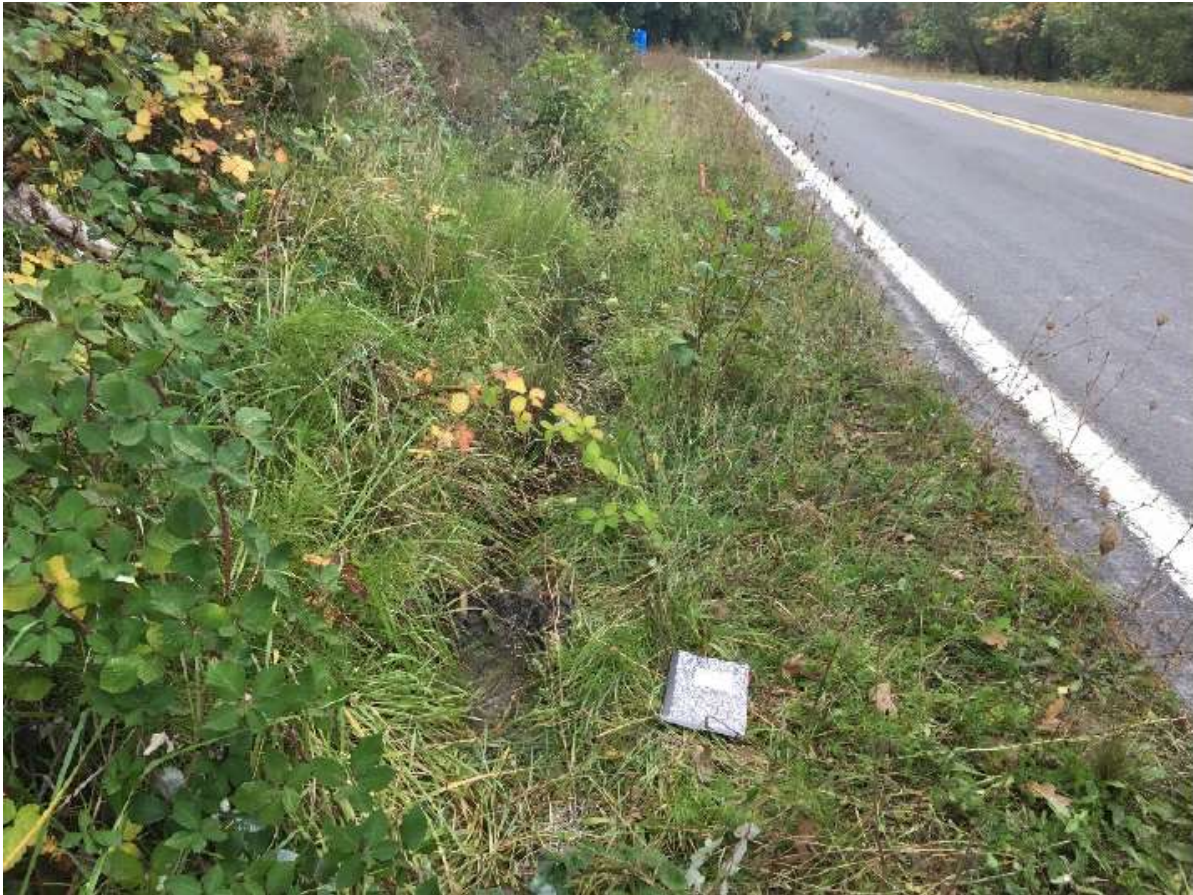
Daily biological surveys were conducted, and biologists surveyed in front of crews no more than three days prior to start of ground-disturbing activity. All necessary BMPs were in place. One frac-out occurred on October 21 into sensitive habitat located at approximately MP 14.15. The frac-out was immediately contained, vacuumed, and flushed with water to clean the area. No bore mud reached the unnamed drainage at MP 14.11 with connection to the Klamath River. The cleaned site is presented in Figure 3. The CPUC EM was notified of the frac-out on October 24th. No other frac-out or drill issues occurred.

Figure 3 – Cleaned up location within sensitive habitat where nominal frac-out of bore mud occurred at MP 14.15, October 24, 2019.

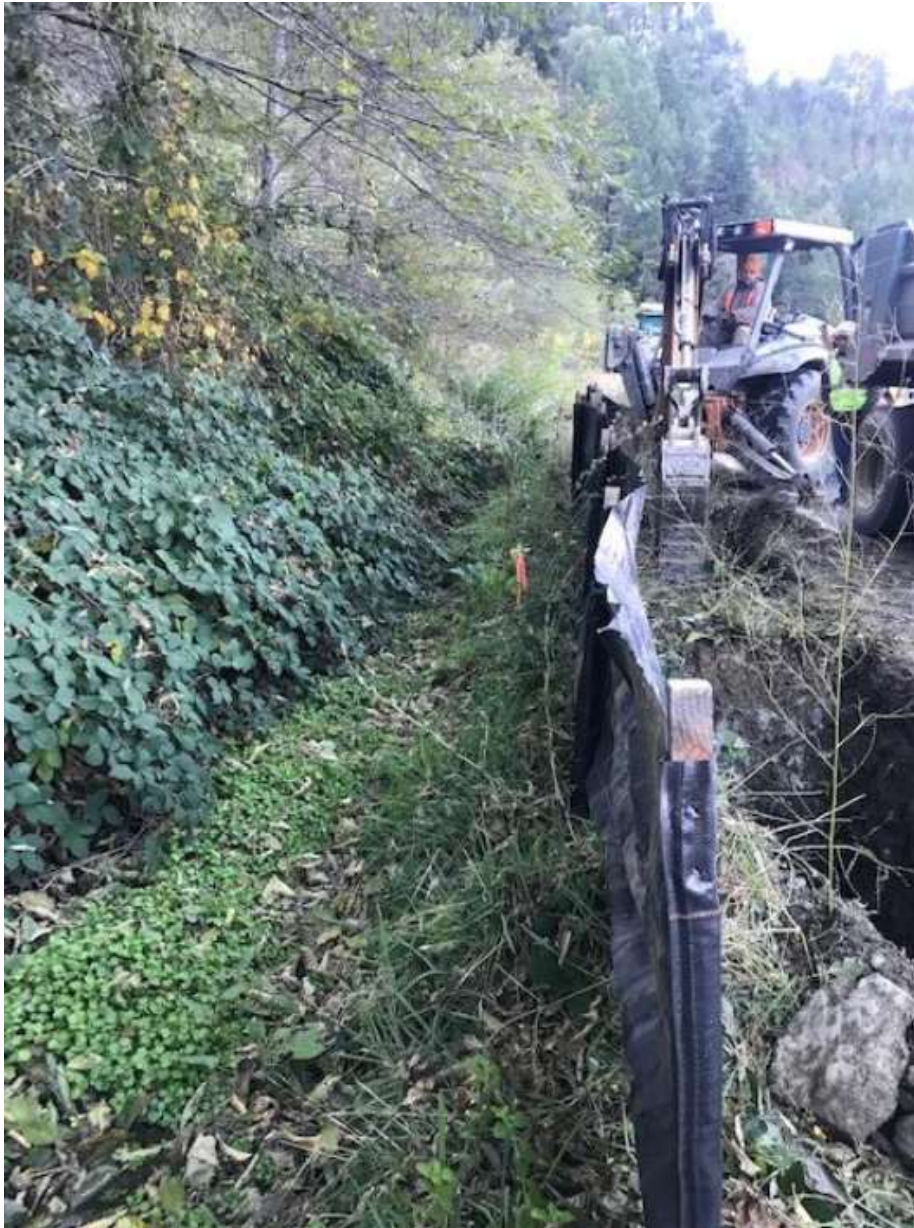
Daily biological surveys were conducted, and biologists surveyed in front of crews no more than three days prior to start of ground-disturbing activity. All necessary BMPs were in place. On October 30, tie-in crews worked adjacent to sensitive habitat at MP 13.75. A silt fence was installed, and all equipment was located on the roadway behind the silt fence (Figure 4). The sensitive habitat was isolated and there was no disturbance to the area (Figure 5). No other frac-out or drill issues occurred.

Figure 4 – Silt fence and tie-in work adjacent to sensitive habitat at MP 13.75, October 30, 2019.

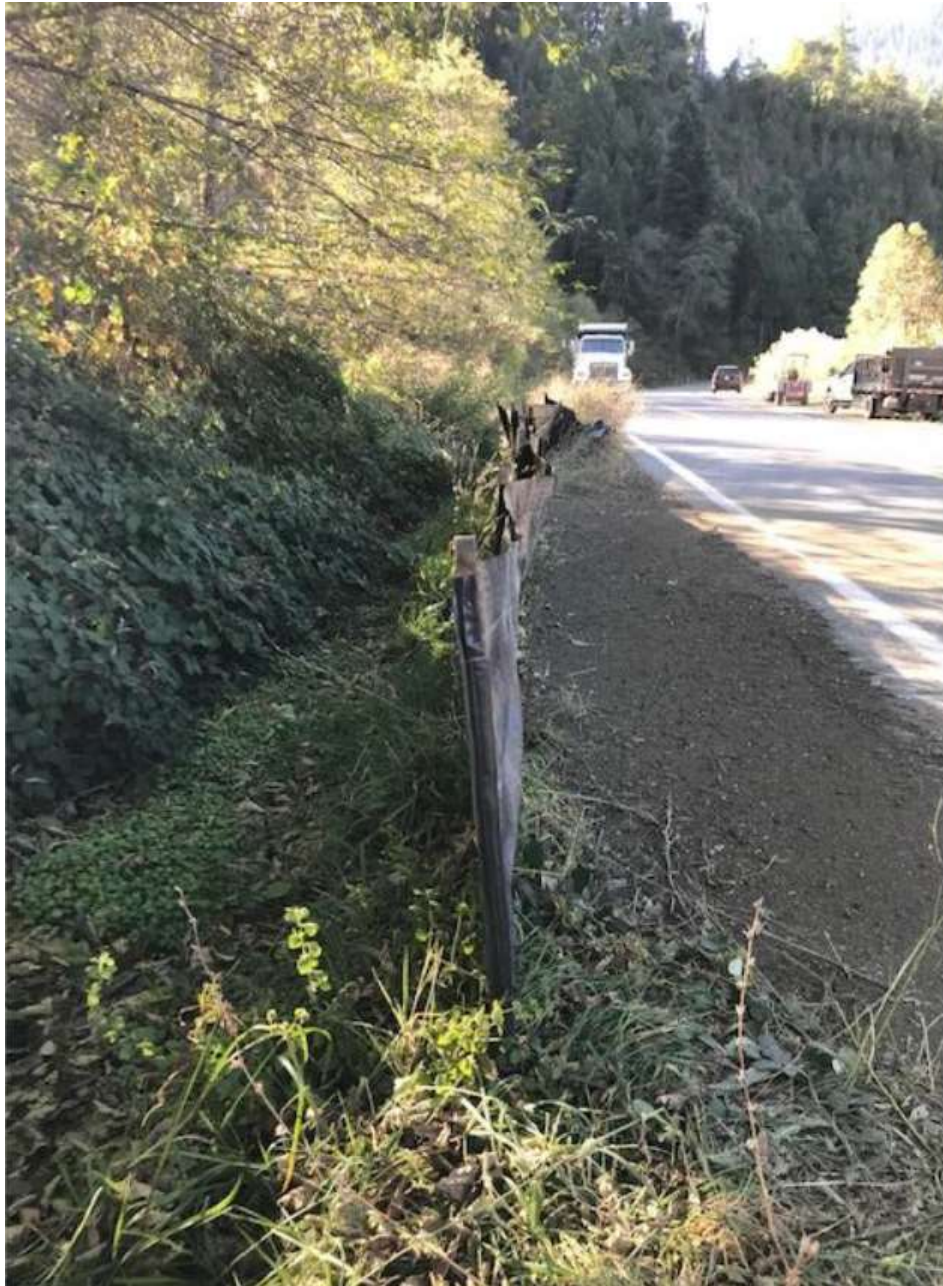
Figure 5 – Cleaned up area adjacent to sensitive habitat at MP 13.75; no impacts to sensitive habitat, October 30, 2019.

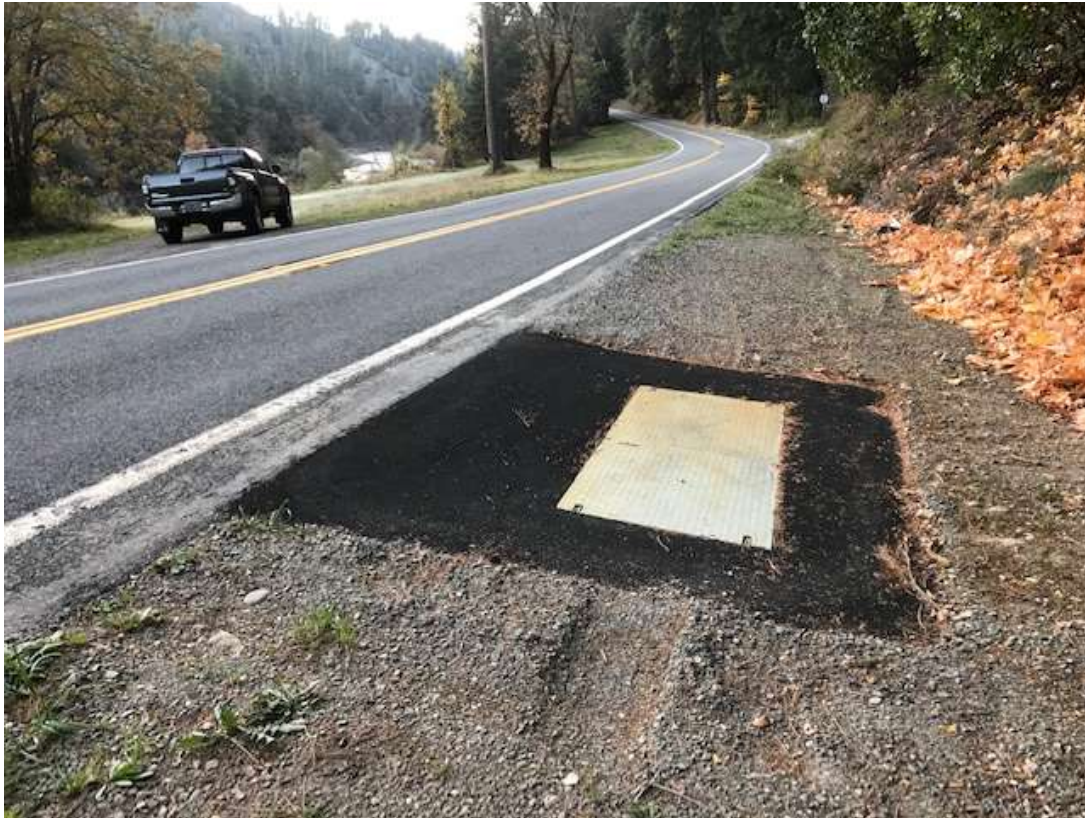
The CPUC EM conducted a final inspection on October 31 of the completed work areas throughout Phases 1, 2, and 3. The CPUC EM noted that all drill and tie-in sites were cleaned up and showed minimal signs of disturbance (Figures 6 and 7). All tie-in boxes south of MP 23.97 are still in need of paving around the edges (Figure 8). The Siskiyou Telephone Project Manager communicated that the weather has been too cold to pave these areas, so they may have to wait until next season. In that case, the gaps around the tie-in boxes will be back filled with gravel and paved next season when the weather warms up. The CPUC EM observed that all staking and flagging was still in place for all Phases of the project. The CPUC EM discussed this with the site biologist, and the biologist began removing staking and flagging from Phases 1 and 2 on October 31.

Figure 6 – Clean drill and tie-in location in Phase 1, October 31, 2019

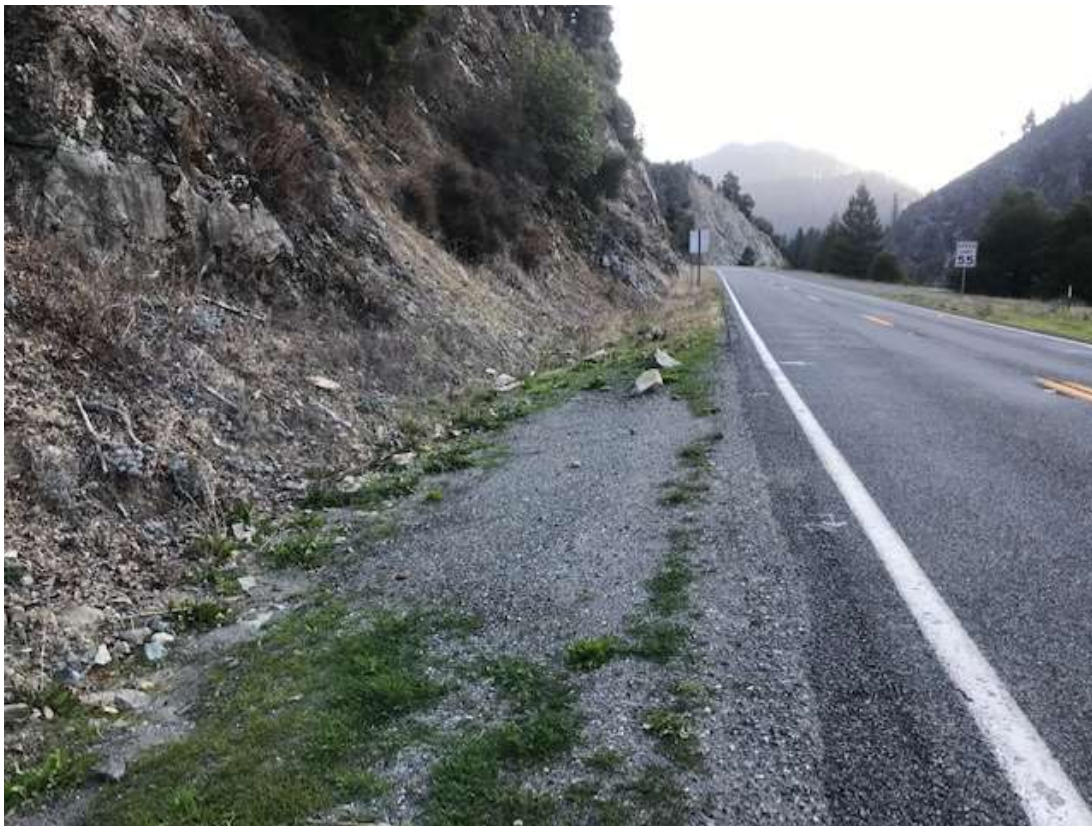
Figure 7 – Clean drill and tie-in location with minimal disturbance in Phase 1, October 31, 2019.

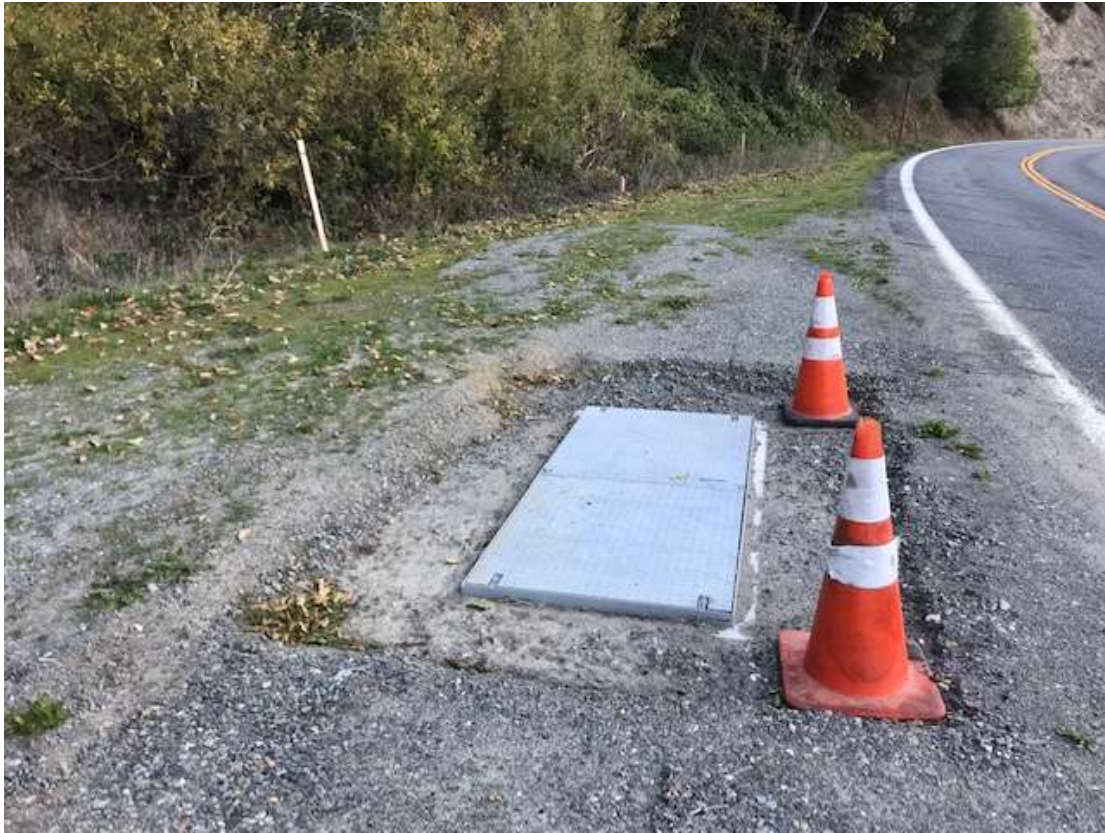
Figure 8 – Tie-in box still needing paving in Phase 2, October 31, 2019.

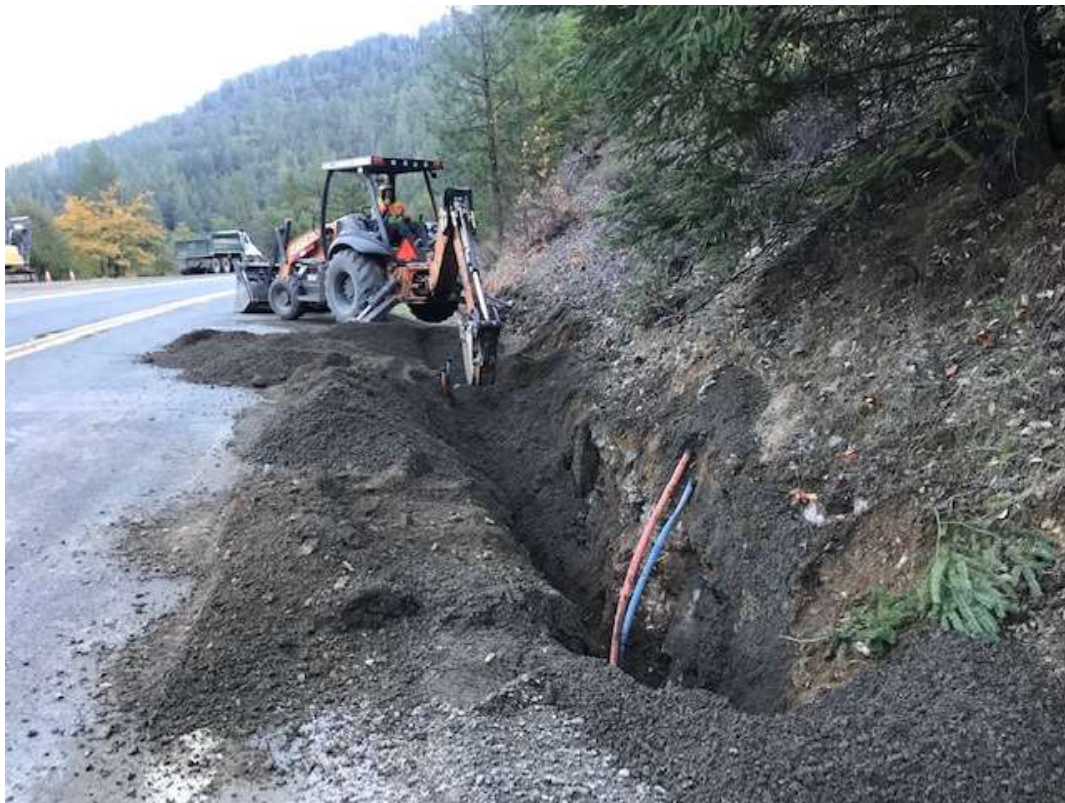
The CPUC EM met with Siskiyou Telephone's biologist at the site of current construction. Since all drilling has been completed, the CPUC EM only observed tie-in work between MP 13.41 and MP 13.2. The CPUC EM observed a total of three tie-in crews. The first crew was using a backhoe to trench at MP 13.52 (Figure 9). The second crew was hand-digging at MP 13.41 (Figure 10). The third crew was digging at MP 13.32 adjacent to sensitive habitat. The crew had erected a silt fence to prevent any soil from disturbing the sensitive habitat (Figure 11).

Figure 9 – Crew trenching with a backhoe at MP 13.52, October 31, 2019.

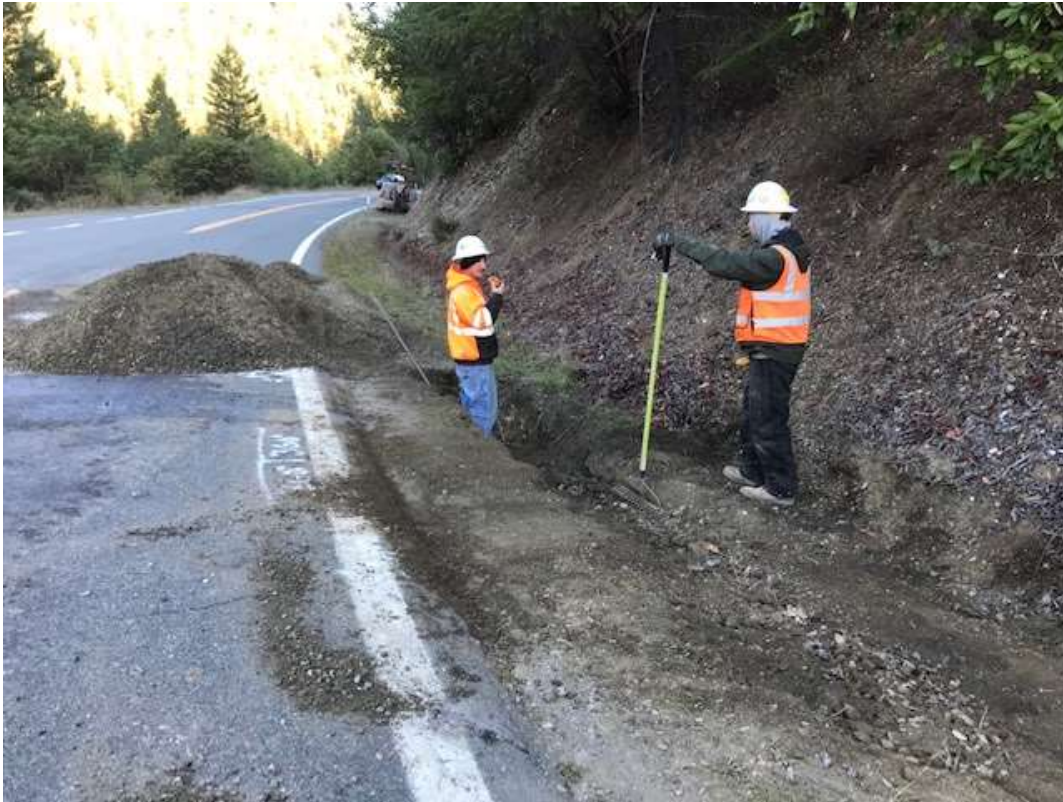
Figure 10 – Crew hand digging tie-in at MP 13.41, October 31, 2019.

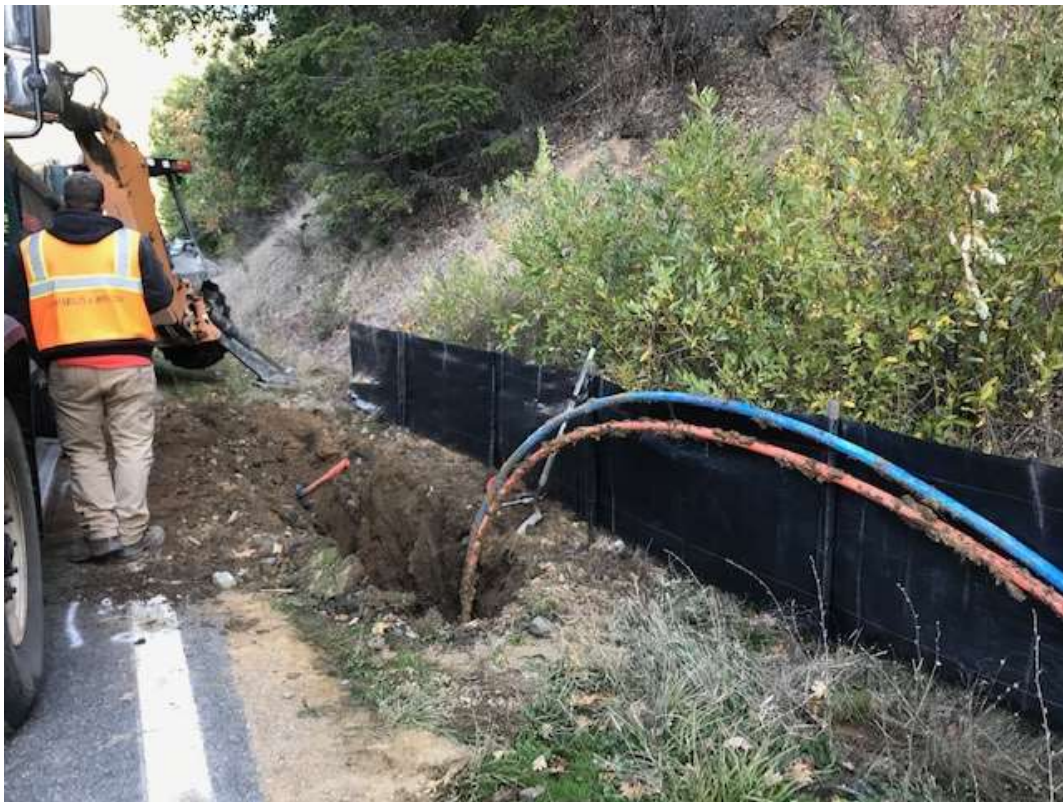
Figure 11 – Crew digging adjacent to sensitive habitat at MP 13.31 with silt fence installed, October 31, 2019
