**Figure 3.14-24a (Revised)**  
**Existing Conditions**  
**for KOP-Center-9**  
**Angeles Crest Scenic Byway**  
**& Rincon-Shortcut Trailhead**  
**(Alternative 2, Segment 6)**  
*Source: Lee Anderson, 2007.*

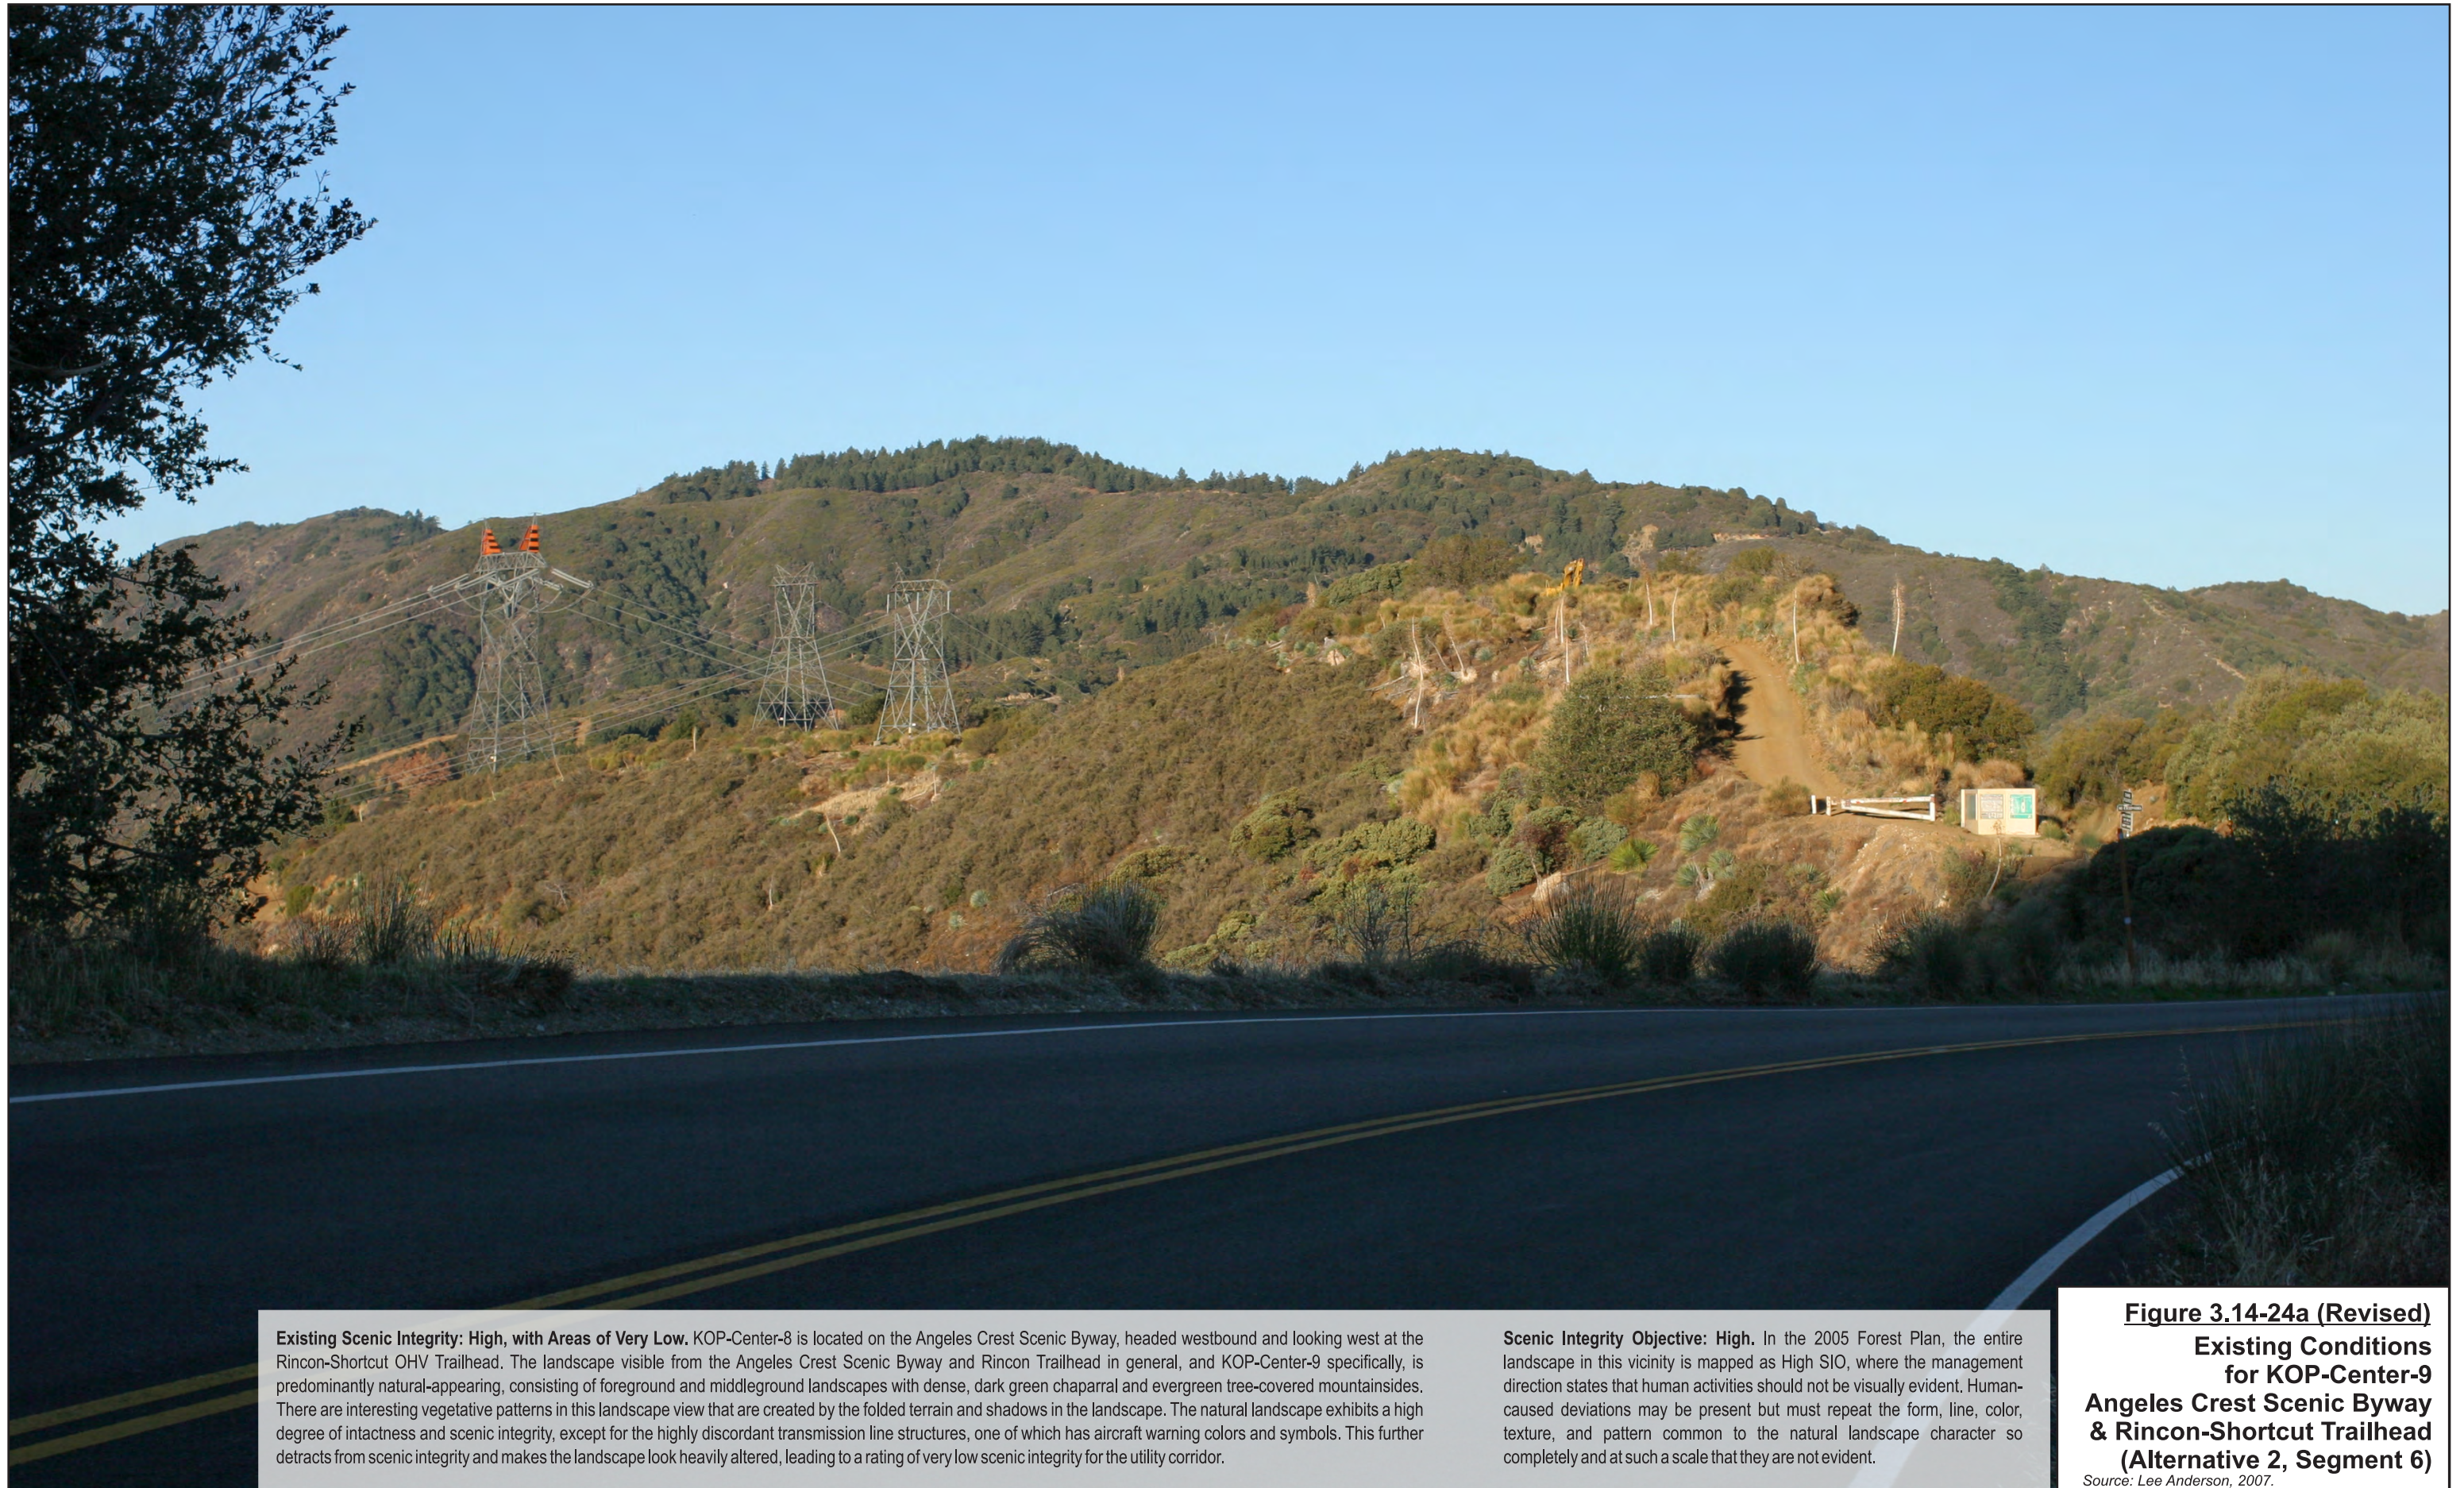
**Existing Scenic Integrity: High, with Areas of Very Low.** KOP-Center-8 is located on the Angeles Crest Scenic Byway, headed westbound and looking west at the Rincon-Shortcut OHV Trailhead. The landscape visible from the Angeles Crest Scenic Byway and Rincon Trailhead in general, and KOP-Center-9 specifically, is predominantly natural-appearing, consisting of foreground and middleground landscapes with dense, dark green chaparral and evergreen tree-covered mountainsides. There are interesting vegetative patterns in this landscape view that are created by the folded terrain and shadows in the landscape. The natural landscape exhibits a high degree of intactness and scenic integrity, except for the highly discordant transmission line structures, one of which has aircraft warning colors and symbols. This further detracts from scenic integrity and makes the landscape look heavily altered, leading to a rating of very low scenic integrity for the utility corridor.

**Scenic Integrity Objective: High.** In the 2005 Forest Plan, the entire landscape in this vicinity is mapped as High SIO, where the management direction states that human activities should not be visually evident. Human-caused deviations may be present but must repeat the form, line, color, texture, and pattern common to the natural landscape character so completely and at such a scale that they are not evident.
