**Figure 3.14-31a (Revised)**  
**Existing Conditions**  
**for KOP-Center-16**  
**Southbound Angeles**  
**Forest Highway**  
**(Alternative 2, Segment 11)**

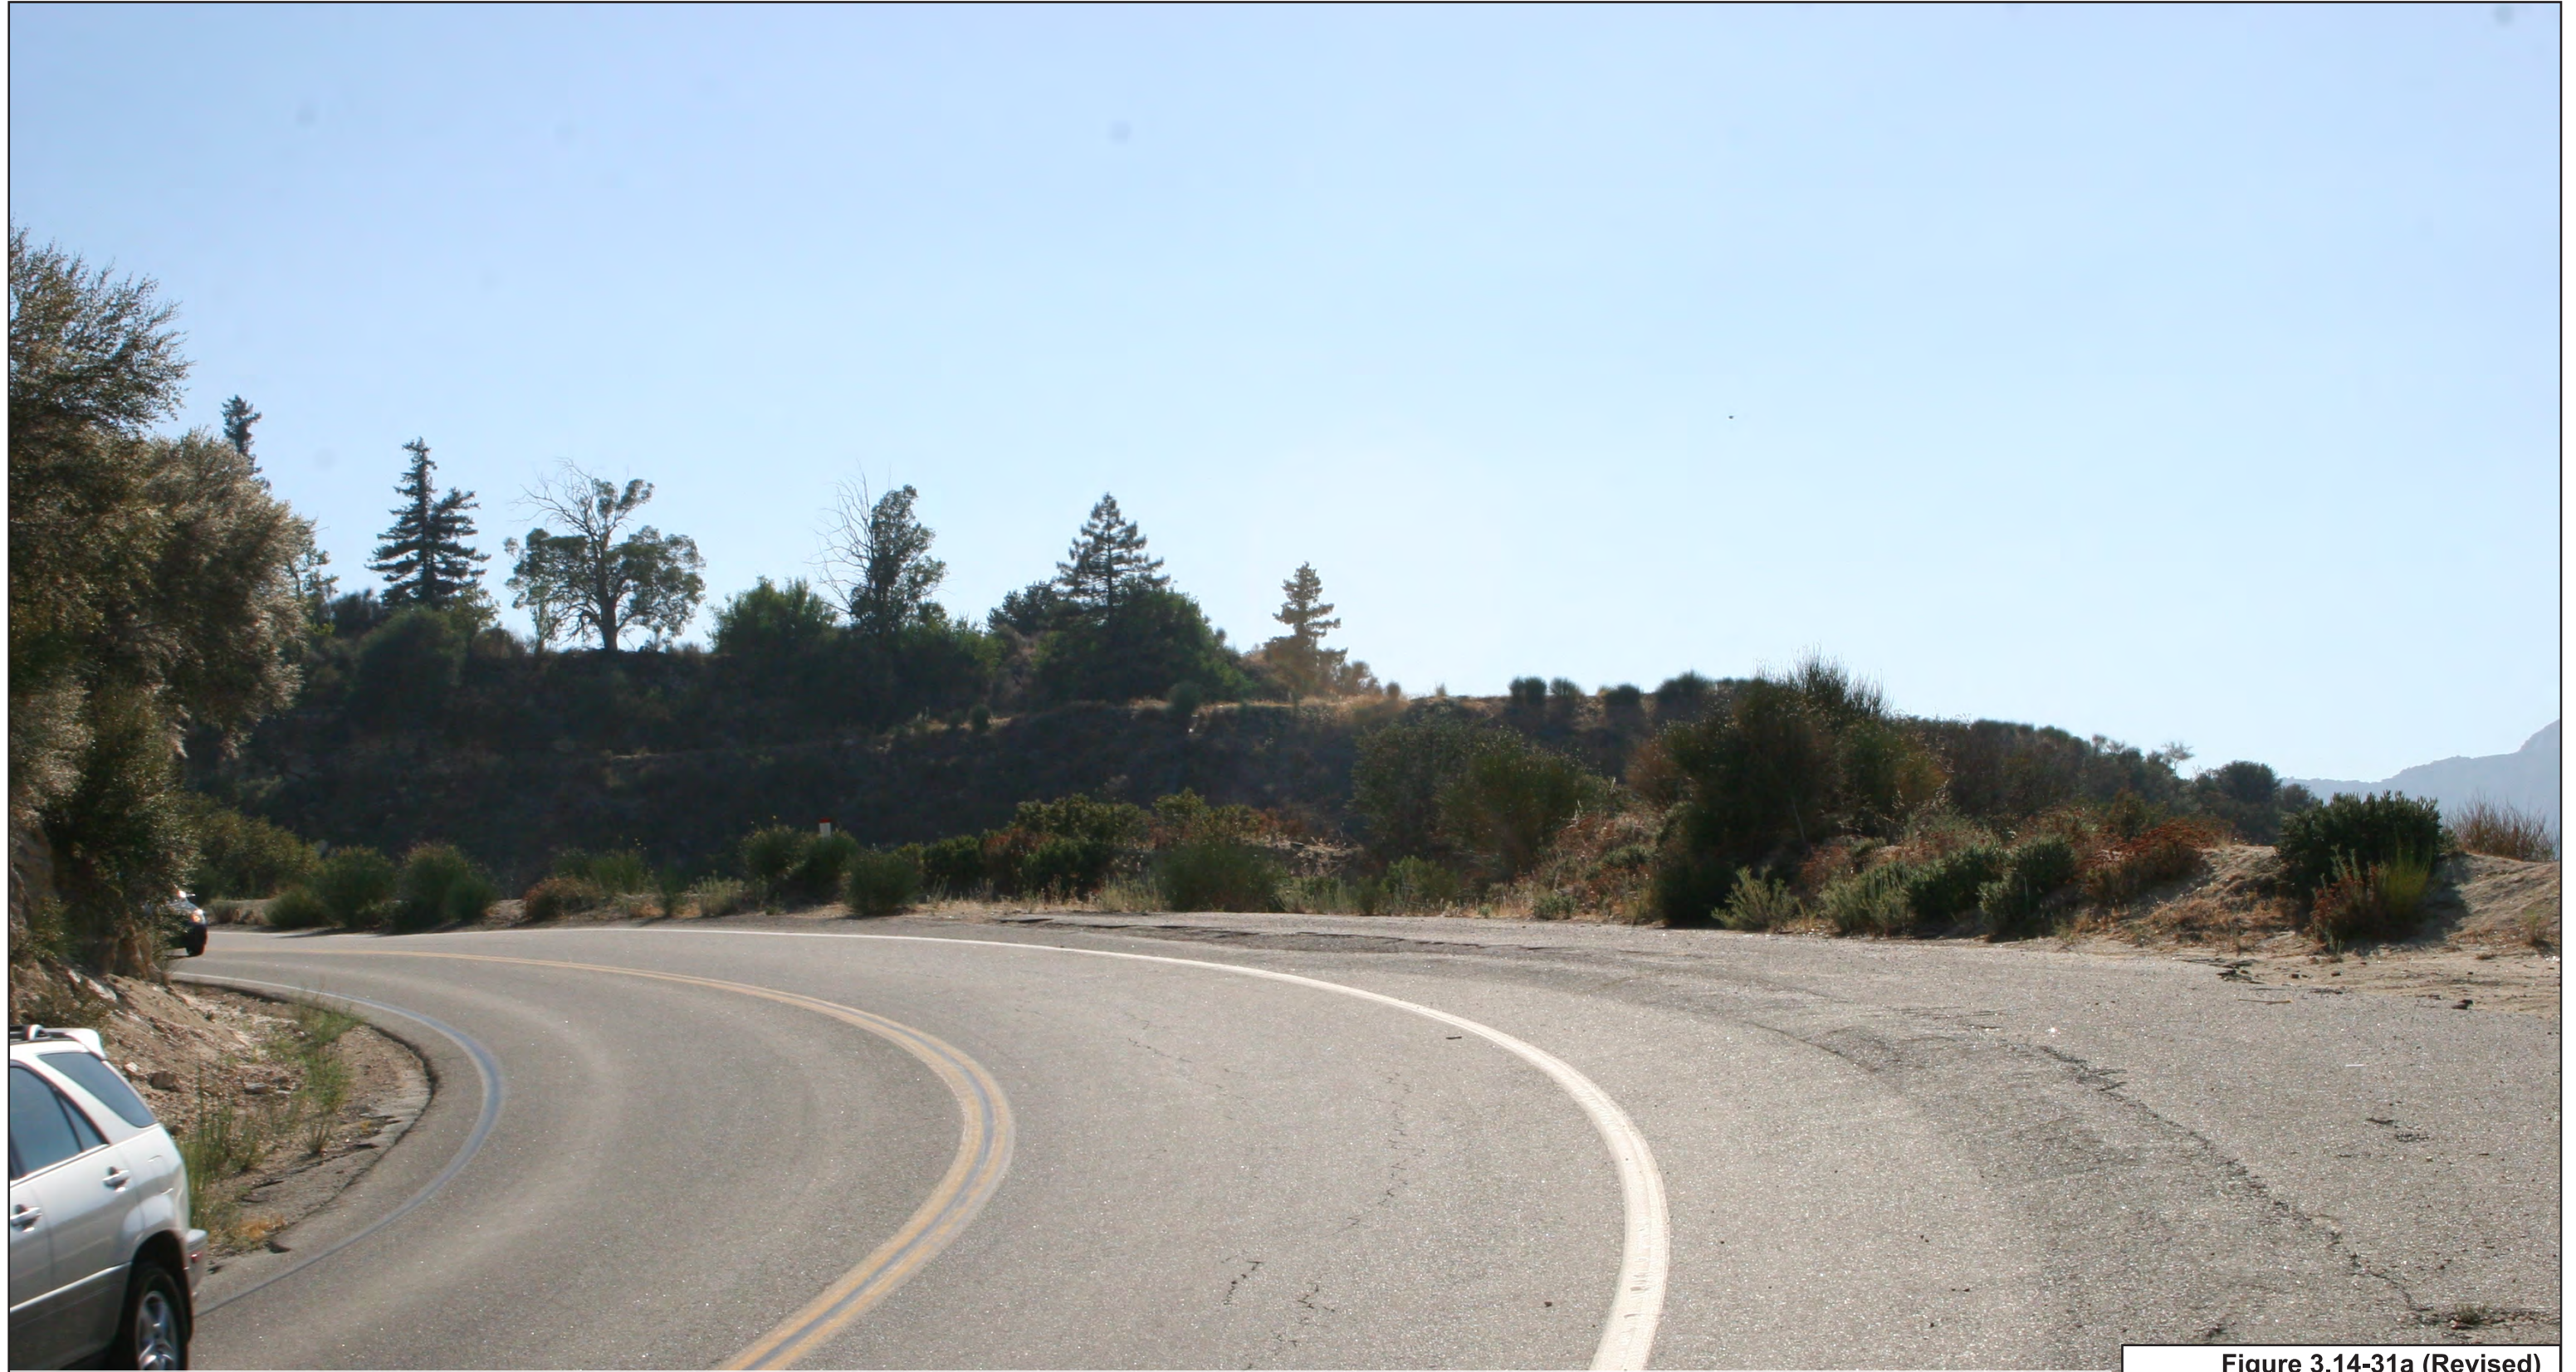
**Existing Scenic Integrity: High, with Areas of Low.** The landscape visible from the Angeles Forest Highway is predominantly modified by the highway, water tank, and former parking area on the skyline. This highway provides panoramic views to the Tujunga Canyon and steep mountainsides. However, because of the direction of view of this photograph, these panoramic views are not shown. Rather, details in the landscape that are somewhat discordant are displayed, and the landscape appears moderately altered. This is a foreground view toward the proposed helicopter staging area #10 for Alternative 6. This same area is not proposed as a helicopter staging area for Alternative 2. The natural landscape no longer exhibits a high degree of intactness, or scenic integrity, because of the manmade features that have begun to dominate the valued landscape character – the highway itself, the cut and fill slopes with bare earth, and the flattened skyline, caused by an abandoned parking lot on the right side of the skyline and a buried water tank on the left half of the skyline in this view. These discordant elements do not borrow form, line, color or texture from the natural-appearing landscape, giving this scene low scenic integrity.

**Scenic Integrity Objective: High.** In the 2005 Forest Plan, the entire landscape in this vicinity is mapped as High SIO, where the management direction states that human activities should not be visually evident. Human-caused deviations may be present but must repeat the form, line, color, texture, and pattern common to the natural landscape character so completely and at such a scale that they are not evident.
