**PROJECT MEMORANDUM
SDG&E'S SUNRISE POWERLINK PROJECT**

To: Billie Blanchard, Project Manager, CPUC
From: Vida Strong, Aspen Project Manager
Date: October 13, 2011
Subject: Weekly Report 54 – September 25 to October 1, 2011

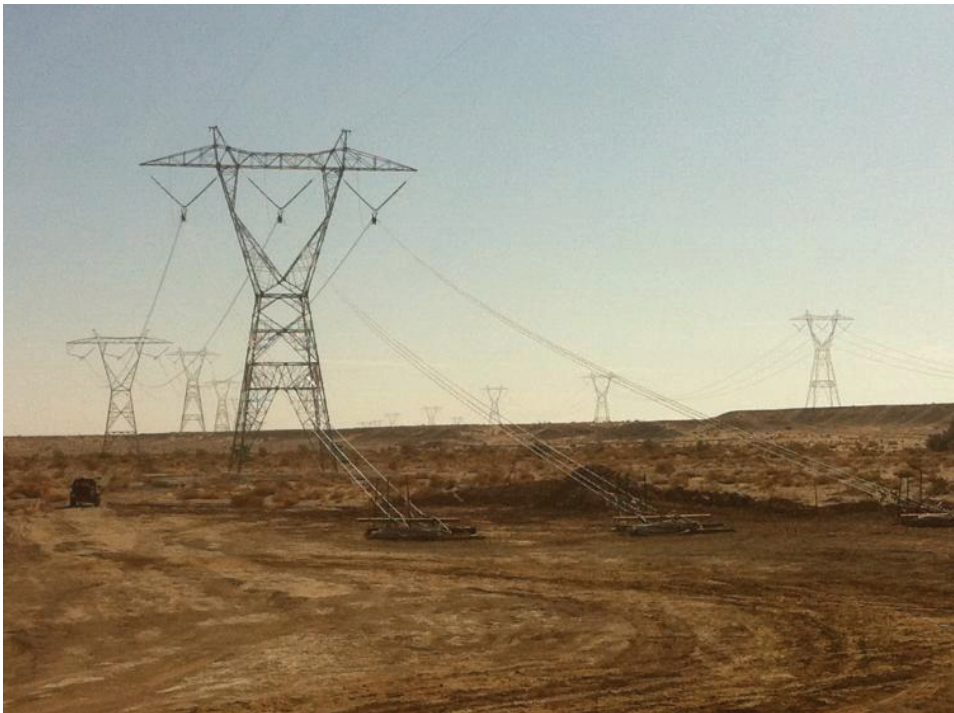
Figure 1: Wire and snubs at EP322/EP323 pull site. Temporary mats have been removed. (Link 1)

- Insulator work was conducted at EP291-1, EP293, EP338, and EP355.
- Conductor sleeving took place at the EP355/EP356 pull site.
- Temporary mats were removed from EP323-1 and EP324 (see Figure 1).

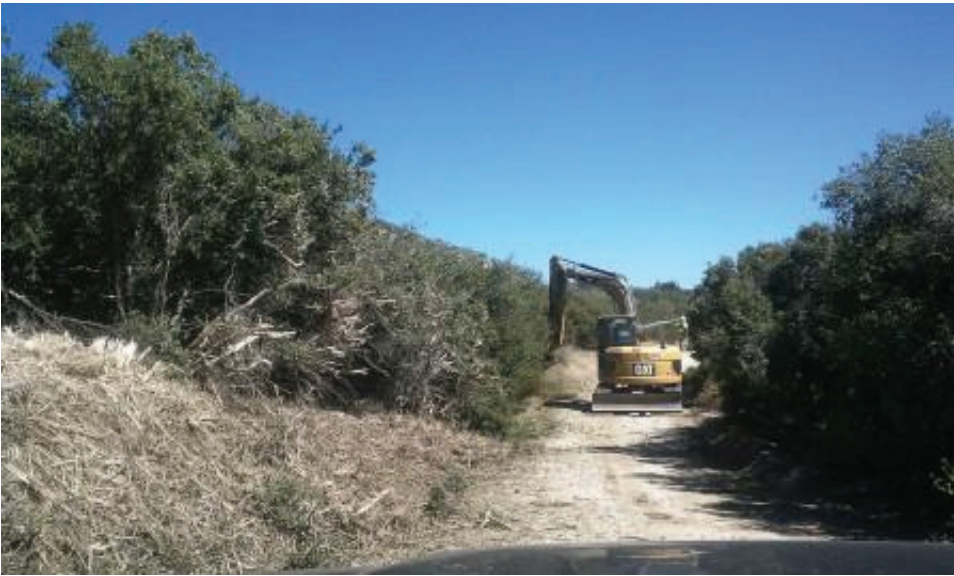
Figure 2: Vegetation brushing on La Posta Road. (Link 2)

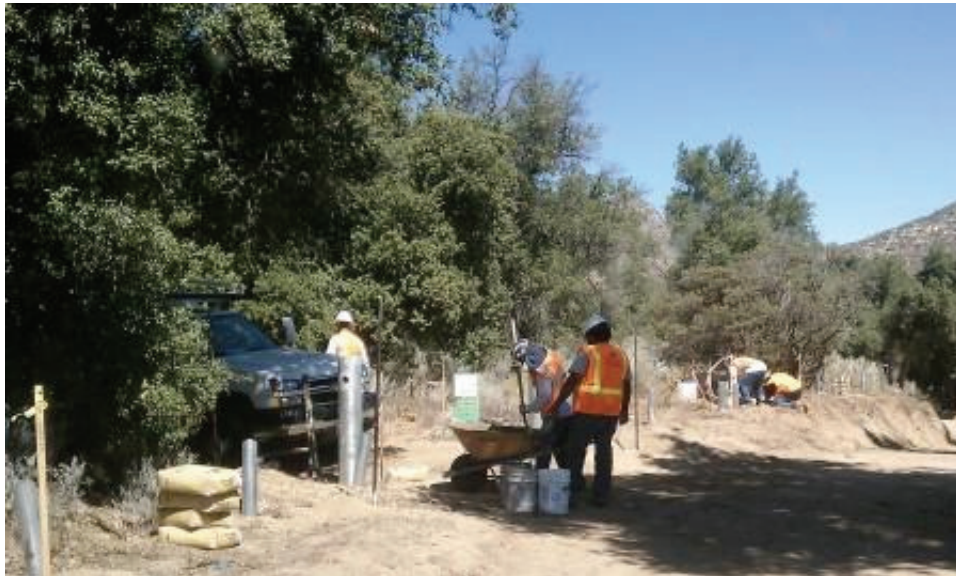
Figure 3: Installation of gate posts along La Posta Road. (Link 2)

- During this reporting period, the PAL Levels were as follows: Monday: C, Tuesday-Friday: EV, and Saturday: C. Work activities ended each day in accordance with the Fire Plan and the approved EV letter as appropriate.
- Access road construction occurred at EP126-1-N, EP127-N, EP131-N, and La Posta Road from EP125 to EP136 (road base laid).
- Culverts were installed along La Posta Road near EP126-1.
- Vegetation clearing occurred along La Posta Road (see Figure 2) from EP138-2 to EP141, EP131, along La Posta Road north of EP131, EP140-1, and EP141-PS-W.
- Tree trimming occurred on La Posta Road between EP129 and EP130-1.
- Grading occurred at EP130-1/EP131 pull site.
- Gate installation occurred at EP125, EP126-1, EP129, and EP130-1 (see Figure 3).

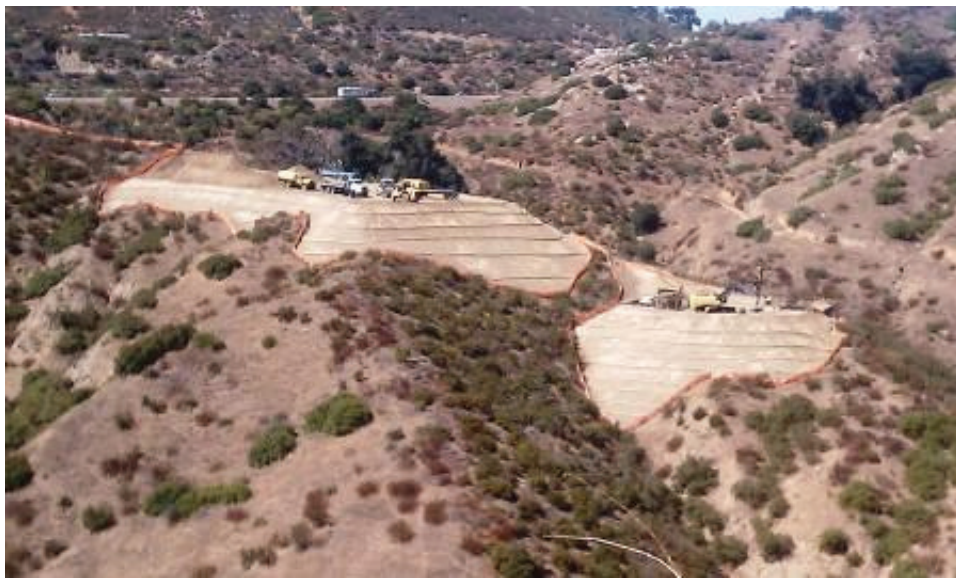
Figure 4: Conventional drilling at CP87-1 (right) with pull site above. (Link 5)

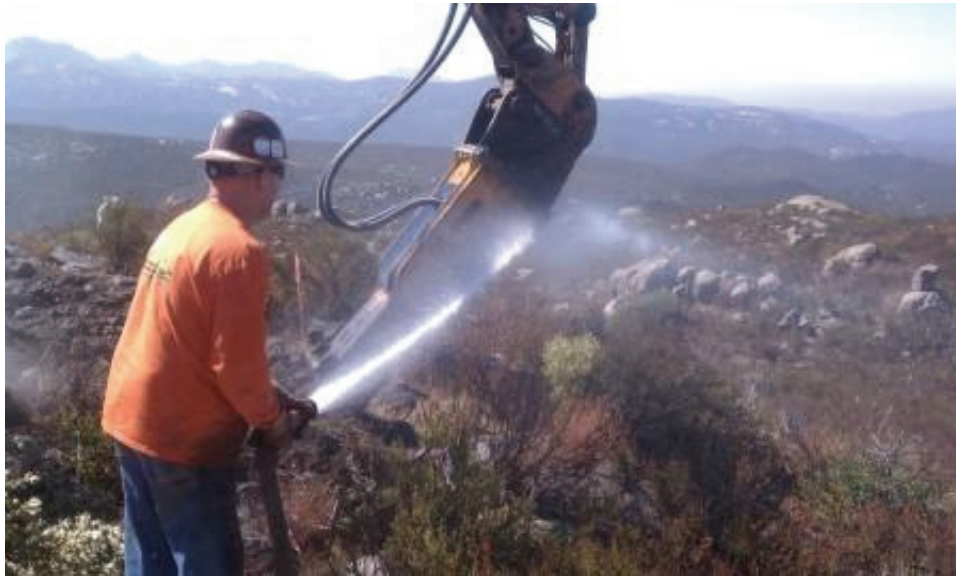
Figure 5: Breaking boulders and wetting vegetation at CP100-1. (Link 5)

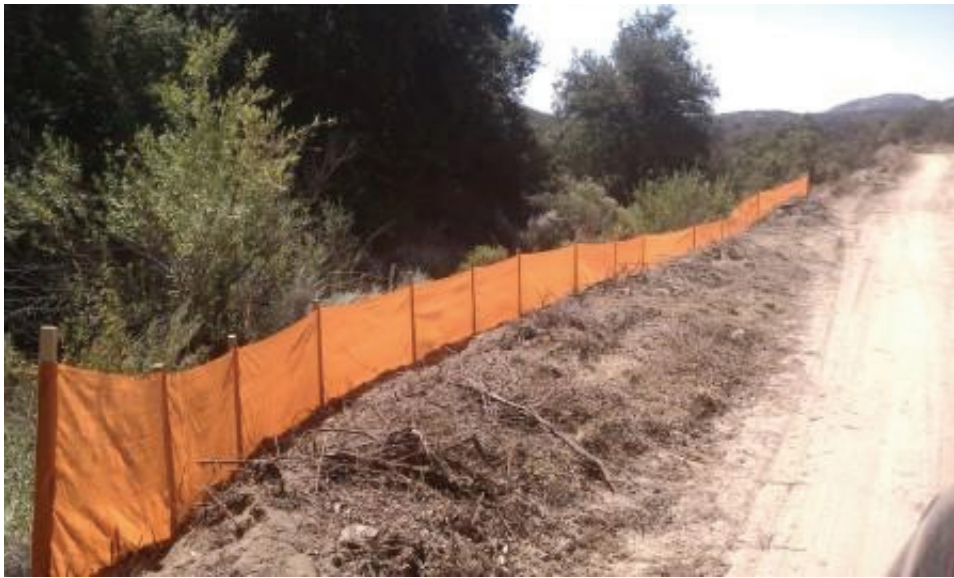
Figure 6: Silt fence adjacent to a creek on La Posta Road. (Link 2)

- EP131, along La Posta Road (see Figure 6) from EP125 to EP131, EP131 pull site, and EP140.
- Hydromulching occurred along La Posta Road between EP125 and EP127.

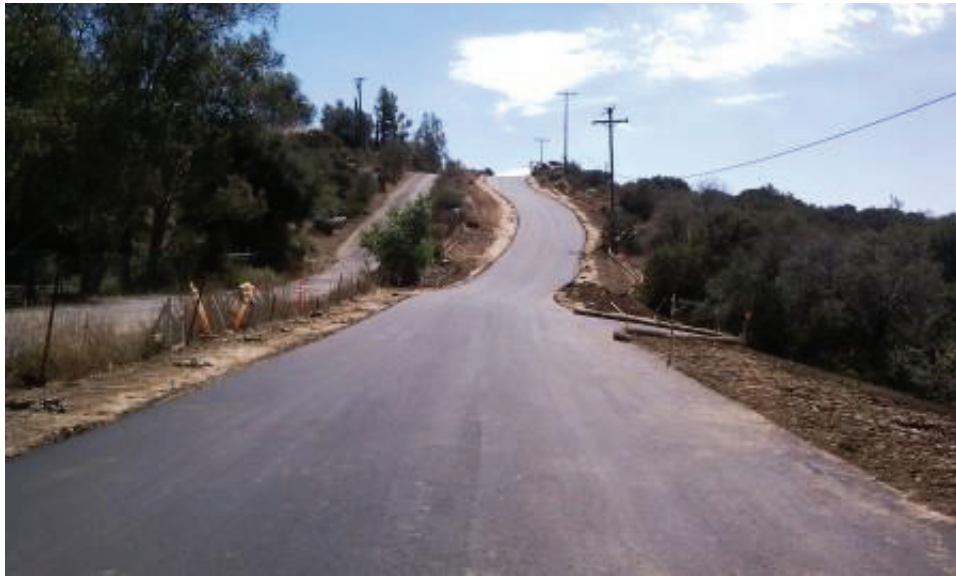
Figure 7: Hydromulching was installed on the sides of the newly paved access road to CP95-1, CP96-1, and CP98. (Link 2)

- CP48-2/CP49-1-PS-E, CP56-1-PS-E-A, and CP98 access road.
- Hydromulching occurred at CP48-2/CP49-1-PS-E and CP98 access road (see Figure 7).

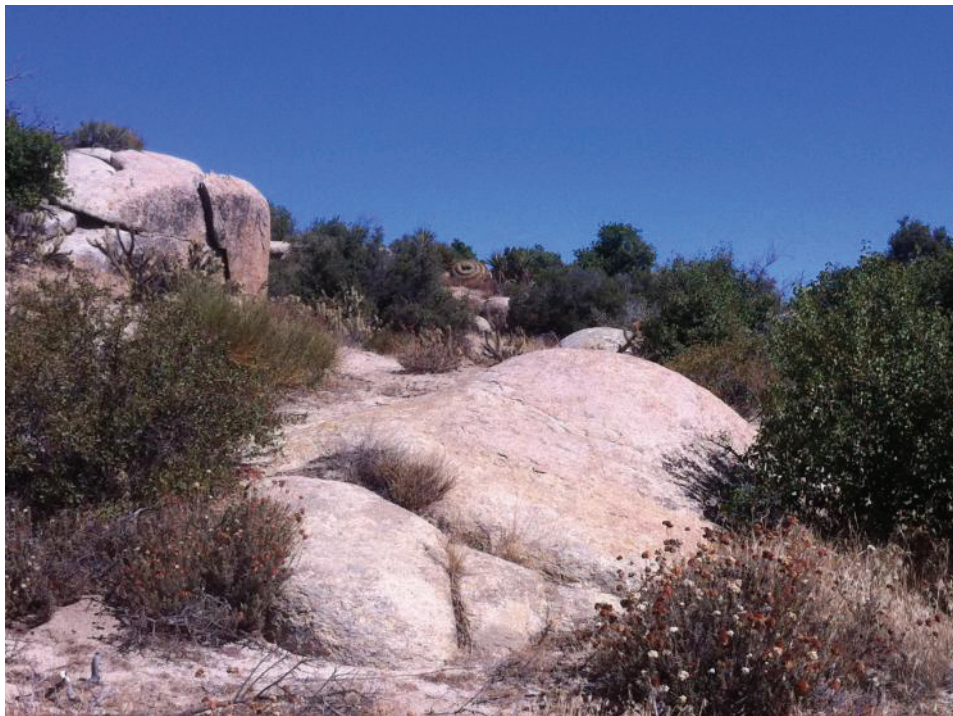
7. On September 26, 2011, an incident occurred where a helicopter traveling from Rough Acres Yard to a site dropped a load of straw wattles near EP196 TSAP, approximately 150-200 feet from McCain Valley Road. A biological monitor, archeological monitor, and Native American monitor were brought onsite to assess any damages to any sensitive resources. No damages were found (see Figures 8 and 9). (Link 1)

Figure 8: View of dropped wattles from McCain Valley Road. (Link 1)

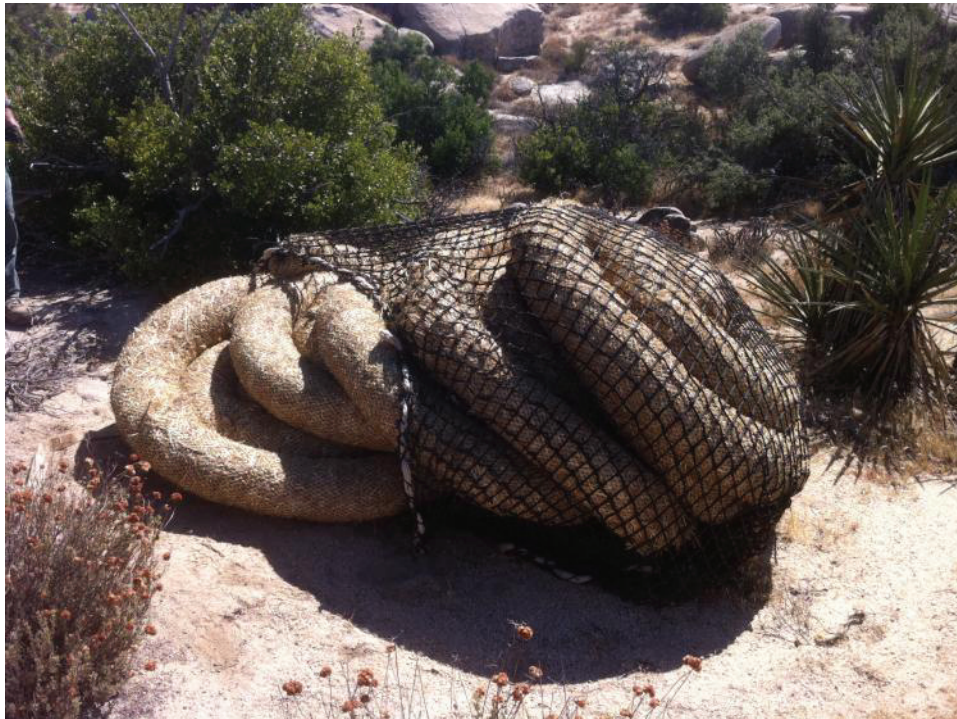
Figure 9: Close-up of wattles dropped near EP196 TSAP. Note that it landed on mostly bare earth. (Link 1)

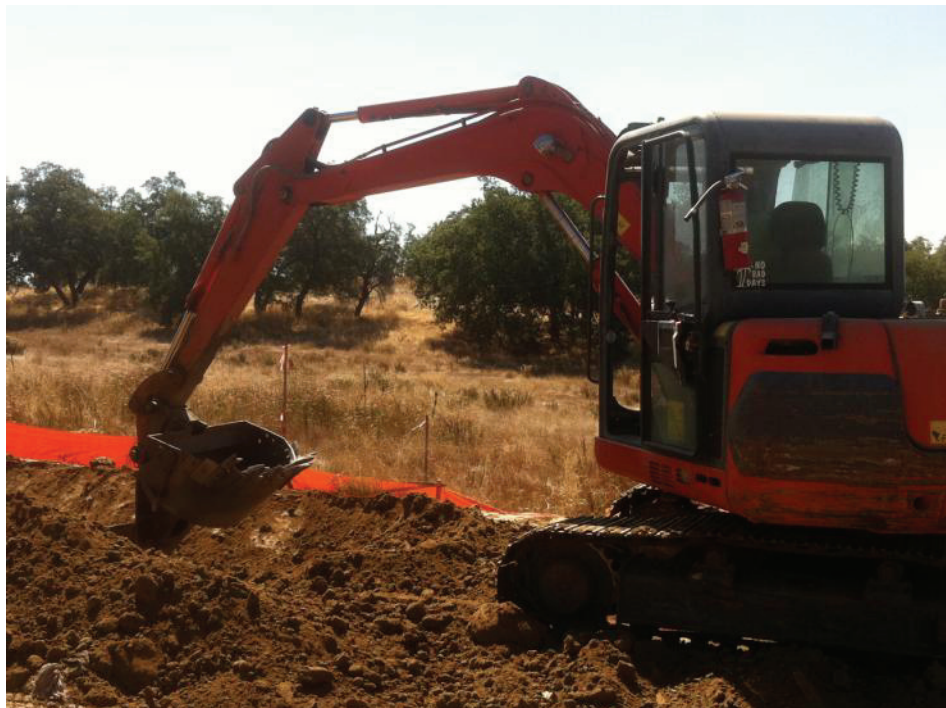
Figure 10: Trenching between vaults for underground utilities along BBTT. (Link 3)

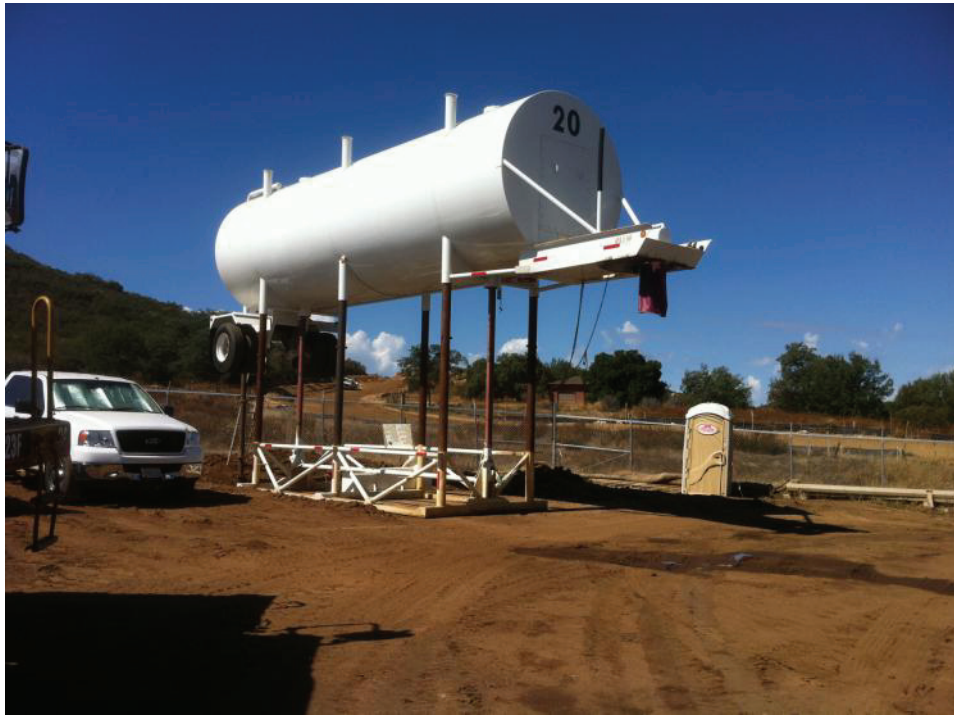
Figure 11: Water tank installed at Wilson Yard. (Link 3)

15. Wilson Yard – Materials were staged for Suncrest Substation. Helicopter operations and tower assembly also took place. Water tanks were also installed for dust control (see Figure 11).
