**PROJECT MEMORANDUM**  
**SDG&E'S SUNRISE POWERLINK PROJECT**

**To:** Billie Blanchard, Project Manager, CPUC  
**From:** Vida Strong, Aspen Project Manager  
**Date:** January 27, 2012  
**Subject:** Weekly Report 69 – January 8 to January 14, 2012

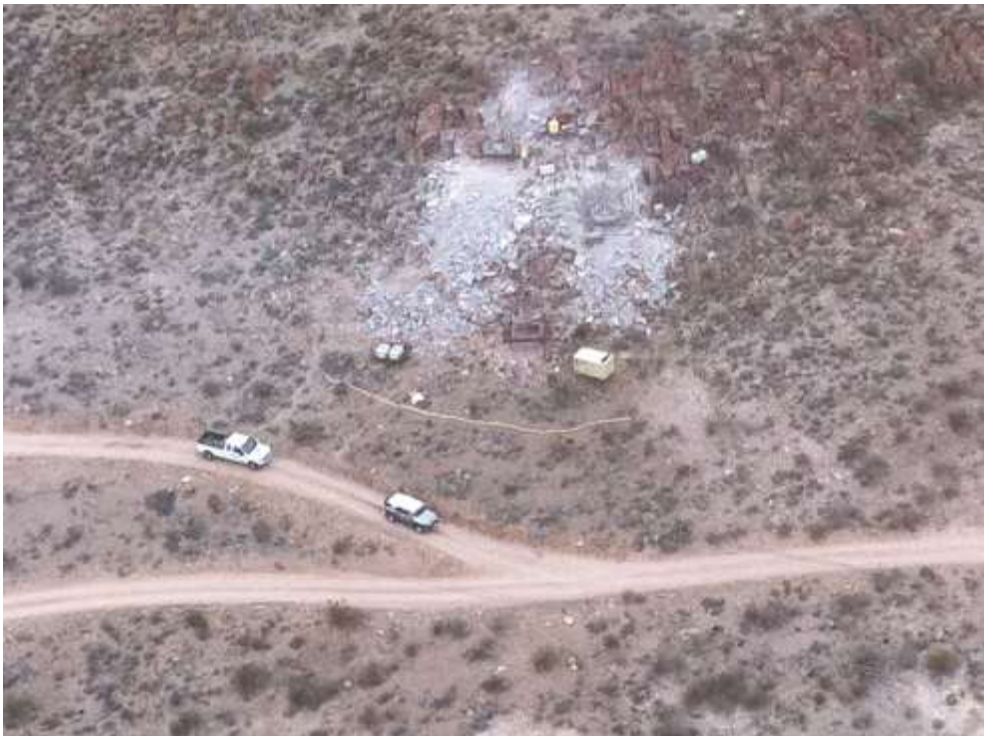
**Figure 1:** Micropile drilling at EP254-3. (Link 1)

- Final grading was conducted at the EP254/EP255 pull site.
- Micropile drilling took place at EP233-1, EP234-1, and EP254-3 (see Figure 1).
- Micropile trimming and pull testing occurred at EP183.

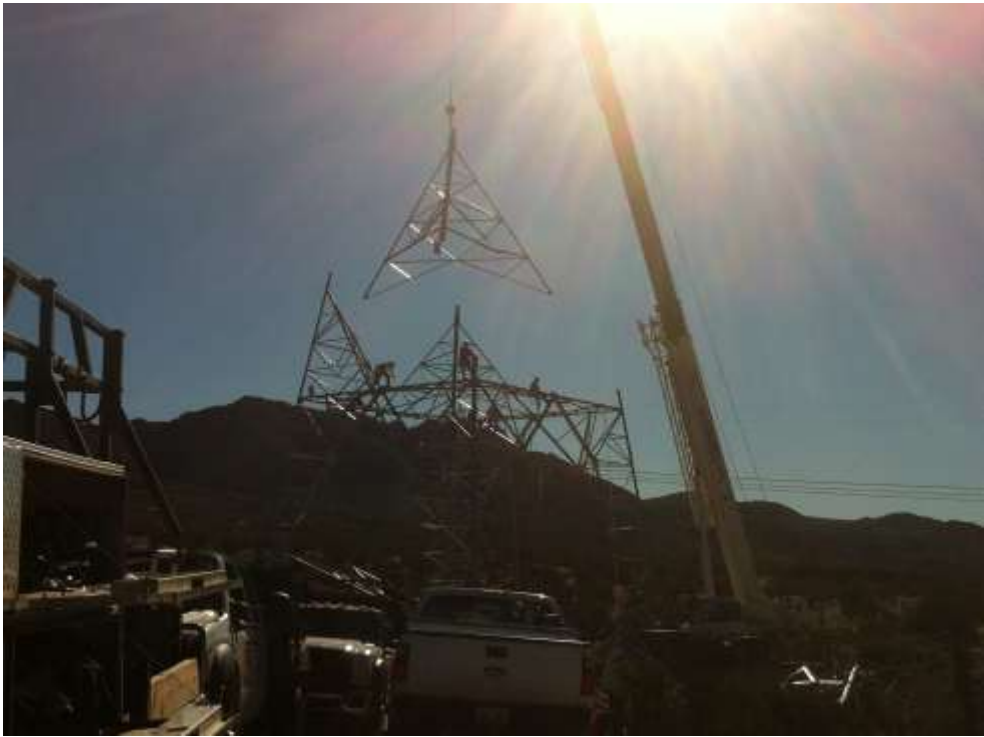
**Figure 2:** Conventional tower assembly at EP252-1. (Link 1)

- Micropile cap work took place at EP183 and EP252A-1.
- Tower assembly occurred from EP183 to EP185-1, EP199-3, EP226-1, EP229-2, EP230-1, EP231-1, EP231A, EP232-1, EP235-1, EP238-1, EP240, EP245-1, EP252-1 (see Figure 2), and EP253-3 (see Figures 3 and 4).

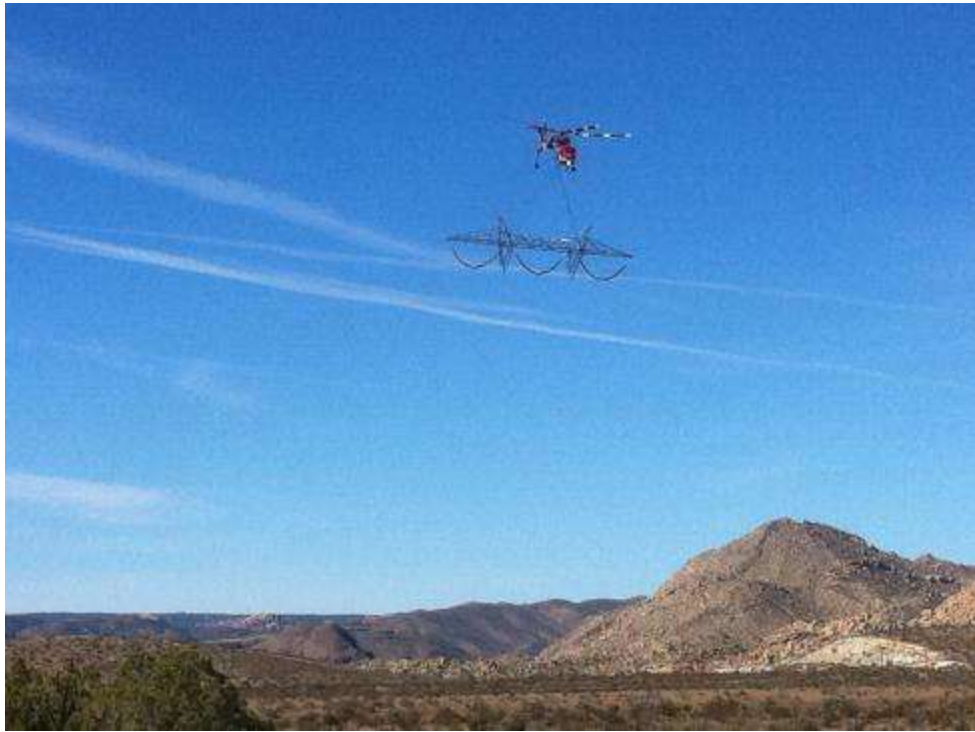
**Figure 3:** Aircrane flying bridge to EP253-3. (Link 1)

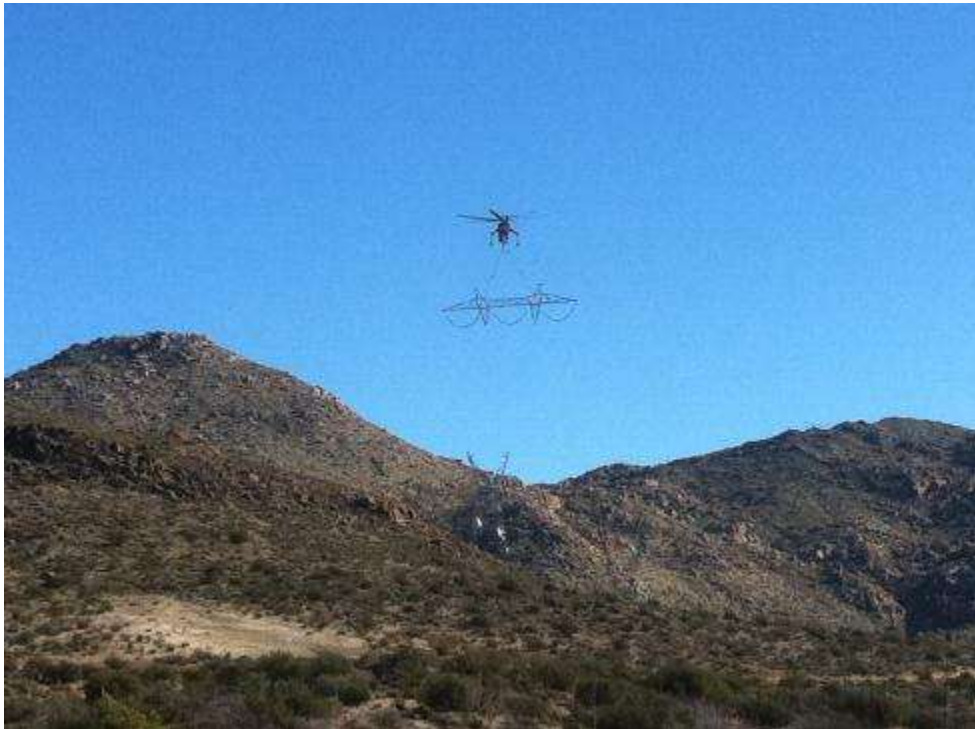
**Figure 4:** Aircrane setting bridge at EP253-3. (Link 1)

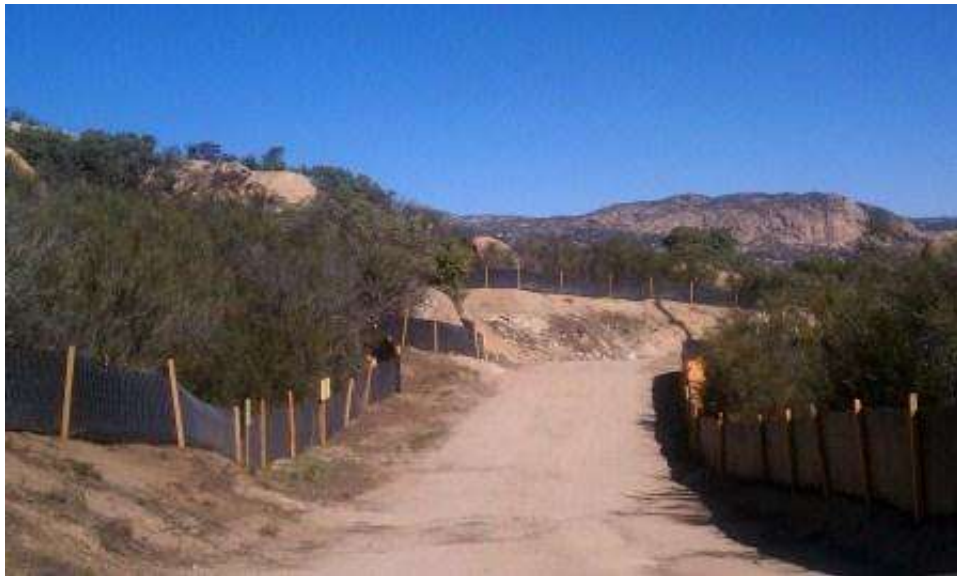
**Figure 5:** Arroyo Toad fencing installed along access road near EP65. (Link 3)

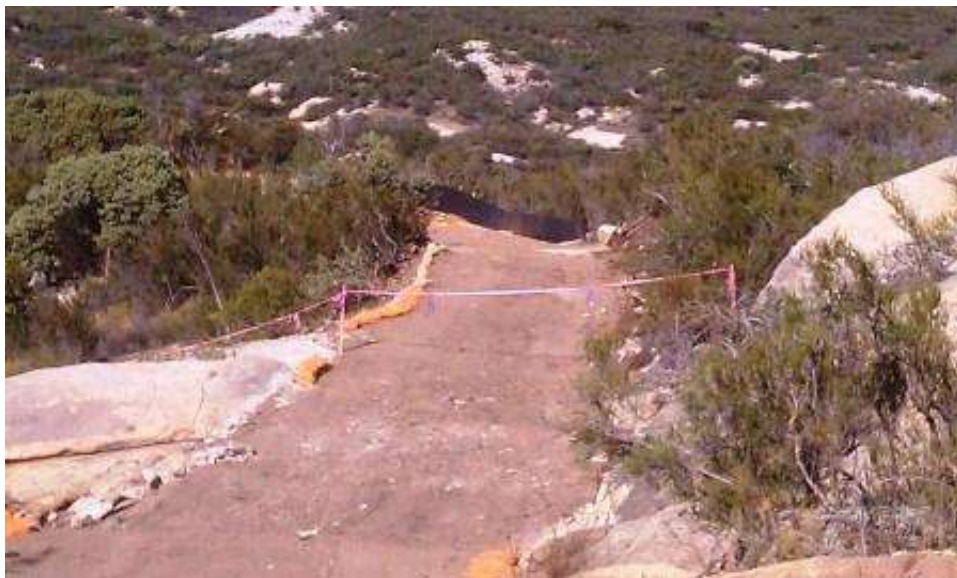
- No work occurred on the USFS during this reporting period (see Figure 6).

**Figure 6:** Access road to EP58-2 closed due to USFS-related work shutdown. (Link 2)

1. On January 7, the USFS issued a stop work order due to repeated violations of the Forest Service Fire Plan. As a result, no work occurred on USFS lands during the subject period.
2. Biological, Cultural, and Native American monitors were present as applicable during all transmission line construction activities.
3. BMPs were installed, refreshed, or maintained on tower sites, access roads, TSAPs, and pads associated with towers on Link 1:

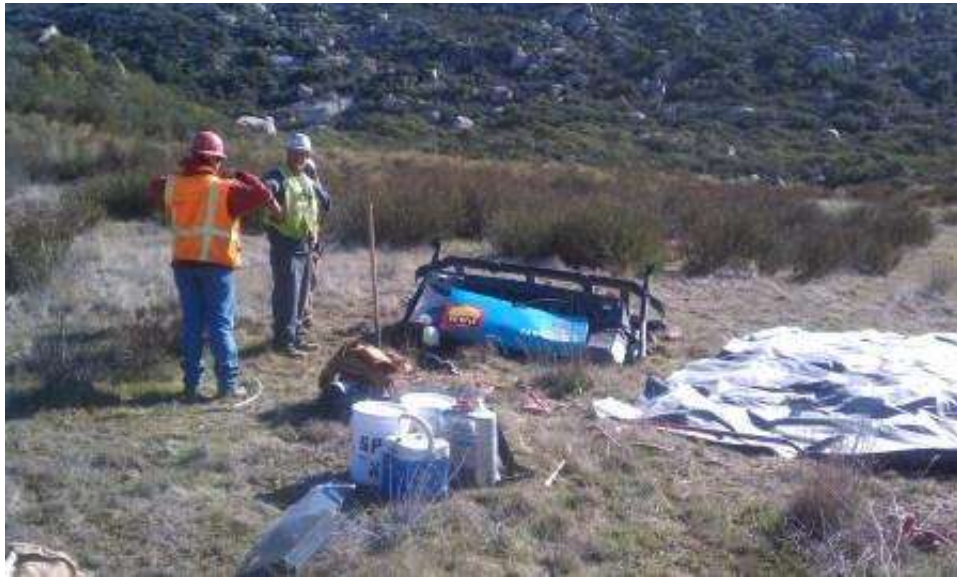
9. On January 9, 2012, a road crew was found to be present and working without an Arroyo Toad Monitor present at EP50. (Link 2)
10. On Friday, January 13, a helicopter dropped an air compressor into a field approximately 100 yards east of Kreuzcamp Construction Yard (see Figures 7 & 8). No people were injured. Crews contained spilling fuel, oil, and coolant. Contaminated soil was removed for processing. (Link 2)

**Figure 7:** Air compressor destroyed after falling from a helicopter into a field. Crew is staging cleanup efforts. (Link 2)

Type	Date	Location	Description
Incident	01/13/12	Link 2	An unanticipated release of a compressor mid-flight approximately 400ft North of Kruetzkamp CY. No injuries or damage to property occurred. Investigation to helicopter hook system is ongoing.
Incident	01/17/12	Link 2	Crew entered access road to EP73/74, Arroyo Toad suitable habitat, prior to the 2 hr waiting period following dawn and biological monitor clearance. Crew was spoken to and better signage is to be installed.
Incident	01/18/12	Link 1	Concrete blocks were placed outside of approved disturbance area at EP224/5 prior to the approval of Variance #37. To limit disturbance, blocks have been left, but cannot be used until approval of the variance.
Incident	01/18/12	Link 1	Assembly crew arrived at EP177 prior to an approved bird survey having been conducted and submitted. Crews were ushered out by onsite avian biologist performing said survey.

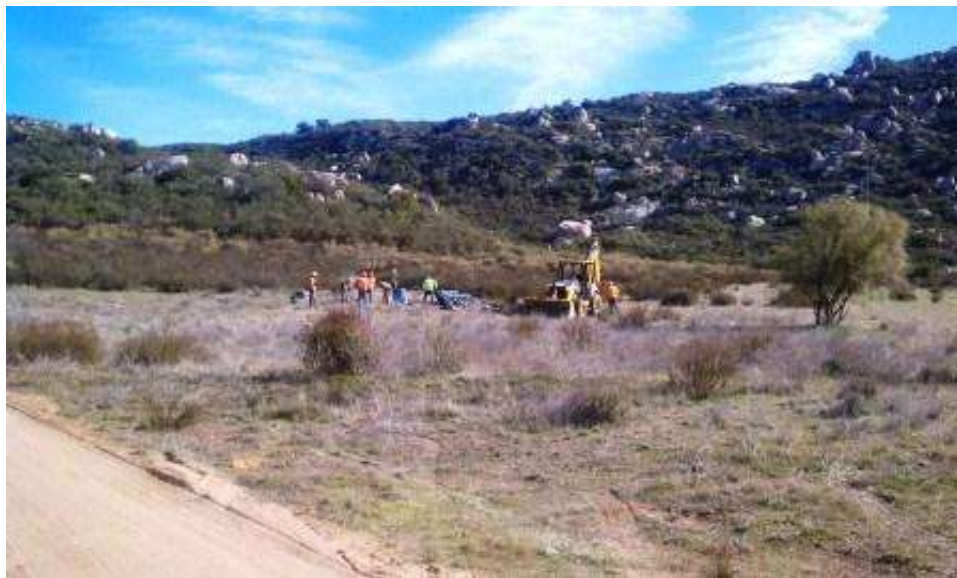
**Figure 8:** View of field where air compressor fell. (Link 2)
