## **PROJECT MEMORANDUM PG&E – TRI-VALLEY 2002 CAPACITY INCREASE PROJECT**

**To:** Roosevelt Grant, CPUC  
**From:** Vida Strong, Aspen Project Manager  
**Date:** February 6, 2003  
**Subject:** Weekly Report #20: January 27, 2003 – February 2, 2003  
**CPUC Environmental Monitor (EM):** Anne Sweet

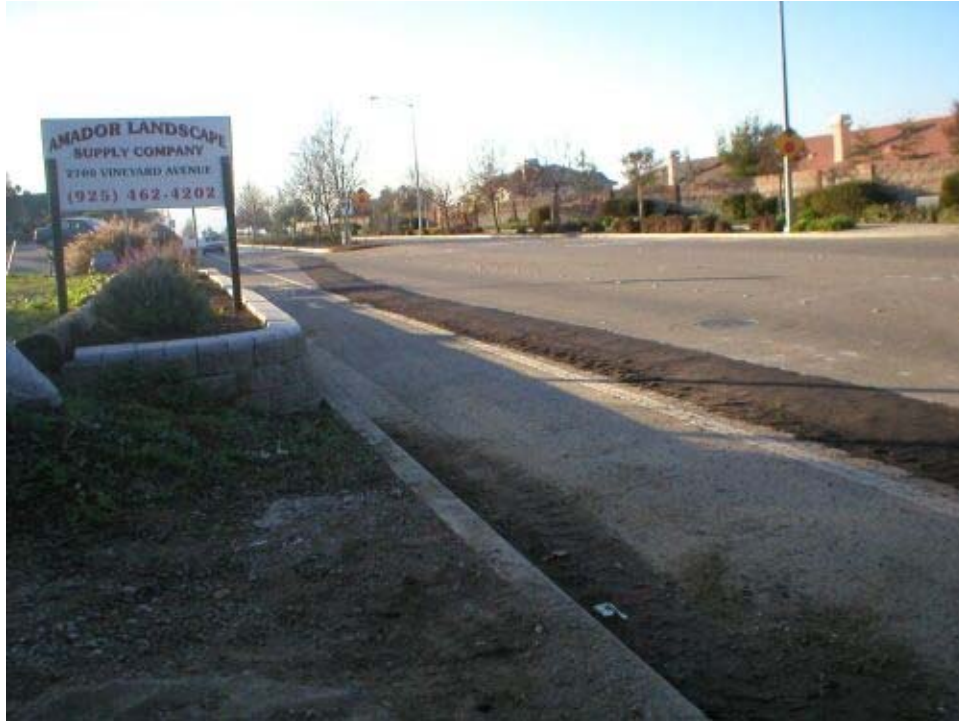
Crews continued trenching within “Old” Vineyard Avenue west of Vista Diablo Court between Stations 261+00 and 262+00. Per the City of Pleasanton, the trench line is temporarily backfilled to allow vehicle passage during non-construction hours (see Figure 1); steel plates are also used as an alternative method to cover the open trench line.

Figure 1  
Temporary backfilled trench line within Vineyard Avenue to allow vehicle passage during non-construction hours.

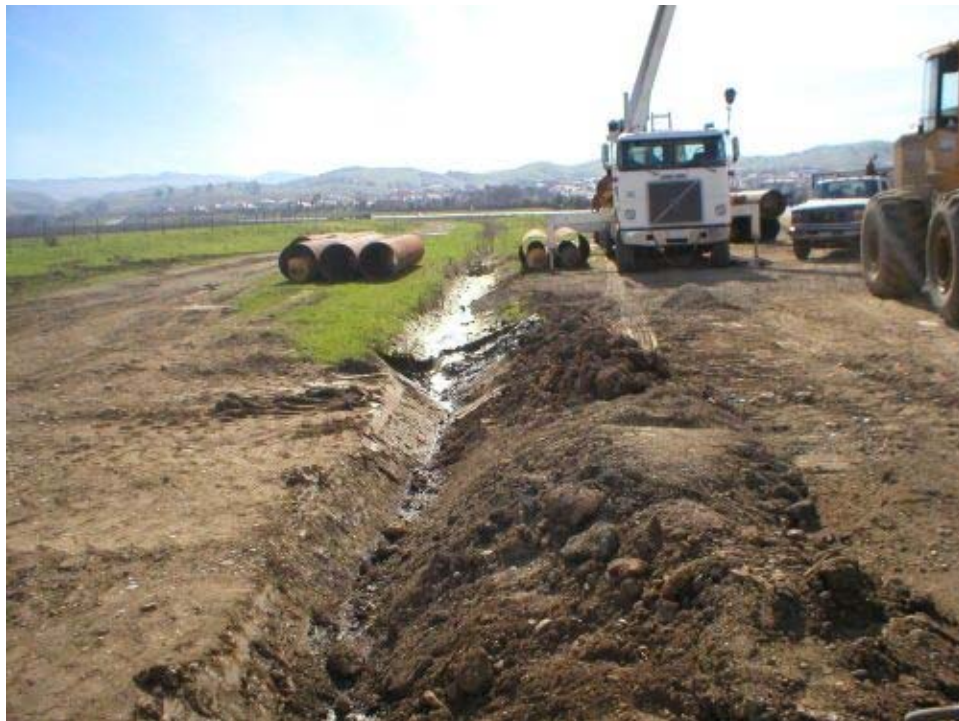
At the Isabel bore location, shoring has been installed and the bore rig and crane placed east of Isabel Avenue; drilling operations should start soon. Spoils are being placed along the right-of-way. A storm drain near the bore has been bridged with steel plates. The Essex EI had requested crews to move equipment away from the drainage area (see Figure 2).

Figure 2  
Storm drain near the Isabel Avenue bore.

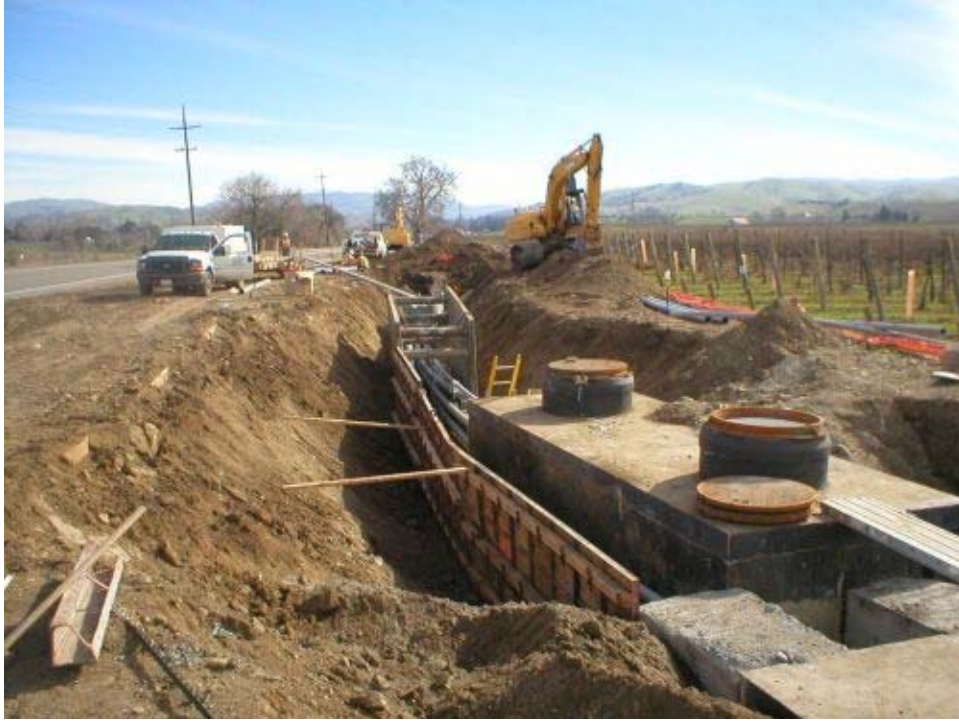
Along "Old" Vineyard Avenue, crews started installation of Vaults 7A and 7B; continued the installation and conduit tie-in for Vaults 6A, 6B, 8A, 8B, 9A, 9B, 15A and 15B; and completed work on Vaults 10A and 10B (see Figures 3 and 4). During the subject week the contractor continued tie-ins to Vaults 17A and 17B. The City of Pleasanton Inspector has requested that the street be kept clean at this location. Crews have been responsive to this request.

Figure 3  
Conduit tie-ins to Vaults 6A and 6B.

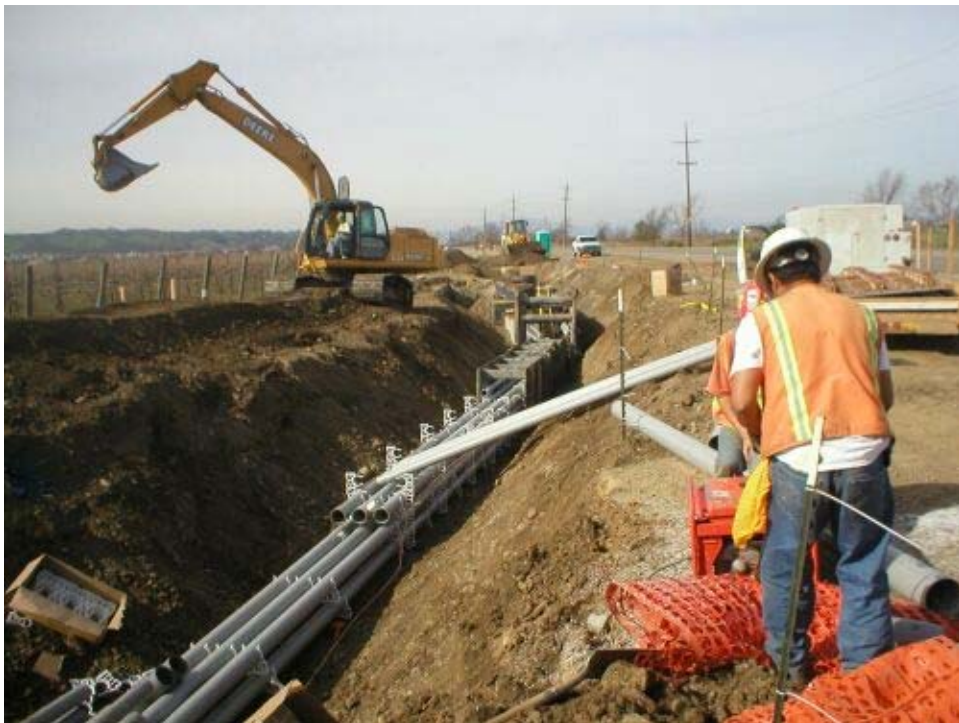
Figure 4  
Conduit tie-ins to Vaults 6A and 6B.
