## **PROJECT MEMORANDUM PG&E – TRI-VALLEY 2002 CAPACITY INCREASE PROJECT**

**To:** Roosevelt Grant, CPUC  
**From:** Vida Strong, Aspen Project Manager  
**Date:** April 24, 2003  
**Subject:** Weekly Report #31: April 14, 2003 – April 20, 2003  
**CPUC Environmental Monitor (EM):** Anne Sweet and Jenny Slaughter

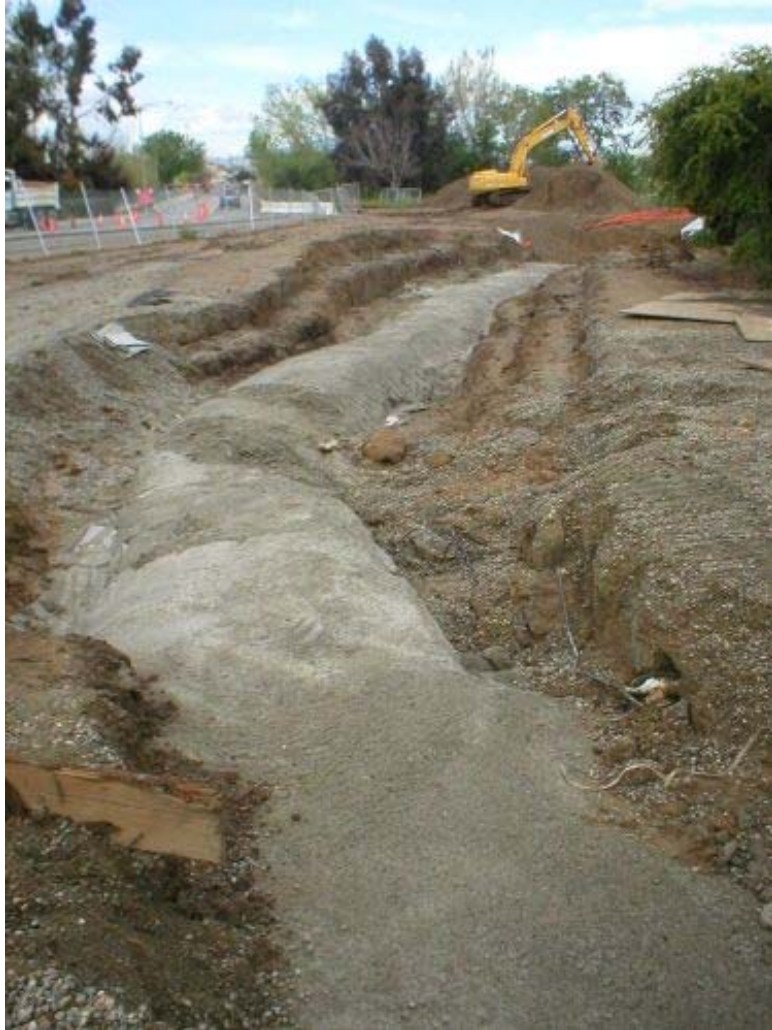
With the completion of trenching and conduit installation within “Old” Vineyard Avenue from Vaults 17A and 17B to the Southern Arroyo Del Valle bore tie-in, crews were pouring concrete over the installation and backfilling took place (see Figure 1). Sections of the trench in this area are also being repaved. Minor repaving and restoration occurred from the Vault 15 location and Vault 14 location. Cable splicing took place at Vaults 14 and 16. Traffic Control Plans were implemented.

Figure 1 - Tie-in to south of the Arroyo del Valle.  
Concrete was poured over the conduit.

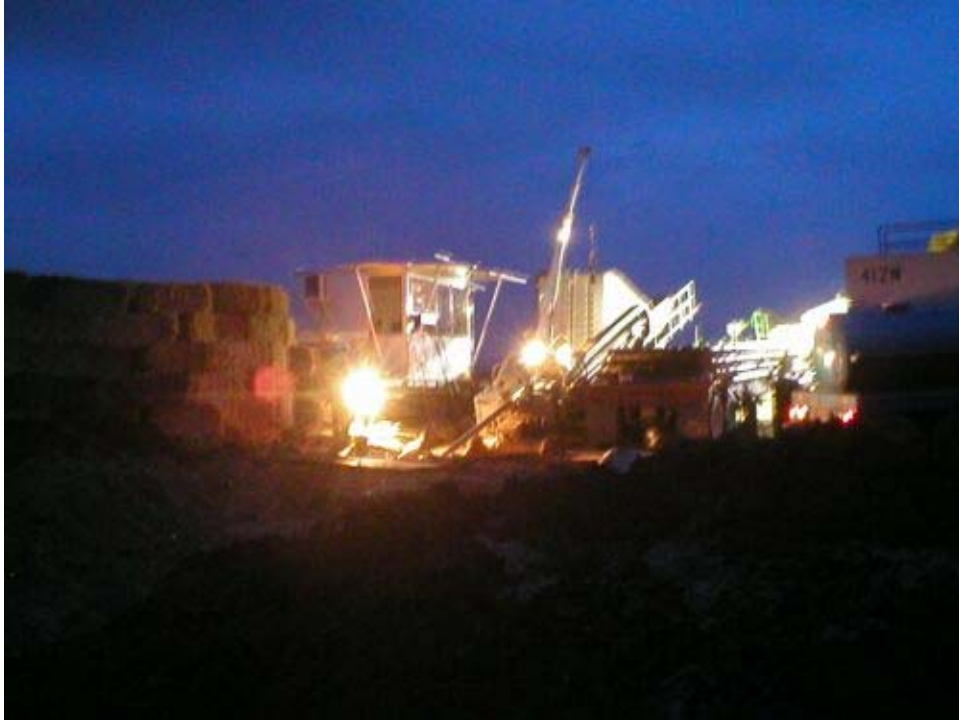
At New Vineyard Road, directional-drilling operations continue at the bridged unnamed tributary that crosses the roadway. Essex submitted a 24-hour work proposal package to the CDFG and on Tuesday April 15, CDFG responded with approval for the 24-hour work contingent on specific lighting and monitoring requirements, as well as frac-out contingency protocol (see Figures 2 and 3). Crews began the second bore during the subject week and are currently operating 24-hours/day. No frac-outs were observed during the subject week. The CPUC EM inspected the installation of erosion controls and frac-out contingency containment and clean-up equipment for the drilling operation.

Figure 2 - New Vineyard Road Tributary Bore Rig Lighting

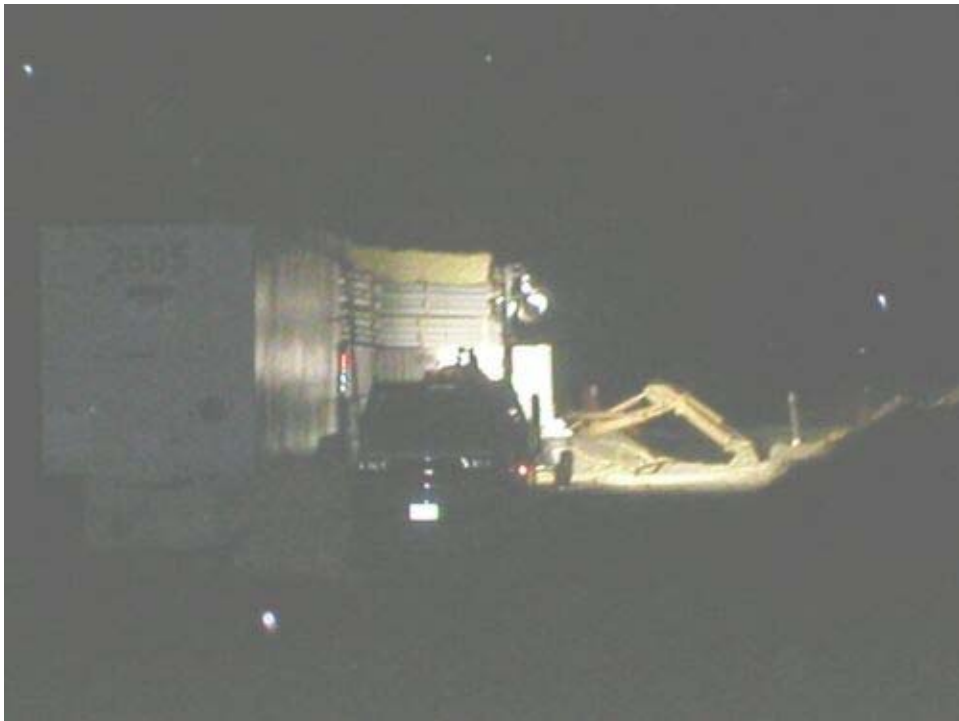
Figure 3 - New Vineyard Road Tributary Bore Exit Pit Lighting.

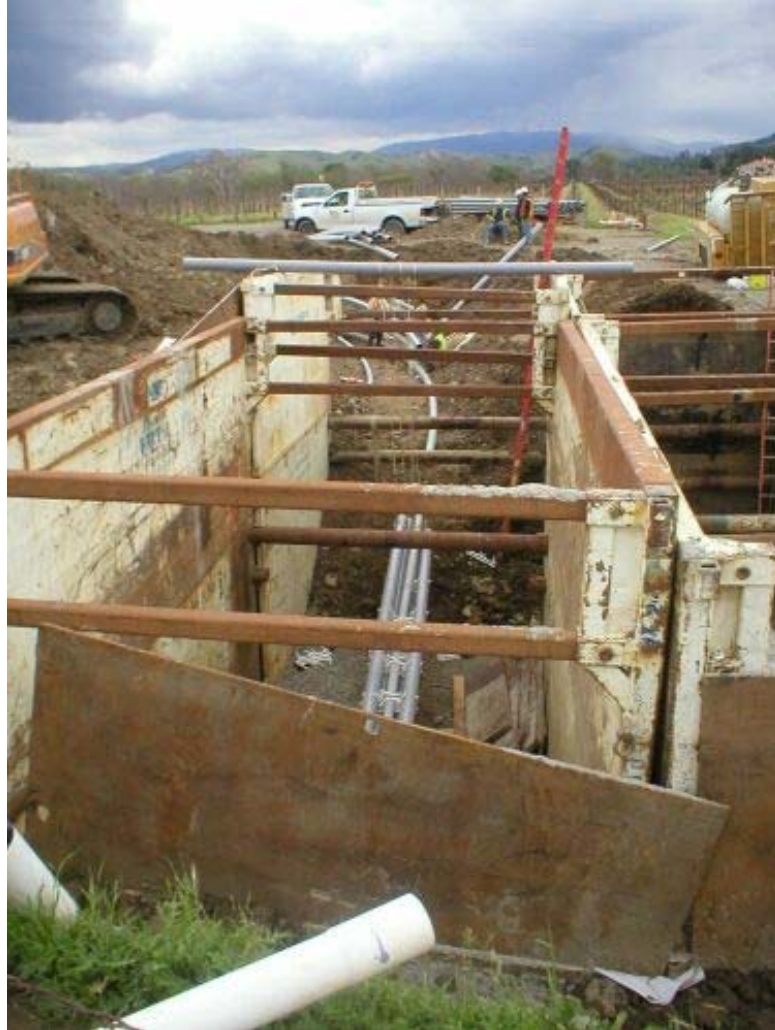
Boring operations have been completed at Highway 84, but de-watering continues. Crews are stringing the conduit through the boreholes and tying into the main line on both sides of the bore (see Figure 4). The site appears to be contained and in compliance. The bottom of the de-watering detention basin is coated with a layer of sediment; however, no run off is occurring.

Figure 4 - Highway 84 bore tie-in work

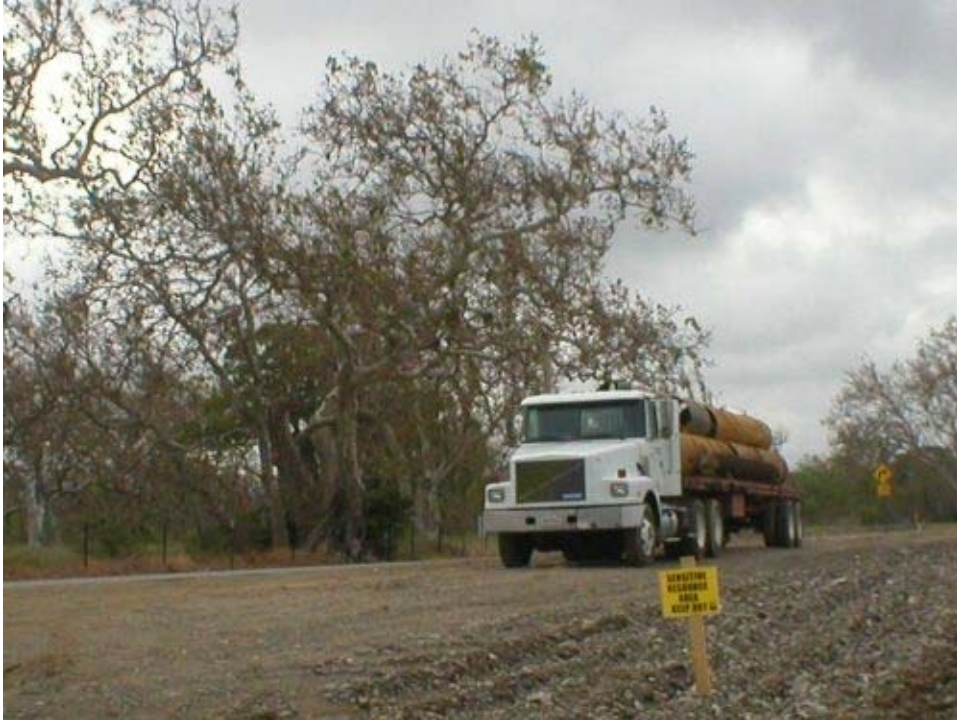
The CPUC EM inspected the Red Tail Hawk’s nest along the right-of-way along the Zone 7 Access Road east of Highway 84 at Station 61+00. Exclusion signs were erected. While on-site, the CPUC observed

that a truck loaded with boring equipment was parked directly within the resource exclusion boundaries (see Figure 5). Photos were taken and the Essex EI showed up at the site. A Project Memorandum was written stating:

*“On April 17 at approximately 8:45 a.m., the CPUC observed a project subcontractor truck and equipment parked within the 250-foot exclusion zone of an active Red Tail Hawk’s nest, which was identified by a PG&E biologist and documented in survey findings. This action is in direct violation of project Mitigation Measure B-5 that states that construction and maintenance activities shall be scheduled to avoid critical seasons. Raptor nests will be avoided during specific seasons throughout the construction, operation and maintenance of the proposed project. Applicant Proposed Mitigation Measure 7.4 States if occupied habitat is detected...a construction free buffer of at least 250 ft around the nest will be maintained to protect the breeding birds.”*

Note: Exclusion signs at the 250 ft buffer boundaries were in place and at the time of the incident and the Environmental Monitor was not on-site. The active nest was identified by survey to have a clutch of eggs.

Figure 5 - Project subcontractor truck parked within the Red Tail Hawk exclusion zone.  
Note the sensitive resource exclusion area sign in the foreground.

On April 17, a Project Memorandum was issued to the Essex EI documenting non-compliance with project Mitigation Measure and applicant-proposed Mitigation Measure 7.4 regarding activity in a resource exclusion area.
