PROJECT MEMORANDUM PG&E – TRI-VALLEY 2002 CAPACITY INCREASE PROJECT

To: Roosevelt Grant, CPUC
From: Vida Strong, Aspen Project Manager
Date: May 8, 2003
Subject: Weekly Report #33: April 28, 2003 – May 4, 2003
CPUC Environmental Monitor (EM): Anne Sweet

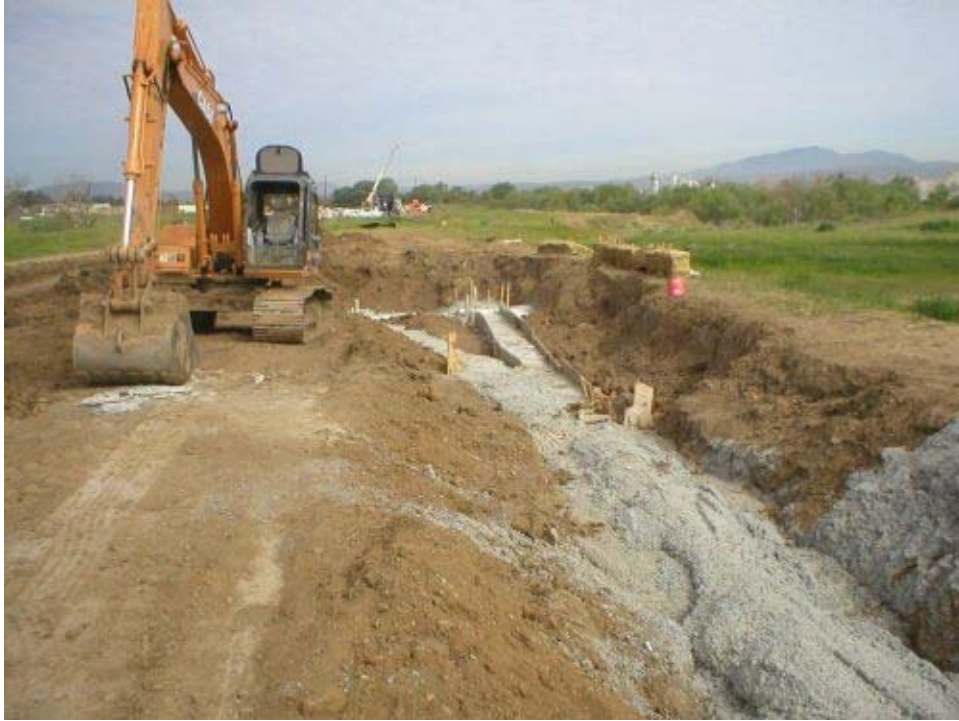
Figure 1 - New Vineyard Road Tributary tie-in work, the HDPE casings and conduit have been poured in concrete.

At New Vineyard Road, boring of the CDFG jurisdictional tributary was completed on Thursday, April 24. All boring equipment and light and sound shielding barriers have been removed from the site. Crews have completed tie-ins to the bore (see Figure 1). Crews pulled line from the Vault 12 location under the tributary to the Vault 11 location (see Figure 2). While on-site the CPUC EM noticed a volume (approximately 300 gallons) of fine sediment laden mud located within 10 feet of the CDFG jurisdictional tributary (see Figure 3). A large storm event was forecasted and the CPUC EM was concerned that the mud could breach the erosion control at the site and impact the resource. The Mueller foreman arrived on-site and stated that the mud would be completely removed by the end of the day. The CPUC EM later re-toured the area and confirmed that the mud was being removed and taken to the dirt enclosure area at the Mueller yard.

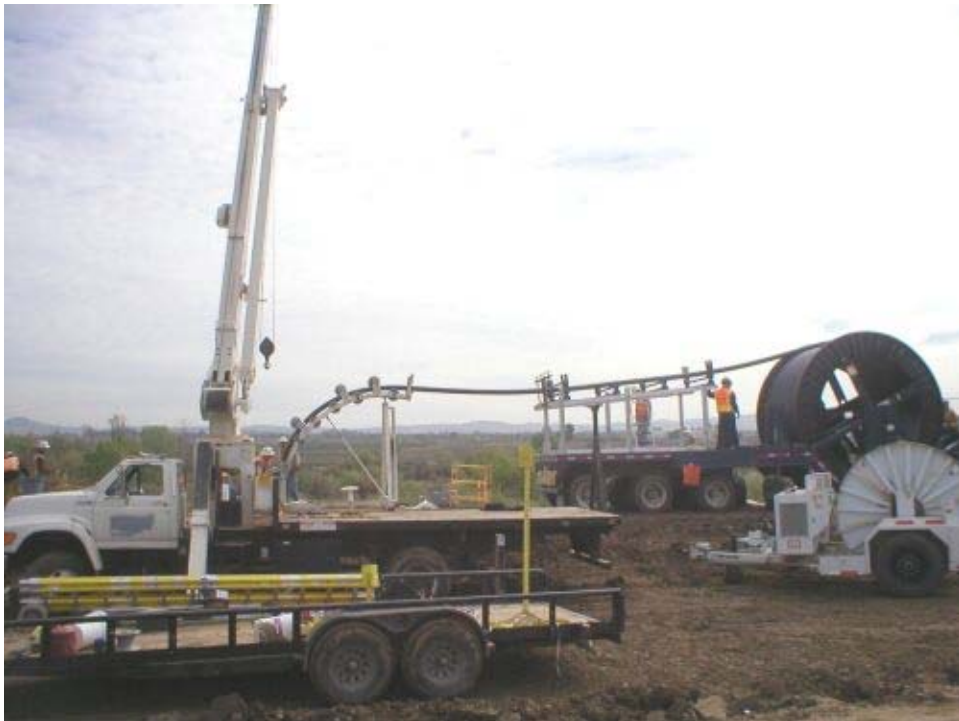
Figure 2 - Transmission line pull from Vault 12 to Vault 11 through HDPE casings installed in the New Vineyard Road Tributary Bore.

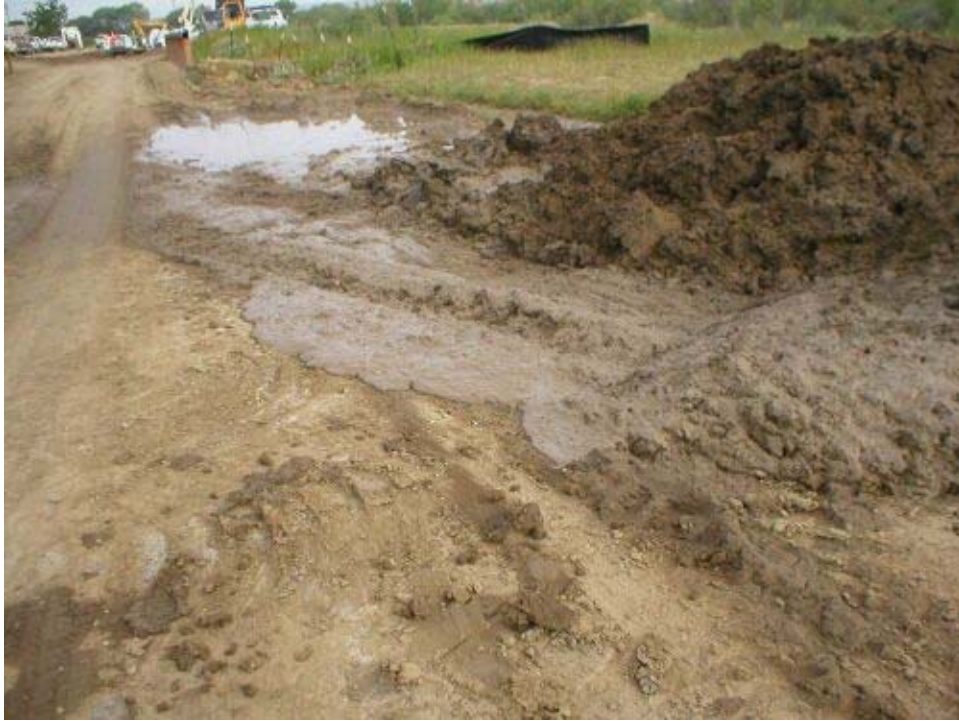
Figure 3 - New Vineyard Road Tributary tie-in work.
Note the large mud pile to the right of the photo.

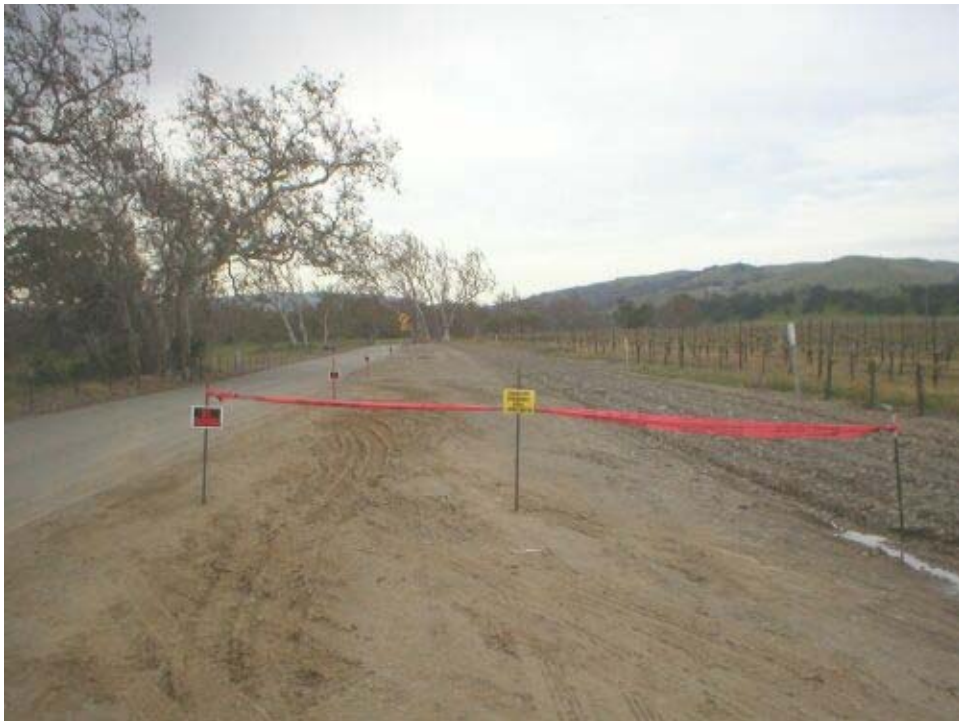
On April 28, the 250-foot buffer for the Red Tail Hawk's nest at Station 61+00 was breached by a project truck driver who willfully removed the excluding posts and tape. This action was in violation of applicant-proposed Mitigation Measure 7.4 regarding activity in a resource exclusion area. Essex documented the issue as a non-compliance and environmentally re-trained all subcontractors on April 29.

Figure 4 – Fencing and additional signs installed at the
Red Tail Hawk's nest exclusion boundaries.

The CPUC EM inspected the Red Tail Hawk's nest along the right-of-way along the Zone 7 Access Road east of Highway 84 at Station 61+00. On April 17, the CPUC observed that a project truck was parked directly within the resource exclusion boundaries. A Project Memorandum was written by the CPUC documenting the issue. Additional exclusion posts and red tape were installed in the area to prevent crewmembers from accidentally entering the exclusion zone. On Monday April 28, the Essex EI called with information that the Red Tail Hawk's nest 250-foot buffer exclusion zone was again breached. A project subcontractor had removed the posts and exclusion tape in order to back a project vehicle into the exclusion zone. The truck breached the line by 25-feet. This incident marks a repeated and willful direct violation of project Applicant Proposed Mitigation Measure 7.4 which states if occupied habitat is detected a construction free buffer of at least 250-foot around the nest will be maintained to protect the breeding birds. Essex identified the problem and reported the incident as a project non-compliance. Essex held an additional tailgate environmental training of all subcontractor personnel on Tuesday April 29, to reiterate environmental regulations. Note that all site personnel and sub-contractors are environmentally trained prior to working on the project. The additional exclusion fencing installed in the area to prevent crewmembers from accidentally entering the exclusion zone had been re-installed and additional no parking-sensitive resource area signs have been put up (see Figure 4).
