## **PROJECT MEMORANDUM PG&E – TRI-VALLEY 2002 CAPACITY INCREASE PROJECT**

**To:** Roosevelt Grant, CPUC  
**From:** Vida Strong, Aspen Project Manager  
**Date:** September 25, 2003  
**Subject:** Weekly Report #53: September 15, 2003 – September 21, 2003  
**CPUC Environmental Monitor (EM):** Anne Sweet and Jenny Slaughter

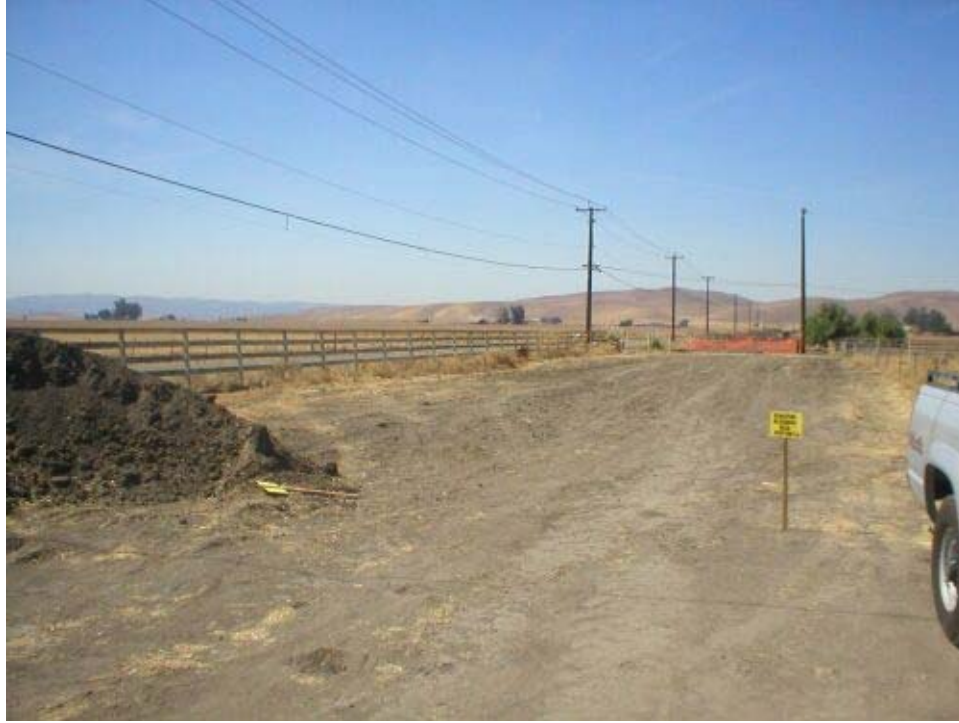
Recently, the burrowing owls, which had occupied the nest located approximately 295-feet from the PSD yard site, began to disperse. One young bird took residence in a burrow located approximately 130 feet west of the PSD yard and 140 feet north of the right of way along May School Road. A 160-foot buffer is required and has been put in place. On September 19, at the PSD Yard a sensitive resource sign delineating the burrowing owl buffer along the right-of way had fallen and was lying on the dirt. The CPUC EM contacted the Essex EI and notified him of the problem (see Figure 1). The EI returned to the site and replaced the sign. On September 19, the Essex PM distributed an E-mail stating that the Essex EI had not seen the burrowing owl at the burrow location since Wednesday, September 17, and that the buffer should no longer apply. The Aspen/CPUC PM asked if the CDFG had given concurrence for the latest request. The Essex PM responded that a request will be going to CDFG and asked if crews could remove equipment from the buffer area by hand. The Aspen/CPUC PM agreed that foot traffic within the buffer was acceptable. The CPUC EM inquired as to whether a survey had yet been conducted by a qualified biologist at the site to confirm the abandonment of the burrow by the fledging. The next day, a biologist reviewed the area and concluded that the subject burrow was no longer in use and that an owl had been spotted in the field across May School Road.

Figure 1- Burrowing Owl buffer signage at the PSD yard and adjacent alignment, Phase Two.

On September 19, at the PSD Yard a sensitive resource sign delineating the burrowing owl buffer along the right-of way had fallen and was lying on the dirt. The CPUC EM contacted the Essex EI who returned to the site and replaced the sign.

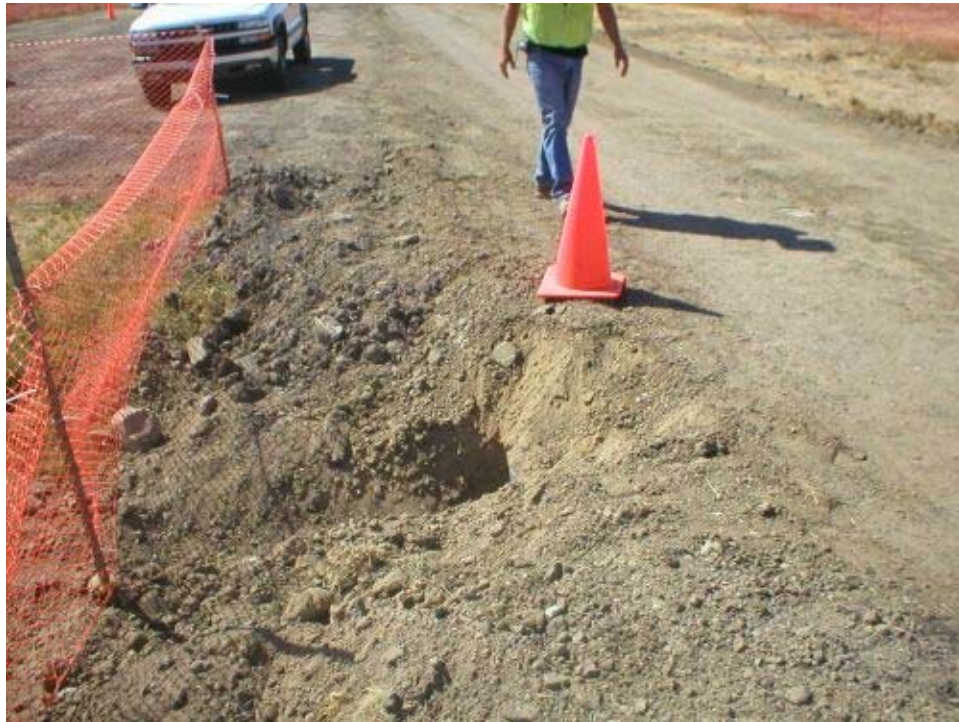
On September 19, along the access road between the Transition Station and Dagnino Road, the CPUC EM observed that the USACE jurisdictional drainage culvert was blocked by dirt; in fact the culvert was no longer visible on one side. Conduit installation and backfilling has already been completed through the drainage; however, the general area had not yet been officially restored. The Essex EI was notified of the issue and replied that PG&E was in compliance, that current mitigation states that the watercourse cannot be changed and that PG&E does not need to take action at this time. The EM responded that the current condition of the drainage (blocked) would indeed change the watercourse. Upon returning to the USACE jurisdictional drainage a while later, the Essex EI and the contractor had completed digging out and clearing the culvert (see Figure 2).

Figure 2 –USACE jurisdictional drainage along the access road between Dagnino Road and the Transition Station, Phase Two.

On September 19, along the access road between the Transition Station and Dagnino Road, the CPUC EM observed that the USACE jurisdictional drainage culvert was blocked by dirt. Upon returning to the USACE jurisdictional drainage a while later, the Essex EI and the contractor had completed digging out and clearing the culvert.
