## **PROJECT MEMORANDUM PG&E – TRI-VALLEY 2002 CAPACITY INCREASE PROJECT**

**To:** Jensen Uchida, CPUC  
**From:** Vida Strong, Aspen Project Manager  
**Date:** March 8, 2006  
**Subject:** Weekly Report #100: February 26, 2006 – March 4, 2006  
**CPUC Environmental Monitor (EM):** Anne Sweet Coronado

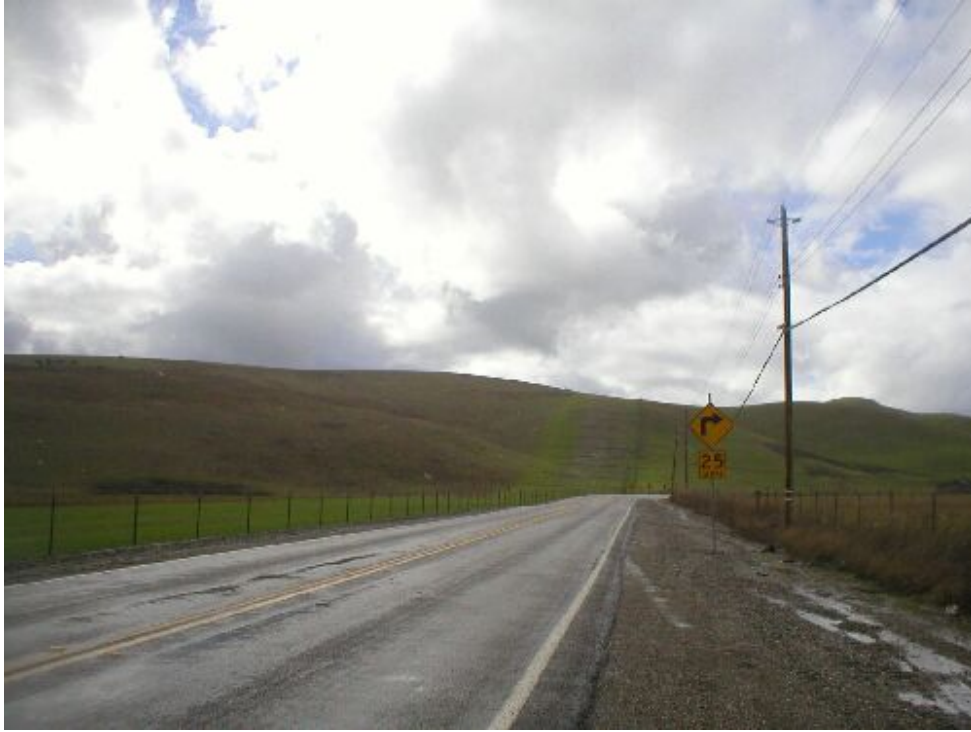
Along the underground alignment installation which extends up a steep slope extending from Manning Road off of North Livermore Avenue, the back filled trenchline (backfilling occurred last fall) appears stable, showing good vegetative growth (see Figure 1). The CPUC EM had noted previously that slumping of the graded areas above the road had occurred along Road 6. Opus and North Valley have been and will continue to take steps to ensure that down slope sedimentation does not occur. Per the PG&E ‘Erosion and Sediment Control Concern’ letter dated February 24, 2006 “Once the project area is sufficiently dry to conduct work, this area will be repacked, re-contoured, and reseeded”.

**Figure 1** – View of the underground alignment along a steep slope extending from Manning Road off North Livermore Ave. – February 28, 2006.

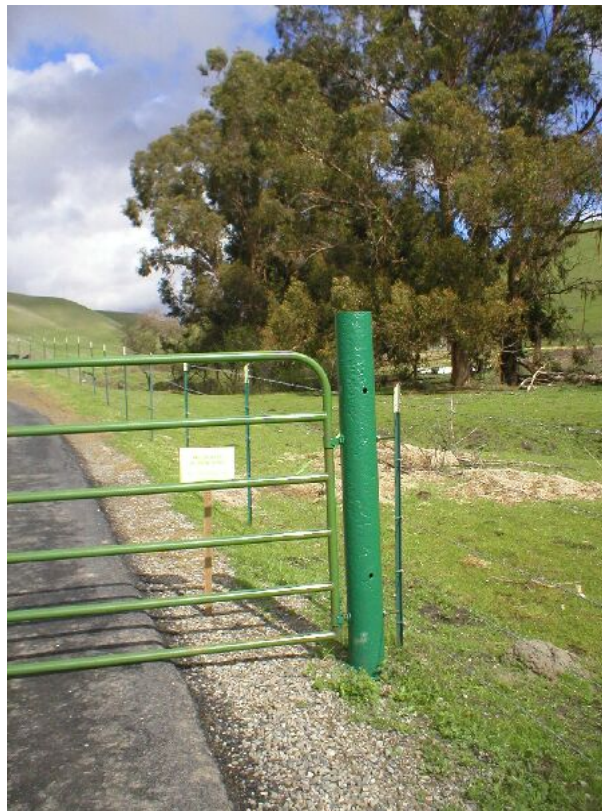
On Monday, February 13<sup>th</sup>, Opus reported that multiple tri-colored blackbirds were observed foraging along Moller Road near the Substation site. These birds continue to occupy the area. On Thursday, February 16<sup>th</sup>, a pair of red-tailed hawks were observed near a nest structure adjacent to Moller Road at Station 14+50. Opus continued to monitor the area and potential nesting activities continued during the subject week. On February 23<sup>rd</sup>, PG&E established a 250-ft buffer extending from each side of the nest where project parking and stopping are prohibited. A portion of Moller road lies within 250 feet of the nest (see Figure 2). Moller Road is currently being used for project ingress and egress. Opus contacted CDFG on February 23<sup>rd</sup> and 24<sup>th</sup> to inquire about the establishment of the buffer zone around the hawks. CDFG concurred that travel could continue along Moller Road at the current level.

**Figure 2** – Red tail hawk nest buffer beginning at the Moller Road entrance gate, February 28, 2006. Note the posted no parking or stopping signs.

Opus contacted CDFG on February 23<sup>rd</sup> and 24<sup>th</sup> to inquire about the establishment of the buffer zone around the pair or red-tailed hawks which were observed near a nest structure adjacent to Moller Road at Station 14+50. Marcia Grefsrud of CDFG concurred that travel could continue along Moller Road on February 28<sup>th</sup>.
