PROJECT MEMORANDUM PG&E – TRI-VALLEY 2002 CAPACITY INCREASE PROJECT

To: Jensen Uchida, CPUC
From: Vida Strong, Aspen Project Manager
Date: March 31, 2006
Subject: Weekly Report #103: March 19, 2006 – March 25, 2006
CPUC Environmental Monitor (EM): Anne Sweet Coronado

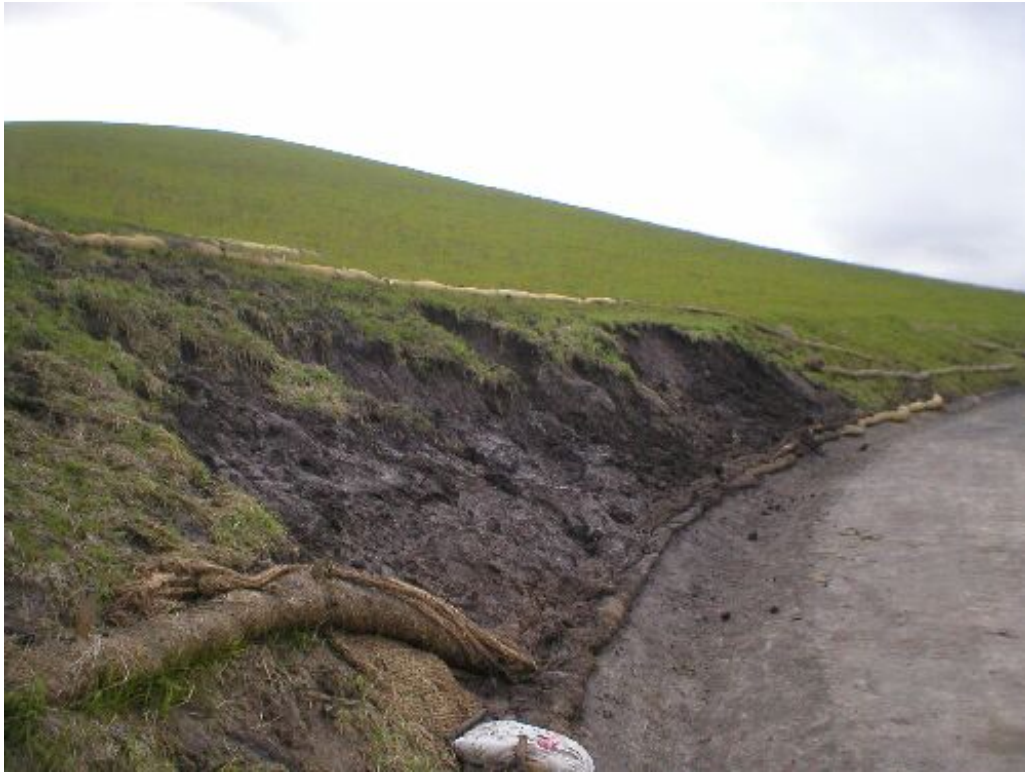
The CPUC EM had noted previously that along Road 6 slumping of cut slope areas above the road had occurred. Due to the recent storms much greater slumping of the area continues to occur (see Figure 1). Per Opus, “On March 23, North Valley Construction (NVC) crews were on site to remove the excess soil that had slid onto Road 6. NVC did not replace the jute netting in this location because PG&E engineers were scheduled to visit this location on Friday, March 24, to investigate permanent solutions to the slope slippage. Due to the other erosion and sediment control measures in place at this location...and the distance from any aquatic resources (over 400 feet), no adverse impacts to adjacent drainages are anticipated in the interim...NVC is scheduled to return to this area on Tuesday, March 28, to replace the jute netting.”

Figure 1 – Continued slumping along Road 6, March 24, 2006.

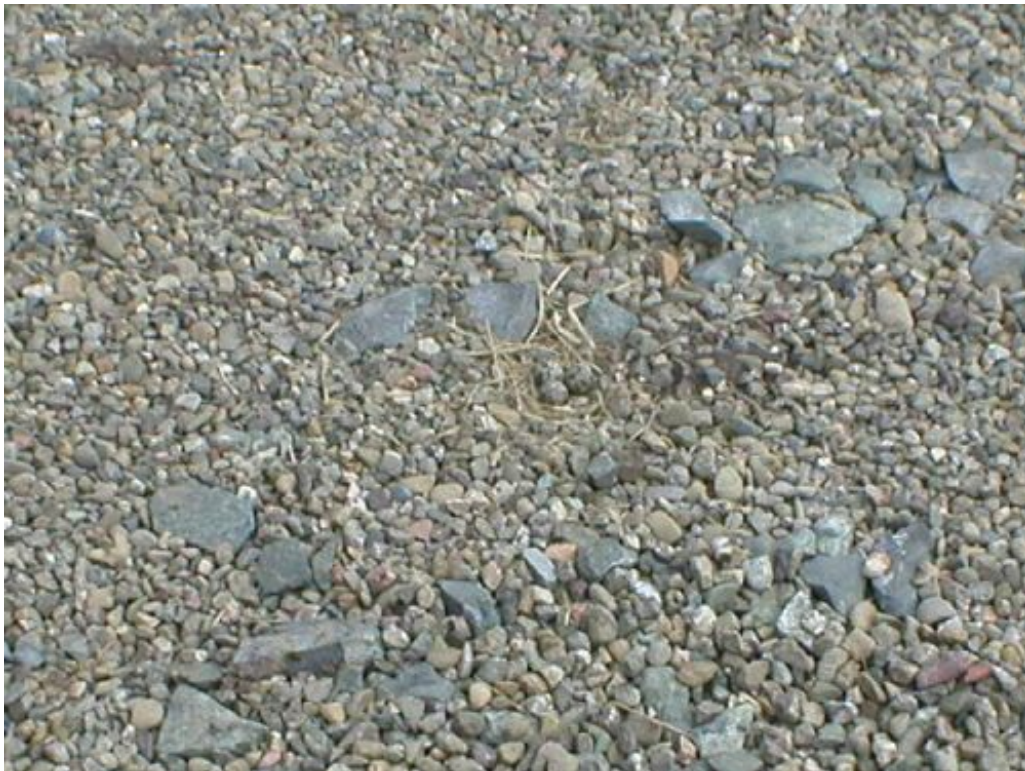
On March 14th, a killdeer bird nest was observed by Opus approximately 20 feet from the edge of Road 6 at Station 13+75. However, on March 20th, the nest no longer contained eggs and no hatchlings or shell fragments were observed. Opus will continue to monitor the area. The burrowing owl which had been previously identified along Road 6 was observed again at the same burrow location during the subject week. No work is currently occurring in the area. At the entry area to Road 7 a new killdeer nest containing 3 eggs was observed (see Figure 2).

Figure 2 – A killdeer nest identified at the entry of Road 7, March 24, 2006.

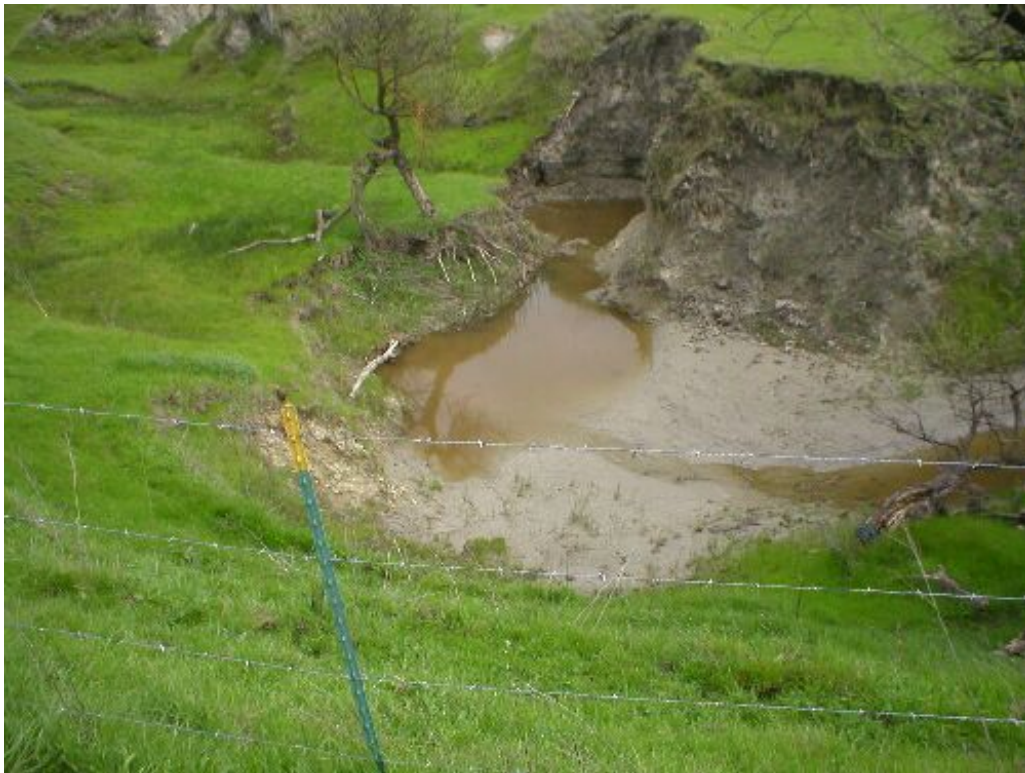
Figure 3 – Area of Tassajara Creek where western pond turtles have been repeatedly sighted, March 24, 2006.
