## **PROJECT MEMORANDUM PG&E – TRI-VALLEY 2002 CAPACITY INCREASE PROJECT**

**To:** Jensen Uchida, CPUC  
**From:** Vida Strong, Aspen Project Manager  
**Date:** April 6, 2006  
**Subject:** Weekly Report #104: March 25, 2006 – April 1, 2006  
**CPUC Environmental Monitor (EM):** Anne Sweet Coronado

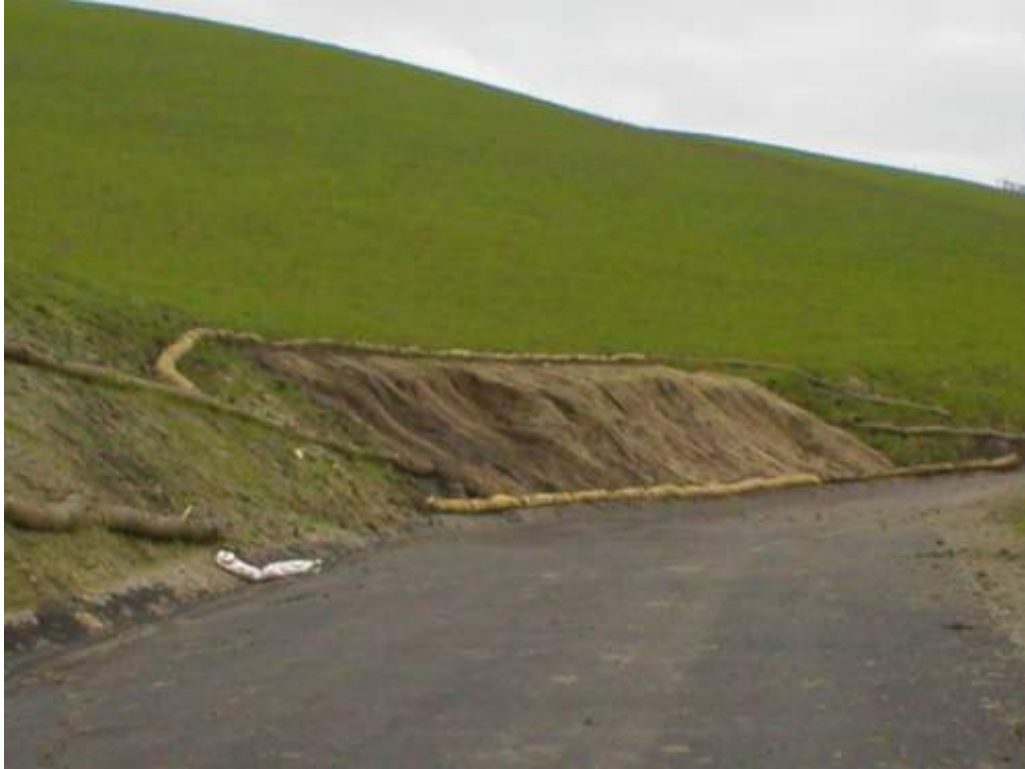
The CPUC EM had noted previously that along Road 6 slumping of cut slope areas above the road had occurred. Due to the recent storms much greater slumping of the area had continued to occur. Per Opus, “on March 28<sup>th</sup>, North Valley Construction (NVC) crews were on site to repair erosion and sediment control measures along Road 6. NVC crews removed the loose soil from the landslide, replaced jute netting and straw wattles, and removed sediment from the asphalt v-ditch and the R6-3 culvert inlet.” (see Figure 1).

**Figure 1** – NVC crews removed loose soil and installed jute netting and wattles along the landslide area along Road 6, March 30, 2006.

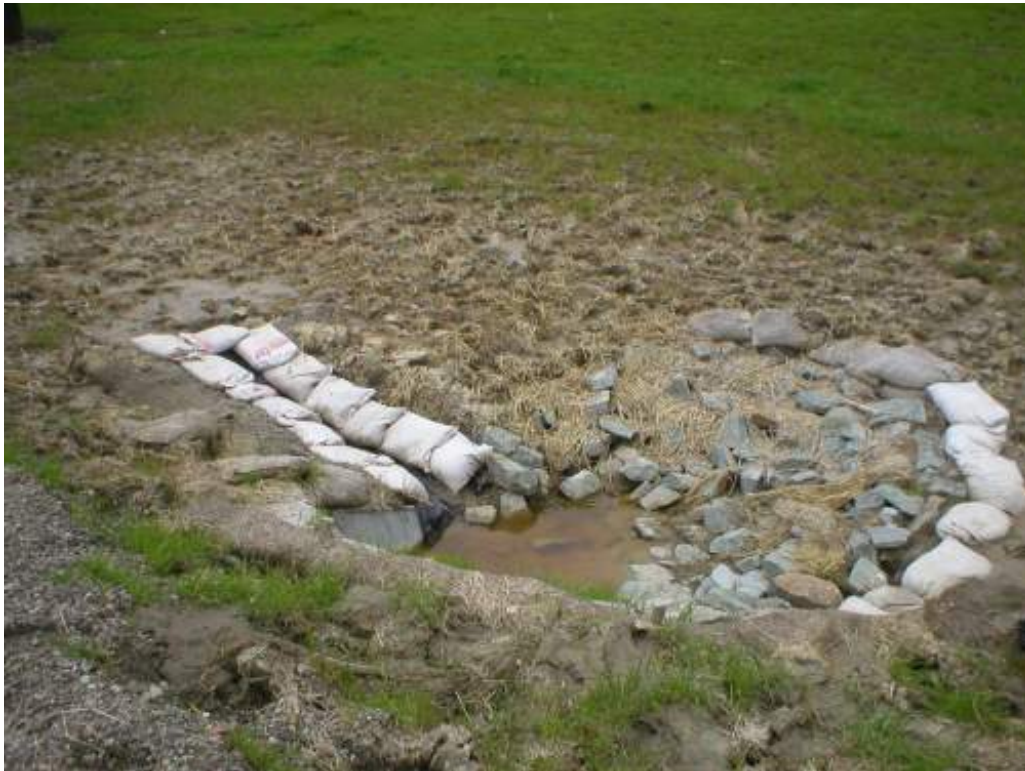
Along Moller Road and the mitigation site access road, a few areas along the new roadbed, including some culvert inlet areas, continue to show signs of ponding. Although sediment has built up in some areas along the road, it is continually being removed by NVC and the area maintained. The two areas of slumping down slope of the road bed remain covered in plastic. Opus and NVC have been and will continue to take steps to ensure that down slope sedimentation into resource areas does not occur. During the subject week NVC conducted culvert repair at MR-2, MR-3, MR-5 and MR-6 (see Figure 2). They also removed no longer needed sediment fencing along Moller Road.

**Figure 2** – Opus and NVC repaired culvert inlet area along Moller Road, March 30, 2006.

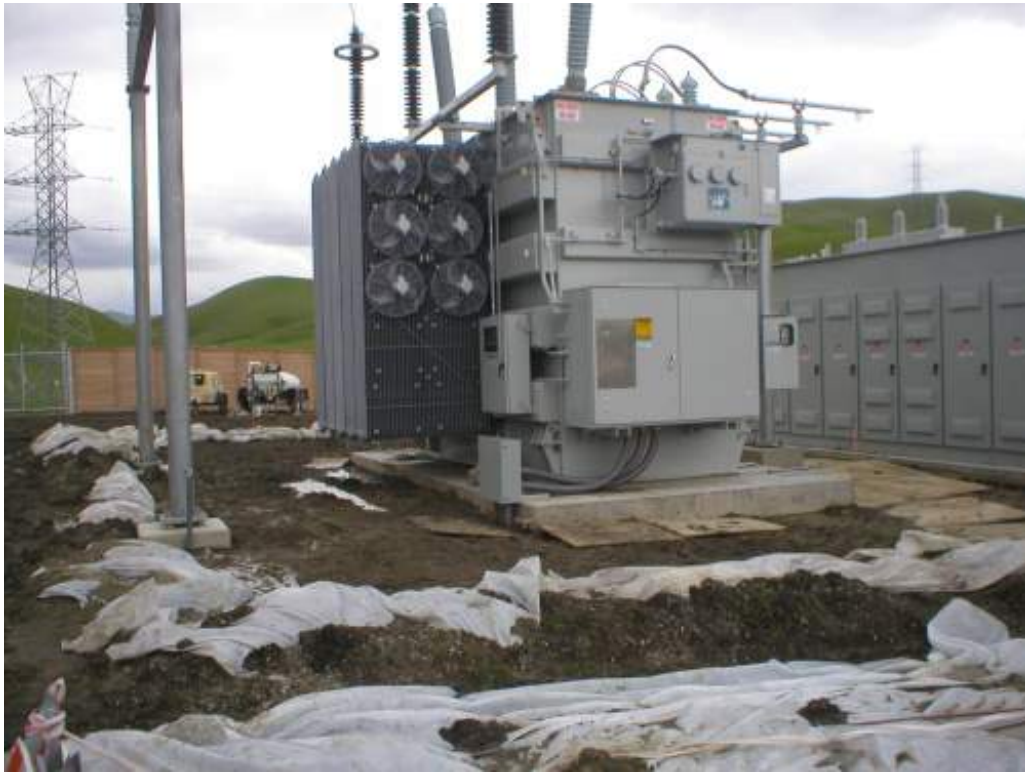
Black and Veatch continued construction at North Dublin Substation during the subject week. Fence crews completed the installation of the chain link fence around the back side of the Substation. On January 25<sup>th</sup>, crews filled the transformer with mineral oil. The Spill Prevention Control Countermeasure (SPCC) pond and drainage network has not been completed. An earthen berm with a plastic cover was placed around the transformer in case an oil spill occurs prior to completion of the pond. The secondary containment will continue to be maintained until the constructed SPCC pond is functional (see Figure 3). On Tuesday, March 7<sup>th</sup>, an adult female California red-legged frog was sighted in the SPCC pond. The frog was relocated to Tassajara Creek by an approved biologist and agency notifications were made. Per the USFWS inquiries and recommendations, exclusion fencing was placed around the pond to prohibit entrance of additional amphibians. On March 30<sup>th</sup>, a killdeer nest with one egg was found 2 feet from Moller Road, just past the Substation entrance area (see Figure 4). An 80-foot buffer was established around the nest.

**Figure 3** – Transformer surrounded by an earthen berm at the North Dublin Substation, March 30, 2006.

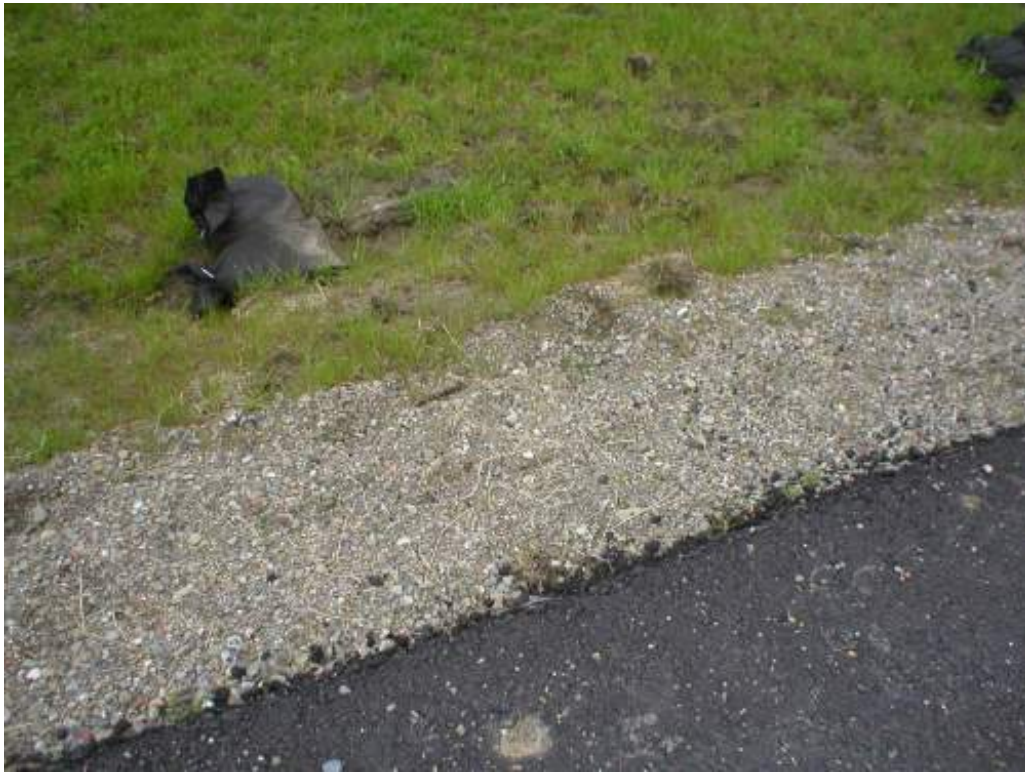
**Figure 4** – Killdeer nest containing one egg along Moller Road, March 30, 2006.
