PROJECT MEMORANDUM
PG&E – TRI-VALLEY 2002 CAPACITY INCREASE PROJECT

To: Jensen Uchida, CPUC
From: Vida Strong, Aspen Project Manager
Date: July 12, 2006
Subject: Weekly Report #115: July 2, 2006 – July 8, 2006
CPUC Environmental Monitor (EM): Anne Sweet Coronado

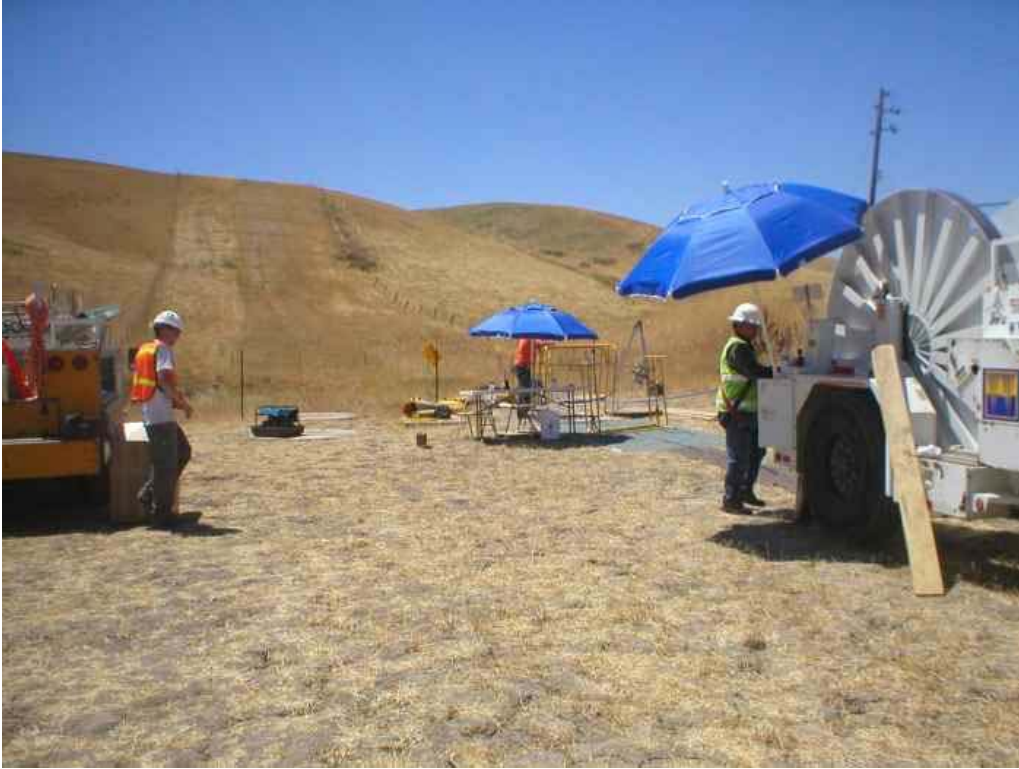
Cable pulling and splicing occurred at Vaults 3, 4, 5 and 6 during the subject week (see Figure 1). Jensen PreCast crews continued racking at Vaults 7 and 8.

Figure 1 – Cable pulling activities at Vault 5. July 7, 2006.

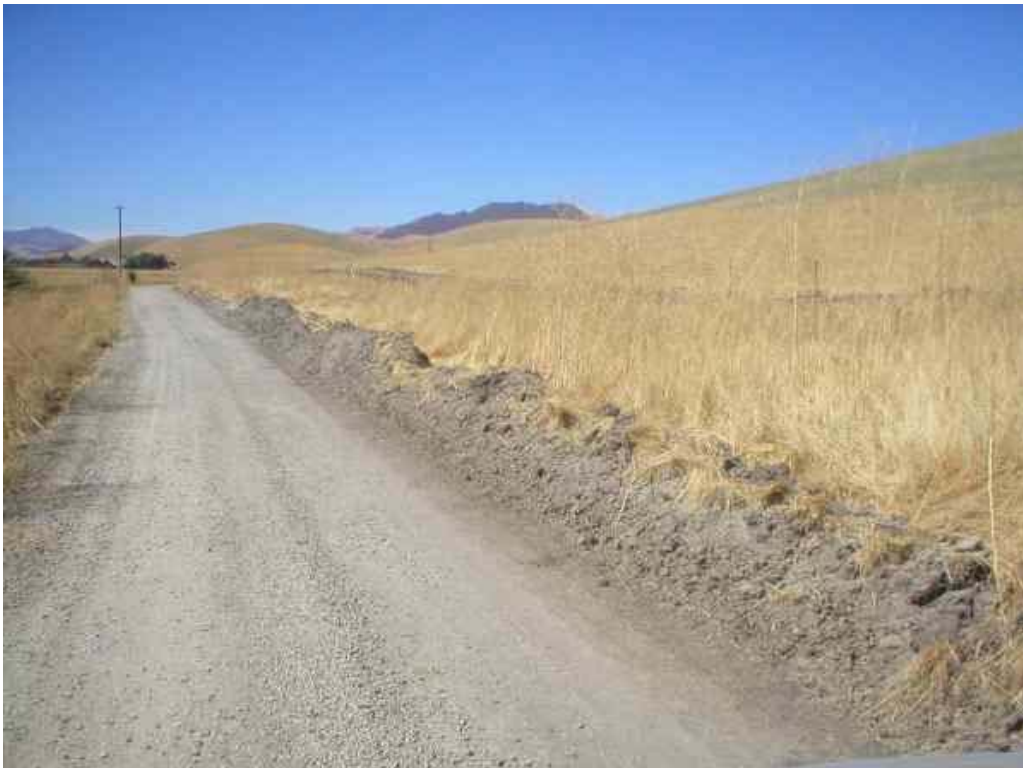
Though not reported in Weekly Report #114, grading activities were conducted on Road 5 on Thursday, June 29th (see Figure 2). More room was needed to accommodate the larger crane used for cable pulling activities. Road 5 was originally slated for upgrades due to the project. Per the Opus Weekly Report “Re-grading activities on Road 5 affected less than 20 potential Congdon’s tarplant individuals. The CDFG amendment allows for up to 81 Congdon’s tarplant individuals to be affected by Road 5 construction activities.”

Figure 2 – Road five after re-grading was conducted. July 11, 2006.

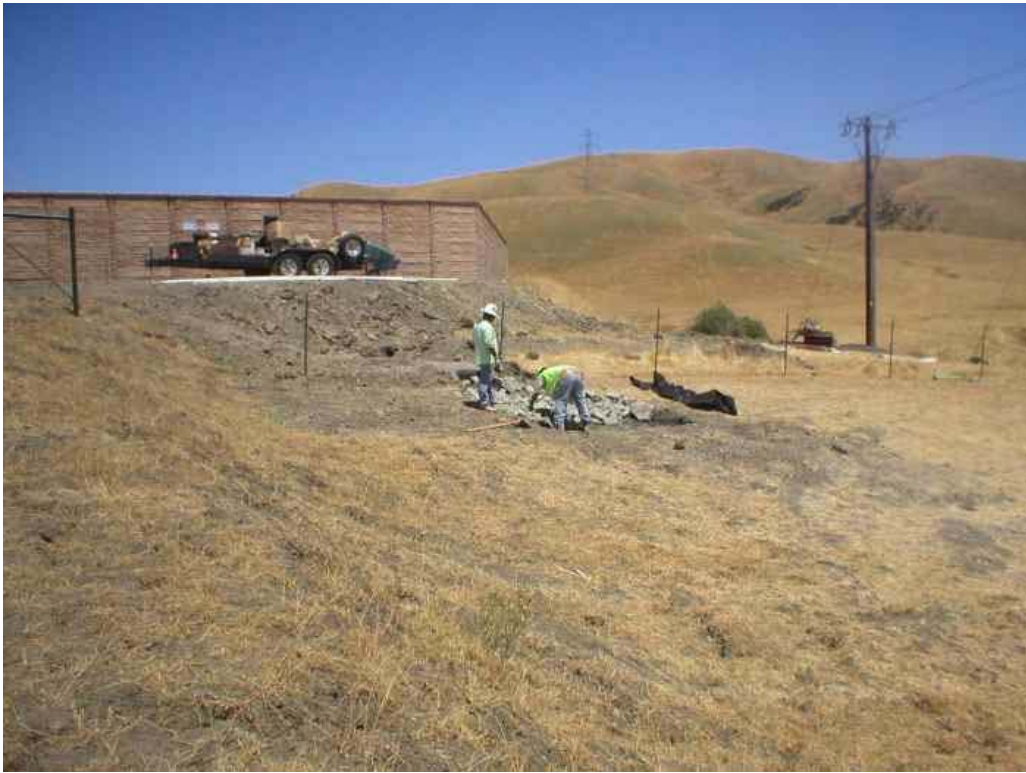
During the subject week, Vitale and Sons continued trenching outside and around the substation wall to install the irrigation line (see Figure 3). The trenches were checked and did contain escape ramps for potentially entrapped wildlife. Sapling trees have been brought to the site for landscape planting, however they will not be planted until a well has been drilled at the site for irrigation.

Figure 3 – Vitale & Sons installing irrigation line around the North Dublin Substation.
July 7, 2006.
