**PROJECT MEMORANDUM**  
**PG&E – TRI-VALLEY 2002 CAPACITY INCREASE PROJECT**

**To:** Jensen Uchida, CPUC  
**From:** Vida Strong, Aspen Project Manager  
**Date:** August 3, 2006  
**Subject:** Weekly Report #118: July 23, 2006 – July 29, 2006  
**CPUC Environmental Monitor (EM):** Anne Sweet Coronado

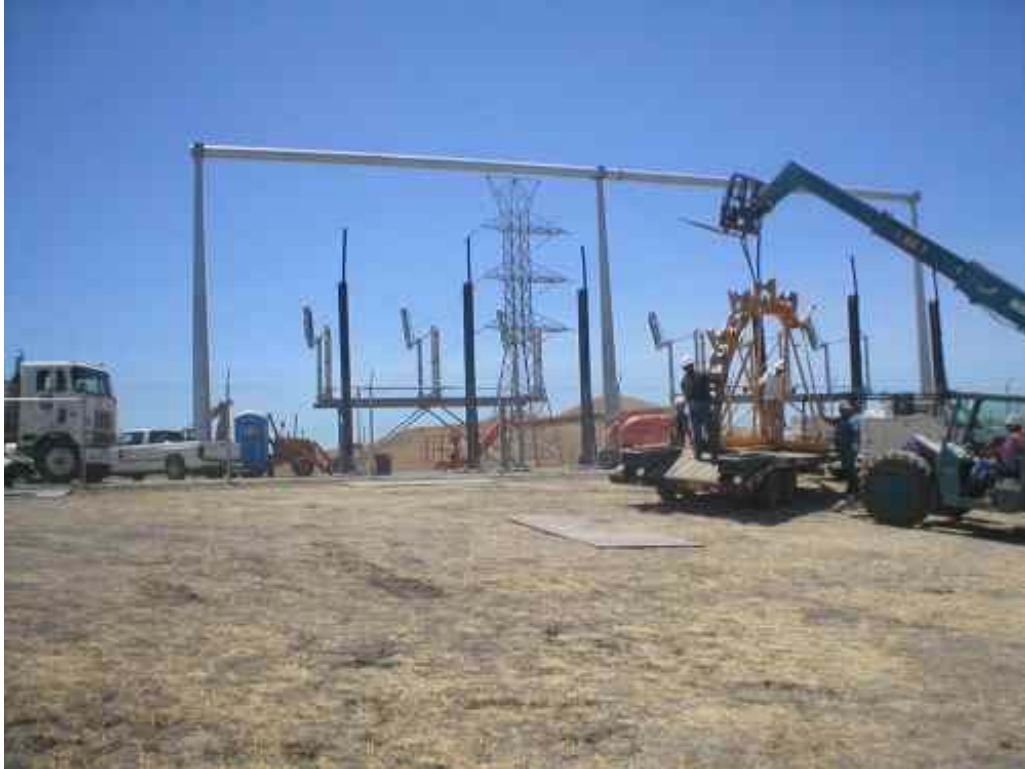
**Figure 1** – Cable pulling operations at Vault 8 next to the Transition Station were completed and crews are shown de-mobilizing from the site. July 25, 2006.

Cable pulling and splicing occurred at Vaults 2, 4, 5, 6, 7 and 8 (located at the Transition Station pad) during the subject week. Crews completed pulling line at Vault 8 (see Figure 1). At the Cayetano Substation a PG&E crew graded, trenched and prepared a communication vault. Cable pulling operations began between Vault 2 and the Cayetano Substation vault during the subject week.

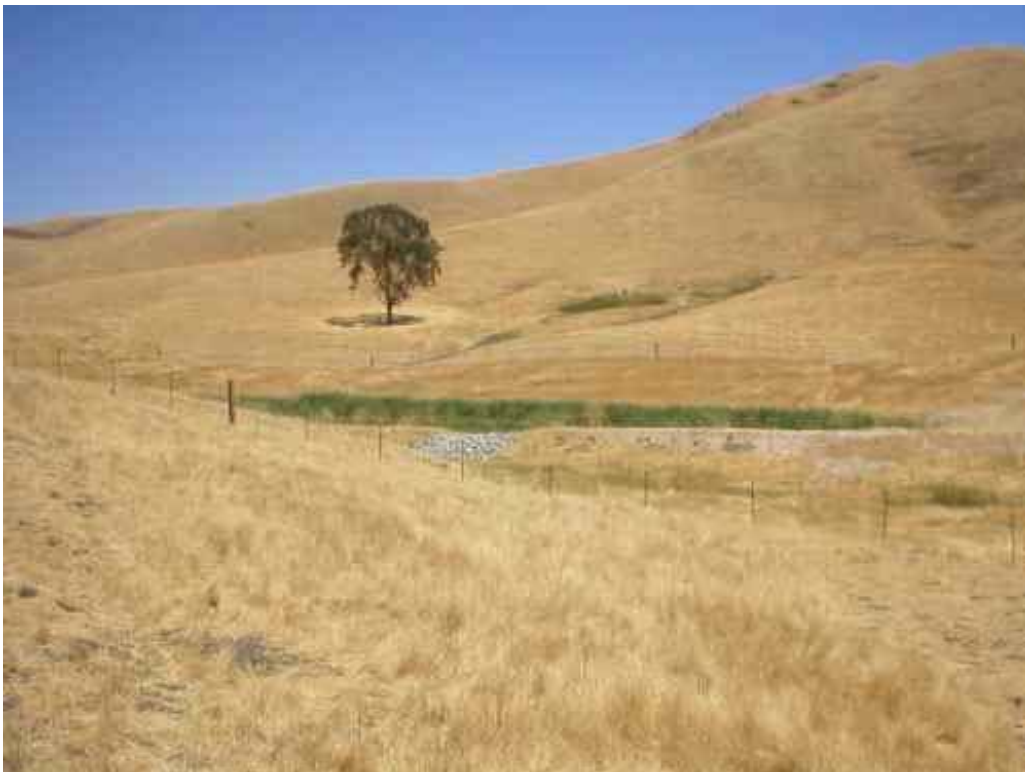
**Figure 2** – The mitigation pond vegetation is doing well. The waterline has gone down quite a bit, but the pond is still holding water, July 25, 2006.

The engineered pond at the mitigation site still contains water, although the waterline has dropped significantly (see Figure 2). Opus has been in communication with Mary Hammer of USFWS to gain clarifications on larval CTS and CRLF monitoring, as well as bull frog eradication protocols covered in the project Biological Opinion.

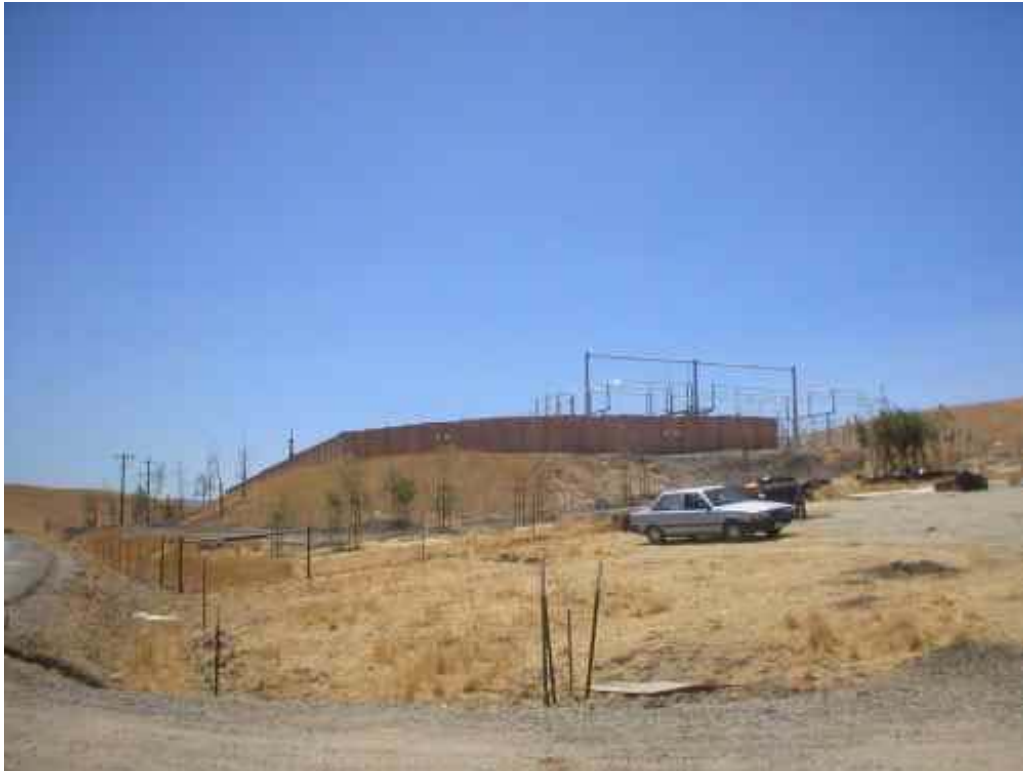
**Figure 3** – Landscape plantings around the North Dublin Substation, July 25, 2006.

During the subject week, Vitale and Sons continued irrigation line work and planted and watered trees outside and around the substation wall (see Figure 3). Martel Water Systems crews conducted well drilling for site irrigation; however, after drilling a very deep (over 500 hundred feet) well they failed to find groundwater. The crew abandoned the well location and grouted the hole. They will be drilling at another location at the opposite corner of the site.
