PROJECT MEMORANDUM
PG&E – TRI-VALLEY 2002 CAPACITY INCREASE PROJECT

To: Jensen Uchida, CPUC
From: Vida Strong, Aspen Project Manager
Date: August 15, 2006
Subject: Weekly Report #120: August 6, 2006 – August 12, 2006
CPUC Environmental Monitor (EM): Anne Sweet Coronado

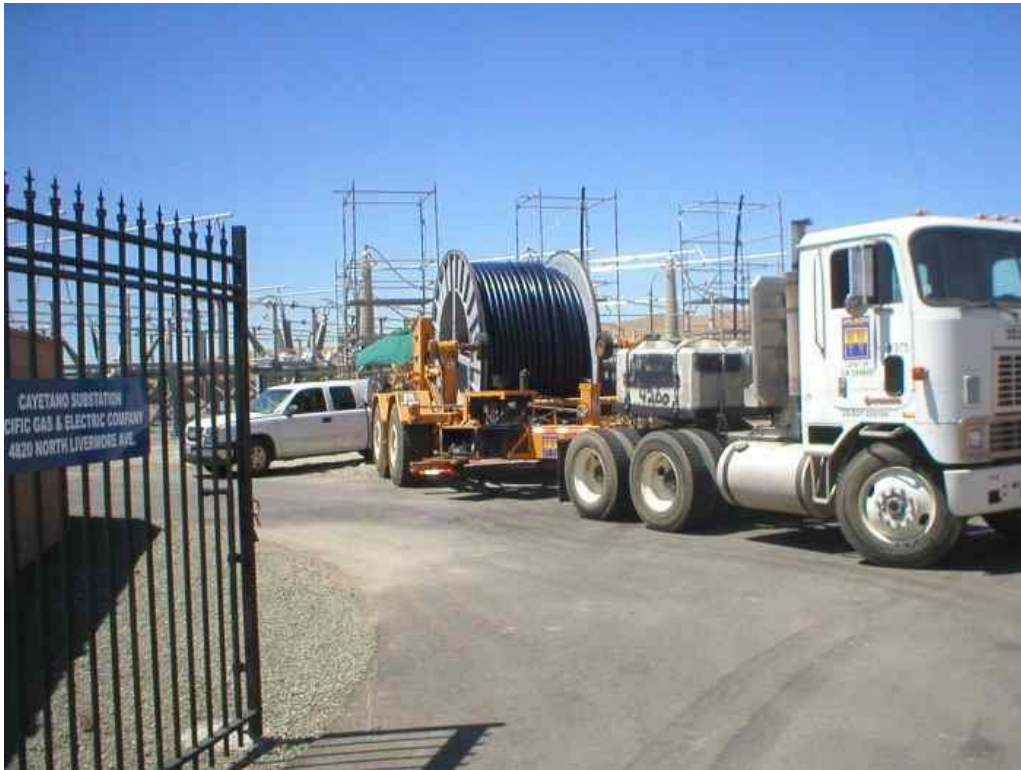
Figure 1 – At the Cayetano Substation, cable was pulled through Vault 2. August 10, 2006.

Cable splicing occurred at Vaults 2, 7, and 8 during the subject week. The final cable reel arrived at the site during the subject week. Crews pulled cable between the Cayetano Substation and Vault 2 (see Figure 1).

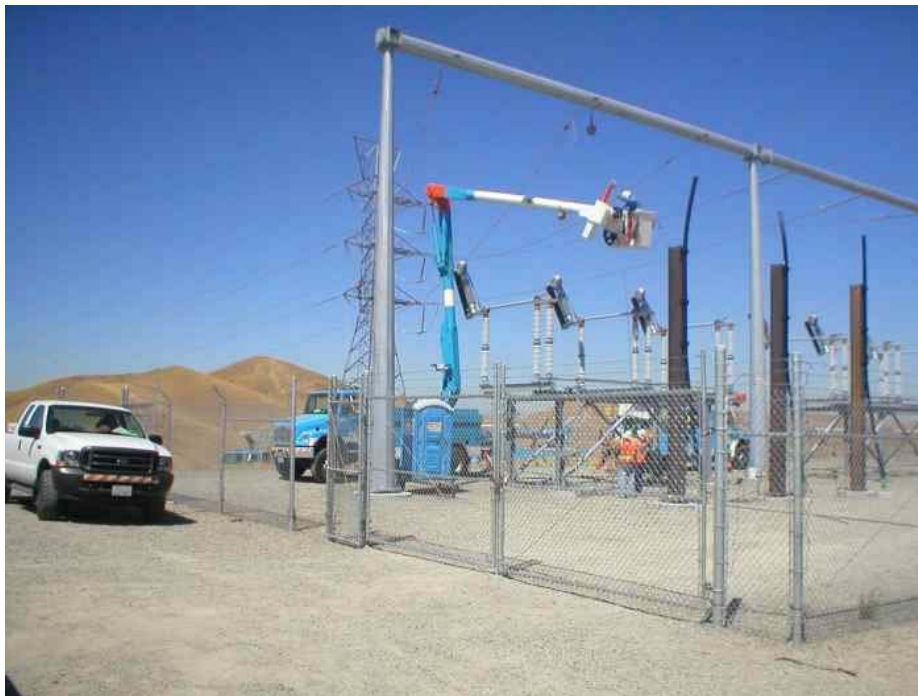
Figure 2 – Transition Station, August 10, 2006.

On Monday, May 15th, Wilson Construction re-erected the beam structure at the Transition Station. Per Opus, a “high-frequency line” was installed with the structure in an effort to prevent the beam movement previously caused by wind and resonance. No issues have been reported. During the subject week, crews installed drops which connect the overhead line to the underground line from the tower located at the Transition Station (see Figure 2).

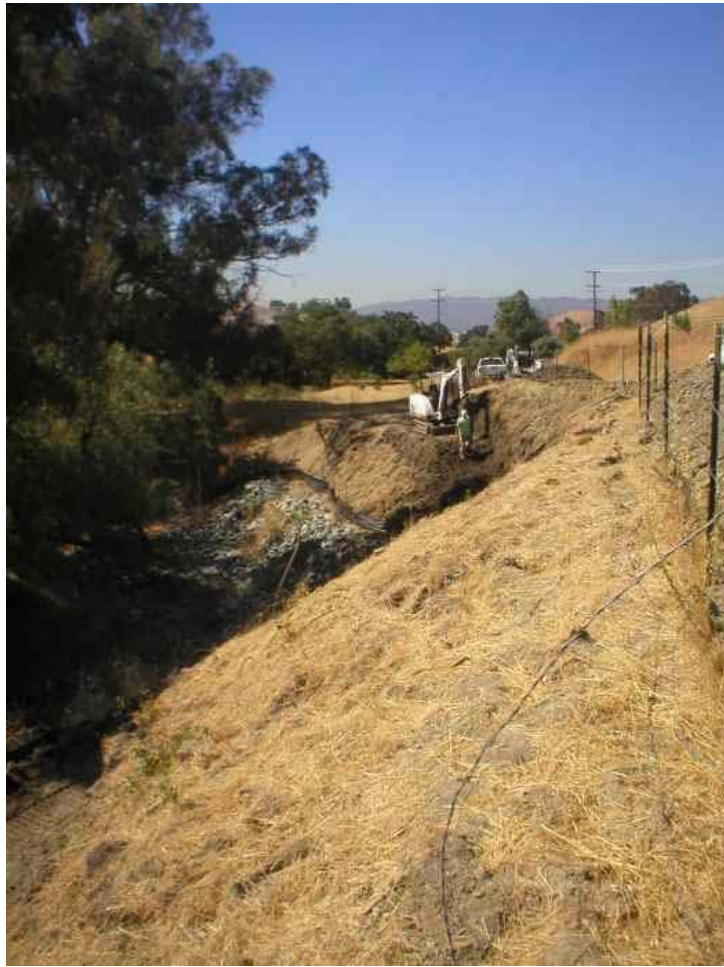
Figure 3 – Bank stabilization work adjacent to Tassajara Creek, August 10, 2006.

Along Moller Road, the CPUC EM had previously noted that the area upslope from the Tassajara Creek bank stabilization area showed poor grass growth and that the installed jute netting was ripped and had pulled away from the slope, possibly preventing further vegetative growth. The CPUC EM also noted that soil had slumped down the slope. NVC started bank restoration efforts during the subject week (see Figure 3). NVC also started repair work on culverts located along Moller Road and they cleaned v-ditches in preparation for concrete lining (see Figure 4).

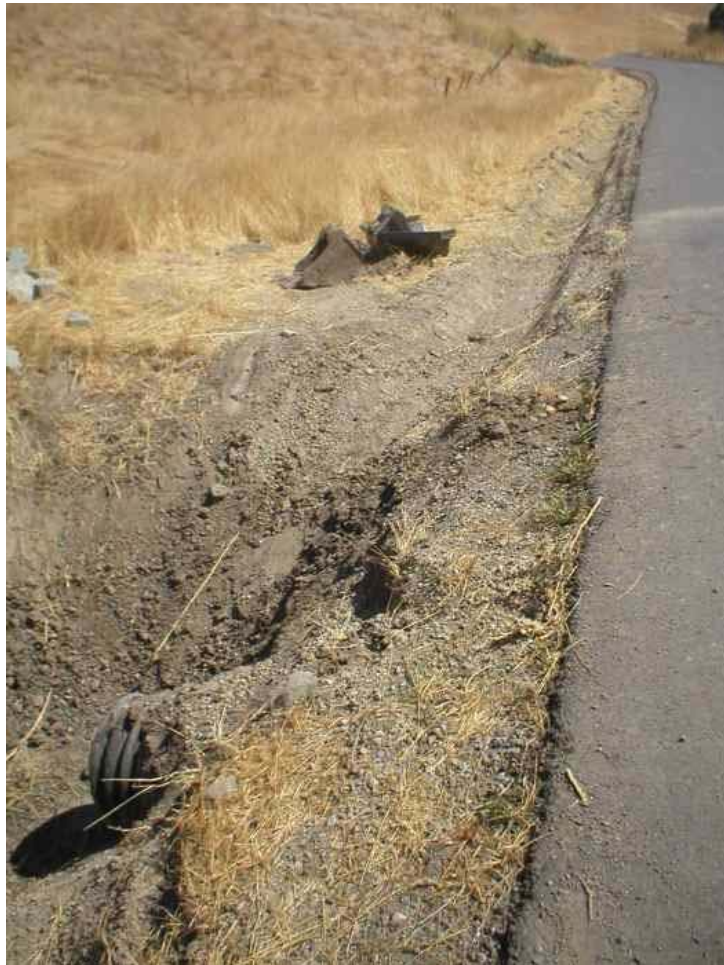
Figure 4 - NVC cleaned out culverts and v-ditch area along Moller Road during restoration activities, August 10, 2006.

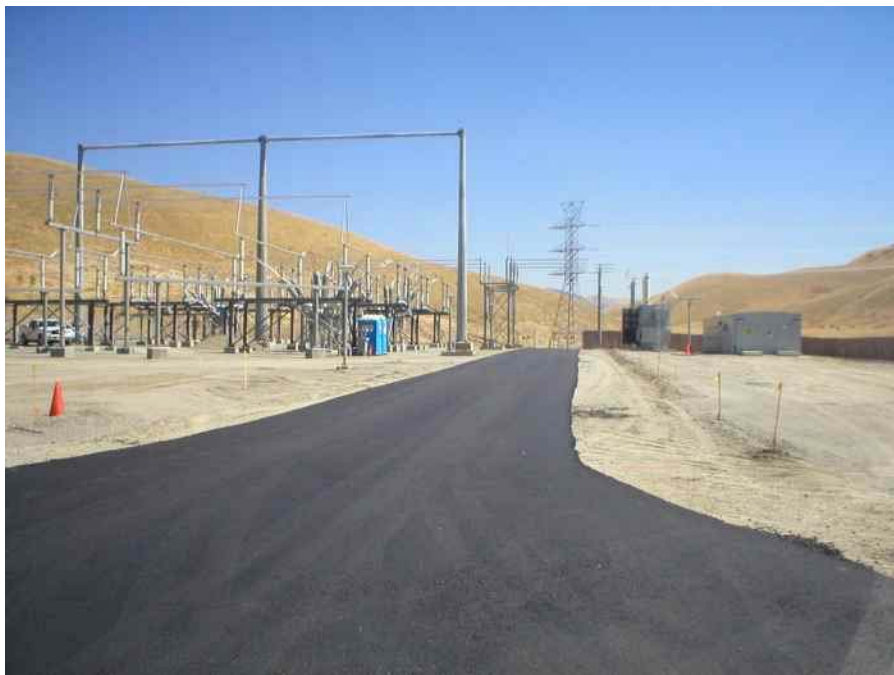
Figure 5 – Granite laid asphalt at the North Dublin Substation, August 10, 2006.

Black & Veatch has been overseeing work at the North Dublin Substation. Granite Construction has returned to conduct earthwork on the site. During the subject week, Granite continued grading and laid asphalt both in the substation and along the station approach ramp (see Figure 5). PG&E crews conducted electrical work in the switchgear buildings. Crews also pulled fiber optic cable.
